KEMPSEY
Shire Council

DIRECTOR SHIRE SERVICES REPORT

| DSS6 | BELLBROOK WATER SUPPLY |

This report is an update on the Bellbrook water supply.

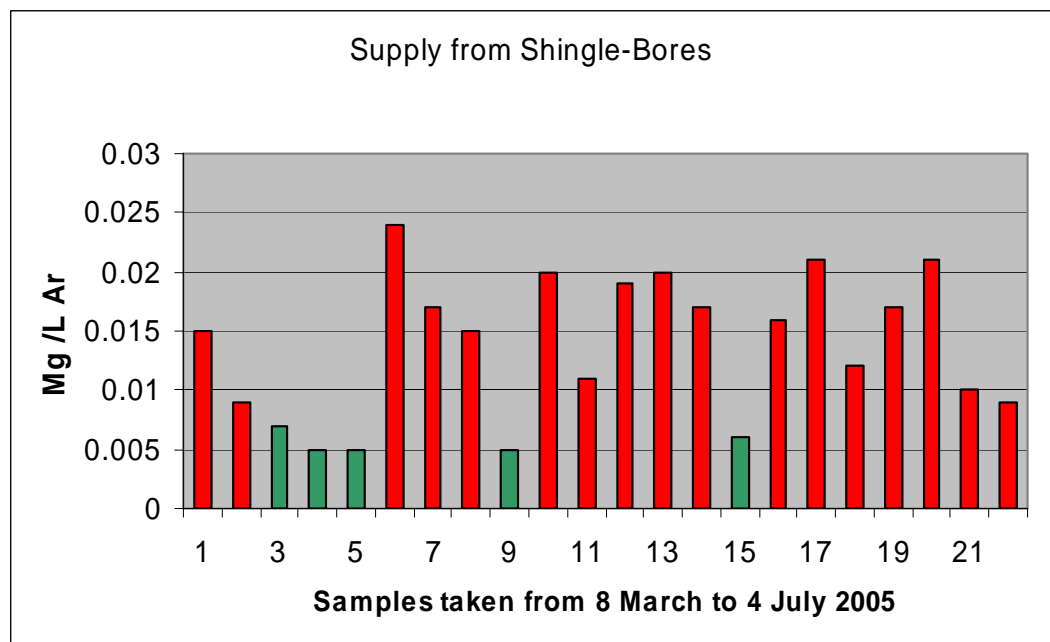
Figure 1: Project Monitoring Results - Round 1 – Southern Bores

The results of the initial sampling period can be seen graphically in Figures 1 and 2. The bore water source had 11 failures of 12 weekly samples in the period 16/5/05 to 4/7/05. The surface water had significantly better water quality than the bores and the quality met ADWG. Macleay Water 's response to these results after consultation with NSW Health was to decommission the bores (southern bores), make the interim source of water the river surface water (and carting when necessary) and that a new bore be trialled on the north side of the river (called the North Bore).

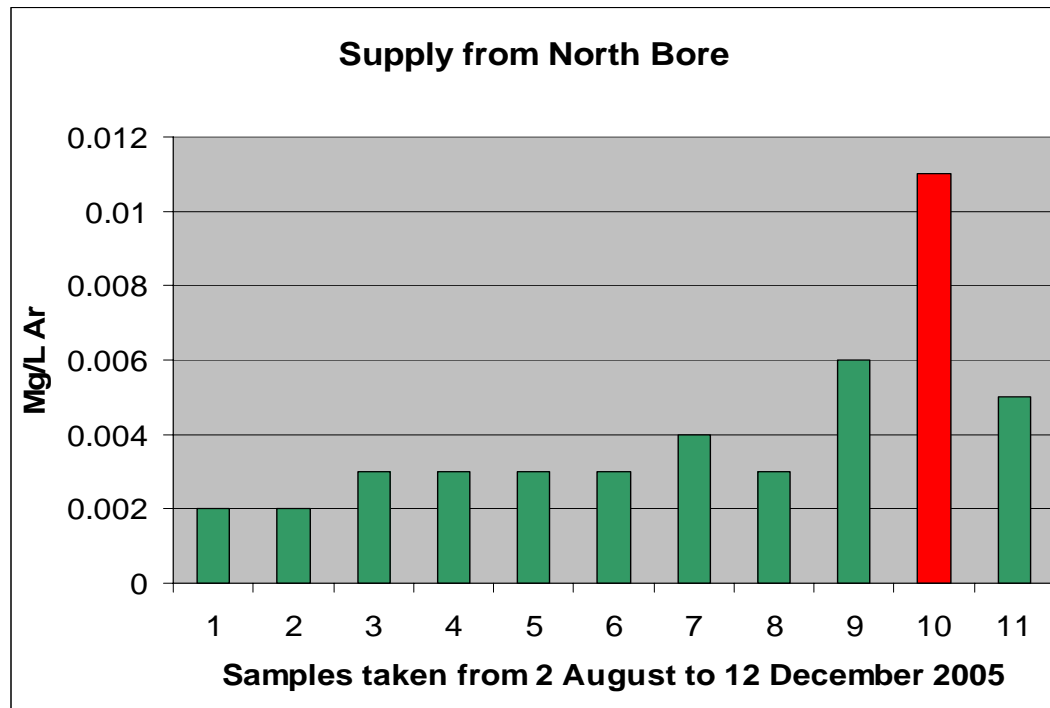
Figure 3: Project Monitoring Results - Round 3 – North Bore

A further project monitoring program (Round 3) was established to assess the water quality (chemical analysis) of the North Bore. The results of the Round 3 project monitoring, are shown in Figure 3 (arsenic results only, other chemicals not shown). Based on the improved results, in early March, NSW Health determined that the North Bore supply was suitable to use.

Before a determination was made the water quality of the North Bore deteriorated with considerable ADWG failures on 6/3/06. A fourth project monitoring program was granted to further monitor the water quality before a decision on the suitability of the North Bore as a permanent supply source could be determined. This fourth round of project monitoring is now one month into a four month assessment.

The current round of project monitoring of the north bores is underway and is not due to conclude until late August. A long-term solution cannot be determined until after this monitoring period concludes. If the bore water results continue to prove unsatisfactory, options such as a water treatment plant will need to be considered.
