Kempsey Shire Council

Toose Road Landslide Remedial Works

Temporary Remedial Preliminary Concept Design Development

Reference: 293180-GE-RPT-02

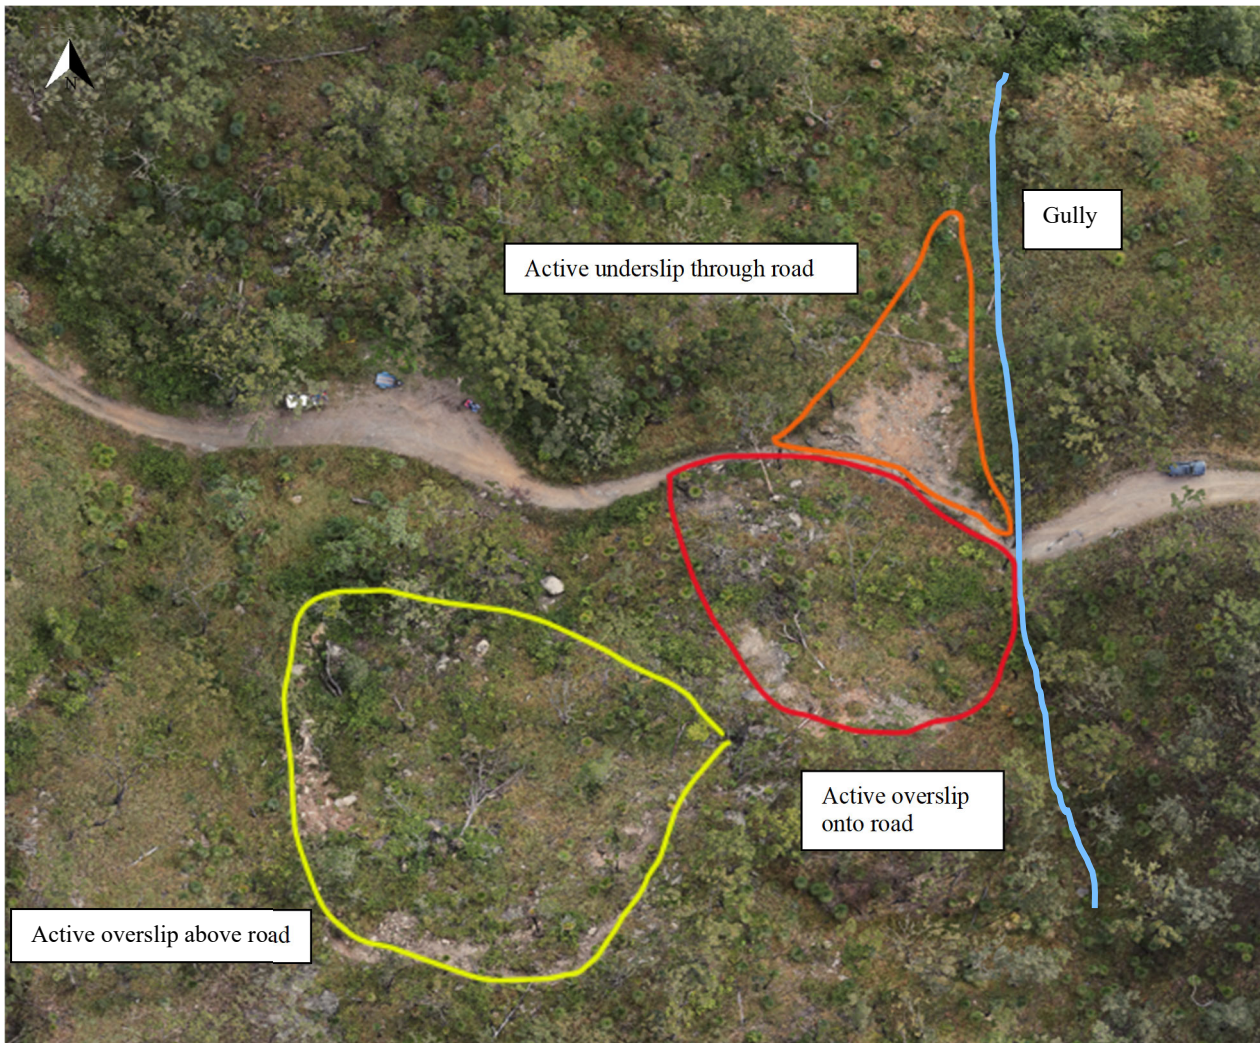
Figure 1: Aerial photographs from April 2023 annotated with observed features adjacent to the closed section of road

Figure 1 shows the aerial photography captured in April 2023 annotated with site features observed during the recent site visit and on the provided drone photography. Figure 2 shows a photograph captured by Diospatial in April 2023 compared to a photograph captured by Council in April 2022.

Comparison of the April 2022 to April 2023 photographs and observations during the site visit on 13 January 2023 and visit on 24 March 2023 indicates the overslip (yellow) to be active and currently moving. This is a development in understanding from the new information available since the desktop study.

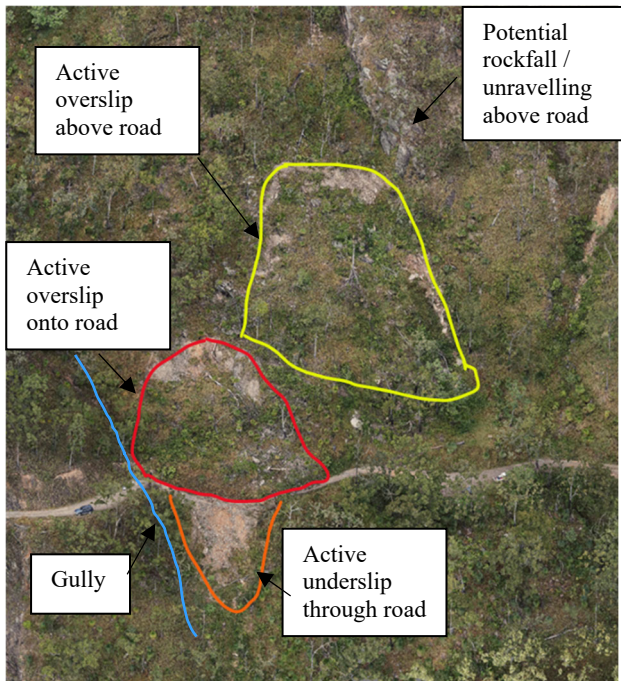
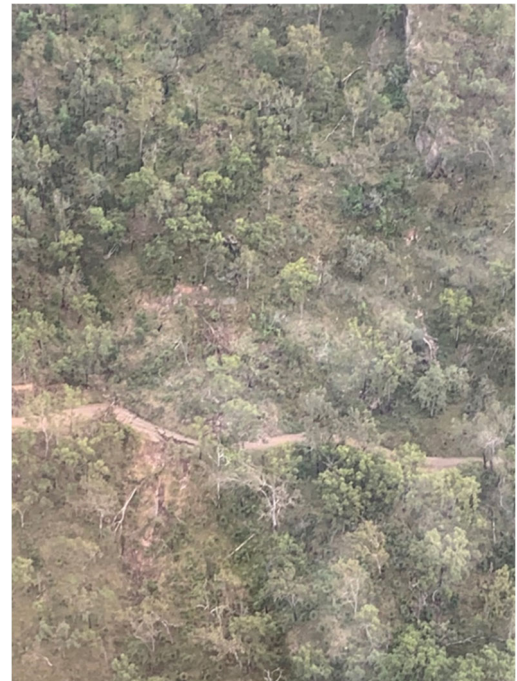
Figure 2: Annotated drone photographs from April 2023 compared to a similar photograph from April 2022

- The ‘active slip onto the road’ (shown in red in Figure 2 and Figure 3) is relatively shallow translational failure, approximately 1 to 2m deep, extending about 50m along the slope.
- There is a shallow (estimated about 0.5m thick) layer of vegetation / root mat and topsoil. Underneath this is probably a finer mat of colluvium / talus material and transition zone of up to about 1m thick. These two layers are what enabled the moisture to be held leading to the active overslip failure onto the road.
- The ‘active underslip through the road’ (shown in orange in Figure 2 and Figure 3) appears to be through fill comprising reworked colluvium assumed to be from cut to fill for construction of the road. It is up to about 2m deep and likely contributed by erosion from flows down the gully.

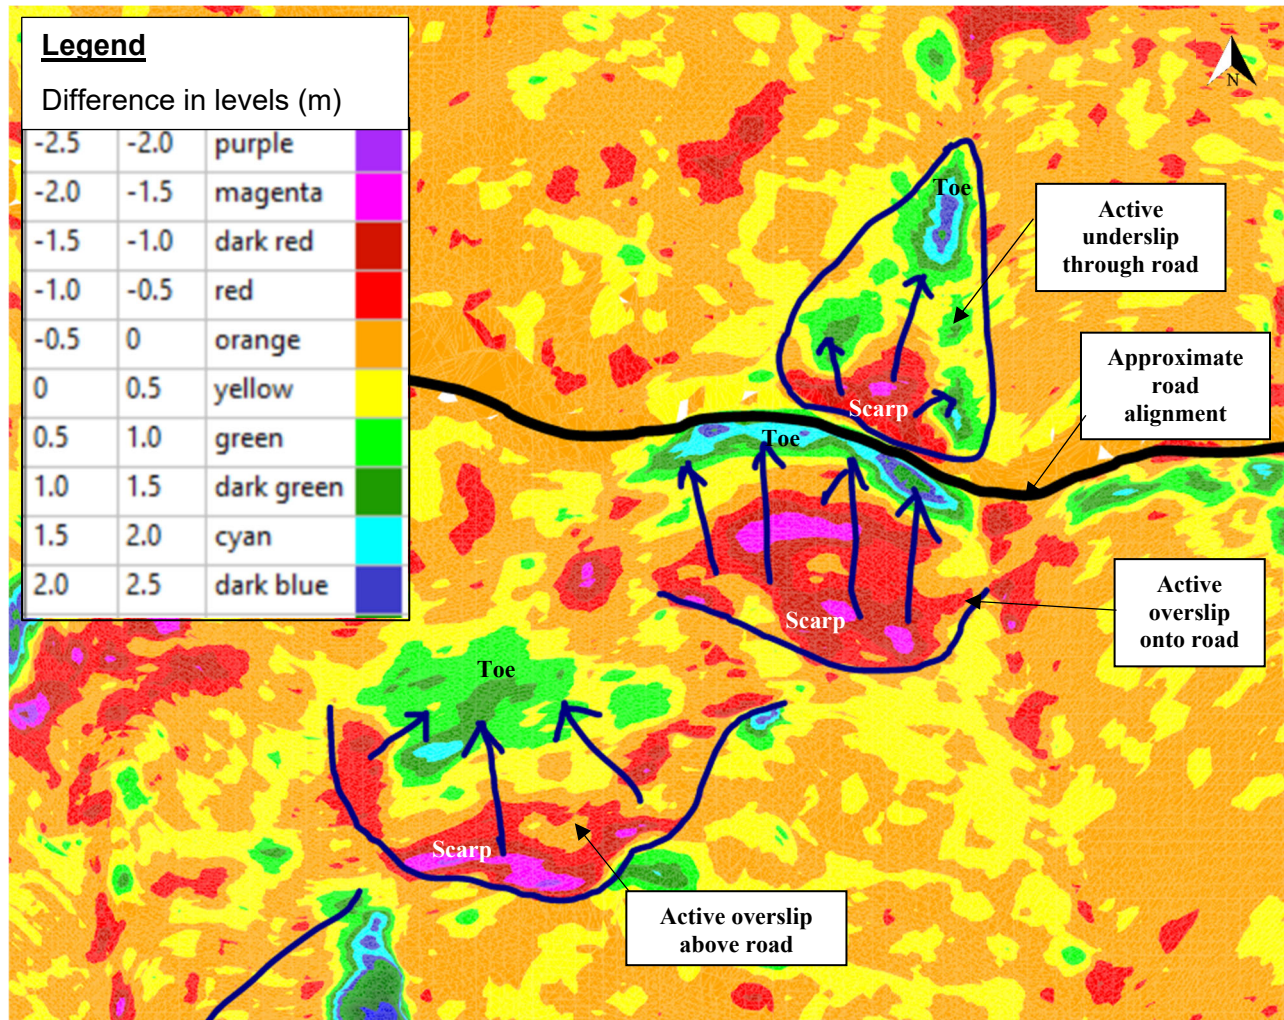
Figure 3: Comparison of 2023 and 2018 LiDAR

The LiDAR captured by Diospatial in April 2023 was compared to the LiDAR previously provided by Council which was understood to be captured in May 2018. An annotated plot of the difference in depth between the two LiDAR sets is provided in Figure 3 below. The slips shown in Figure 1 and Figure 2 are also sketched onto the plot in Figure 3. The scarp and toe of each slip can be seen.

It is noted that the 2018 LiDAR was previously understood to be in GDA94 datum, however on comparison to the Diospatial LiDAR appeared to be to the same datum i.e. GDA2020 datum. This was discussed with Council on 1 May 2023 and it was noted that there are known instances where similar data is labelled as GDA94 but is in GDA2020. It was suggested that if it looks like the 2018 data is in GDA2020 it probably is, so we have assumed that both data sets are in GDA2020.

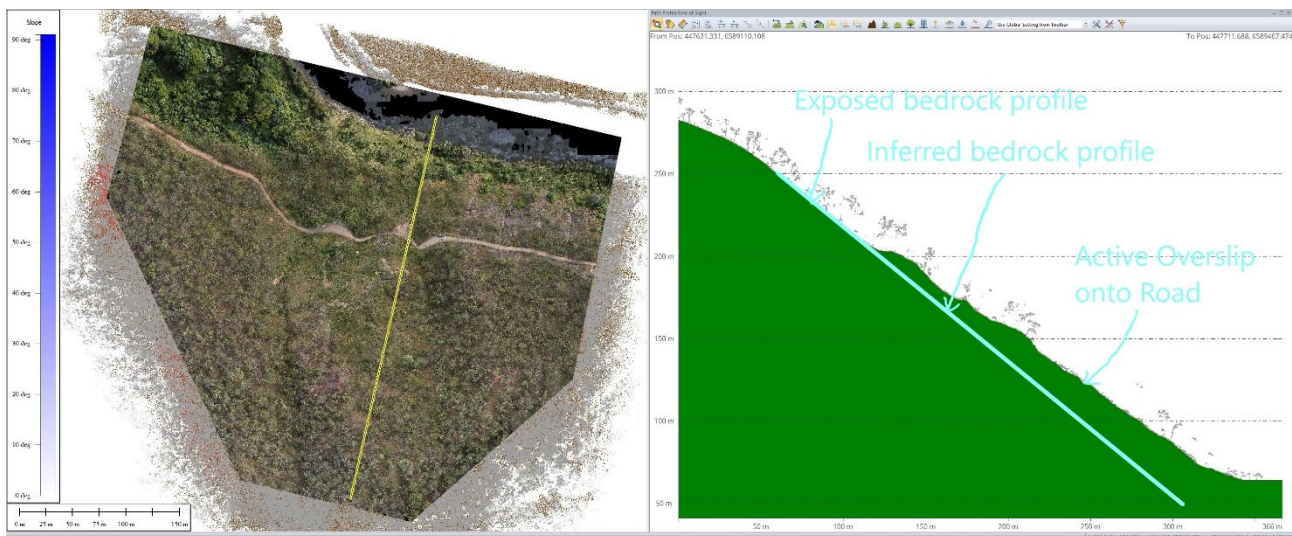
Figure 4: Section prepared by Diospatial with Inferred Bedrock Profile Annotated

- The geotechnical profile at the slip site is expected comprise colluvium / talus overlying metasiltstone bedrock at depth.
 - The colluvium is expected to be a mixture of sand, silt, gravel, and larger size rock pieces derived from the metasiltstone siltstone bedrock.
 - The metasiltstone bedrock in the vicinity of the slip is expected to be around 25m deep at the ‘active overslip’ based on extrapolating the slope of the exposed bedrock between RL 200 to 250m through the slip plane (refer to Figure 4).

This is supported by the geophysical investigation undertaken by GHD (GHD, 2022) which concluded a range of 17m to 34m to bedrock at the slip site.

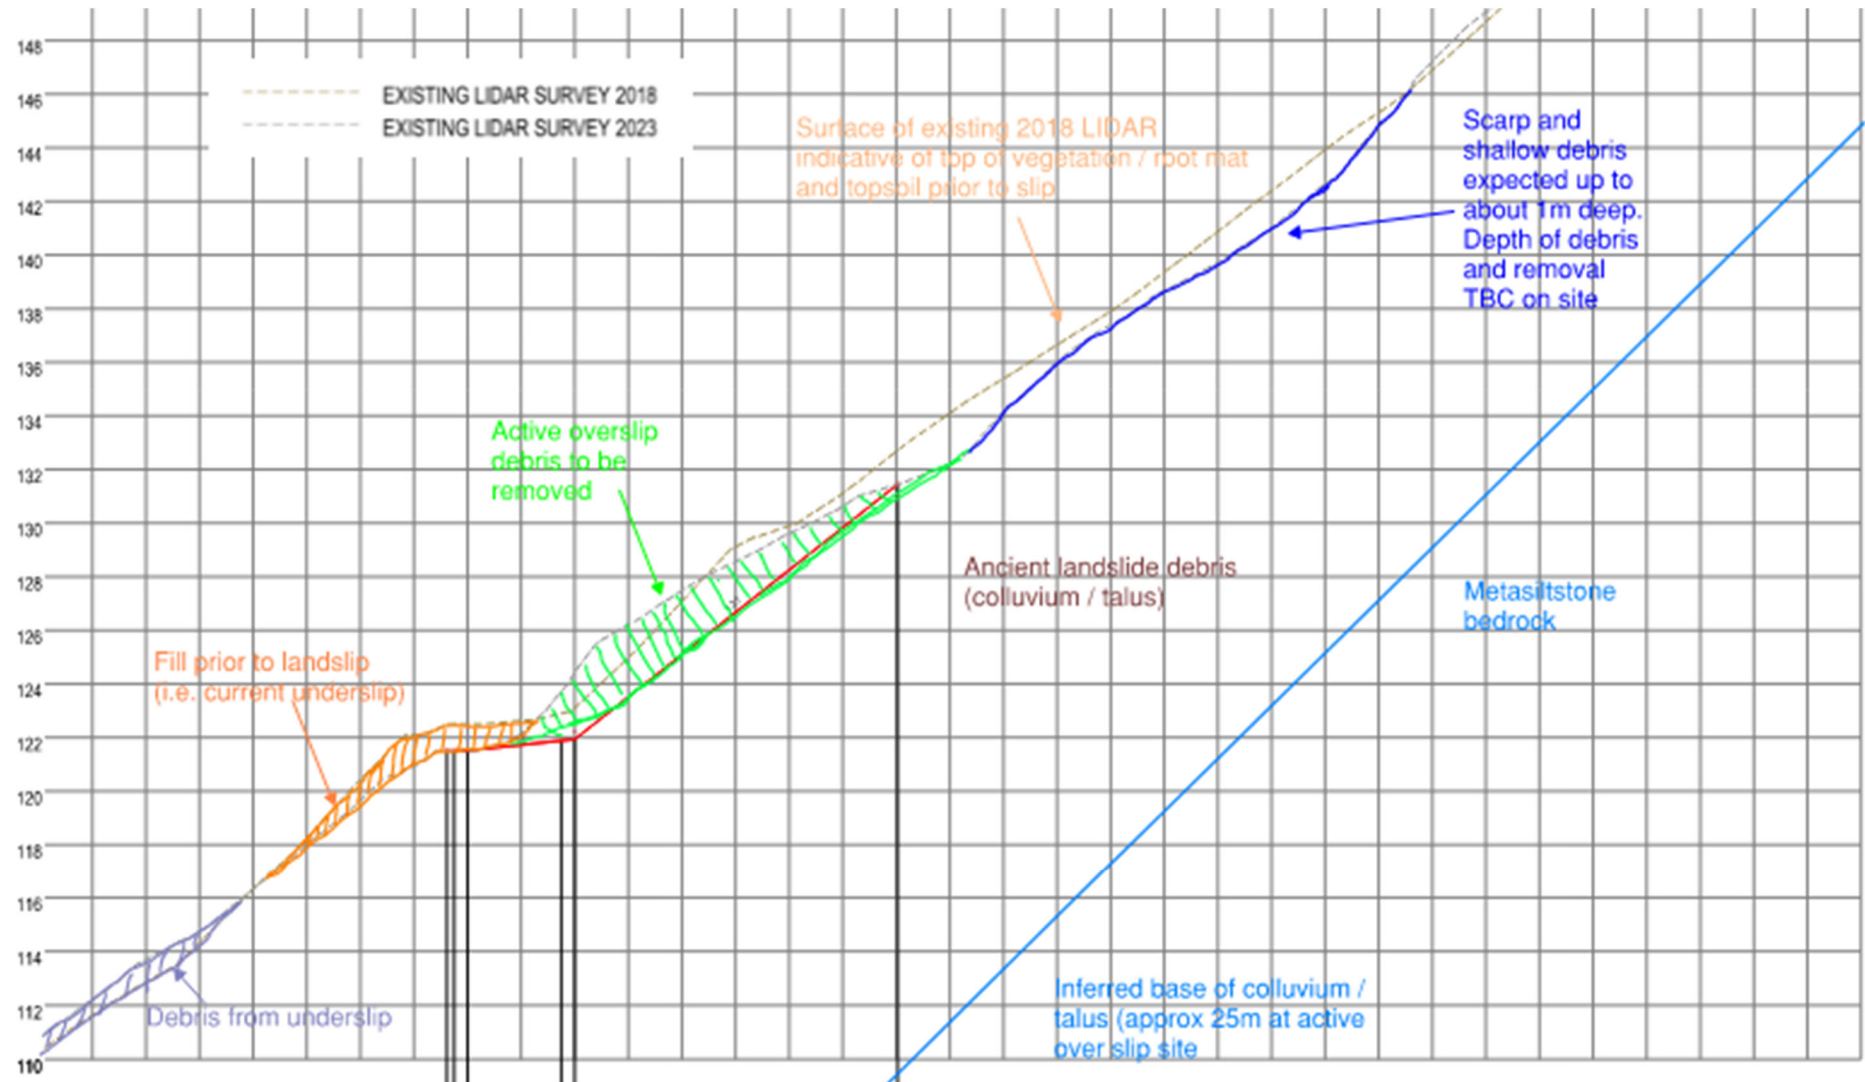
Figure 5: Inferred Geotechnical Profile

From site observations and comparison of LiDAR the following has been inferred about the slips currently impacting the road:

A section (annotated version of Chainage 50 from the draft of the earthworks Preliminary Concept drawings) showing the inferred geotechnical profile is presented in Figure 5 below.

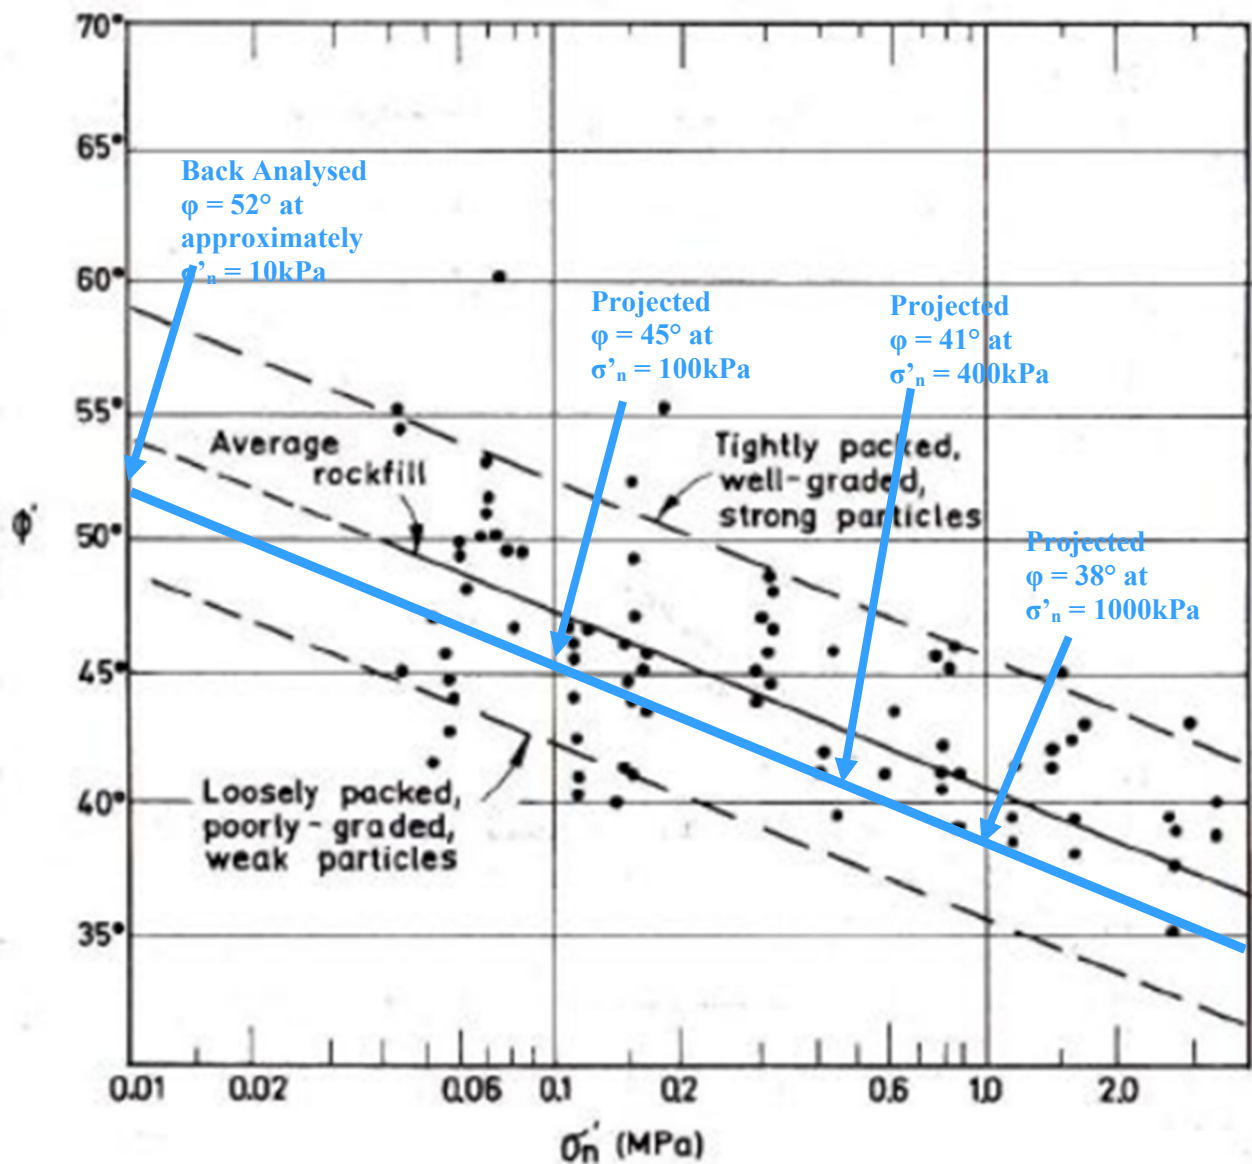
Figure 6: Annotated Triaxial Tests Results for Rockfill from LEPs 1970 (reproduced from (Barton, 1981)) blue line represents Site specific back analysis for Toose Road

For the stability analysis we have assumed a $\phi = 52^\circ$ at an effective normal stress of approximately 10kPa based on the back analysis, and ϕ that reduces with normal effective stress as shown annotated on Figure 6 (reproduced in kPa in (Barton, 1981)).

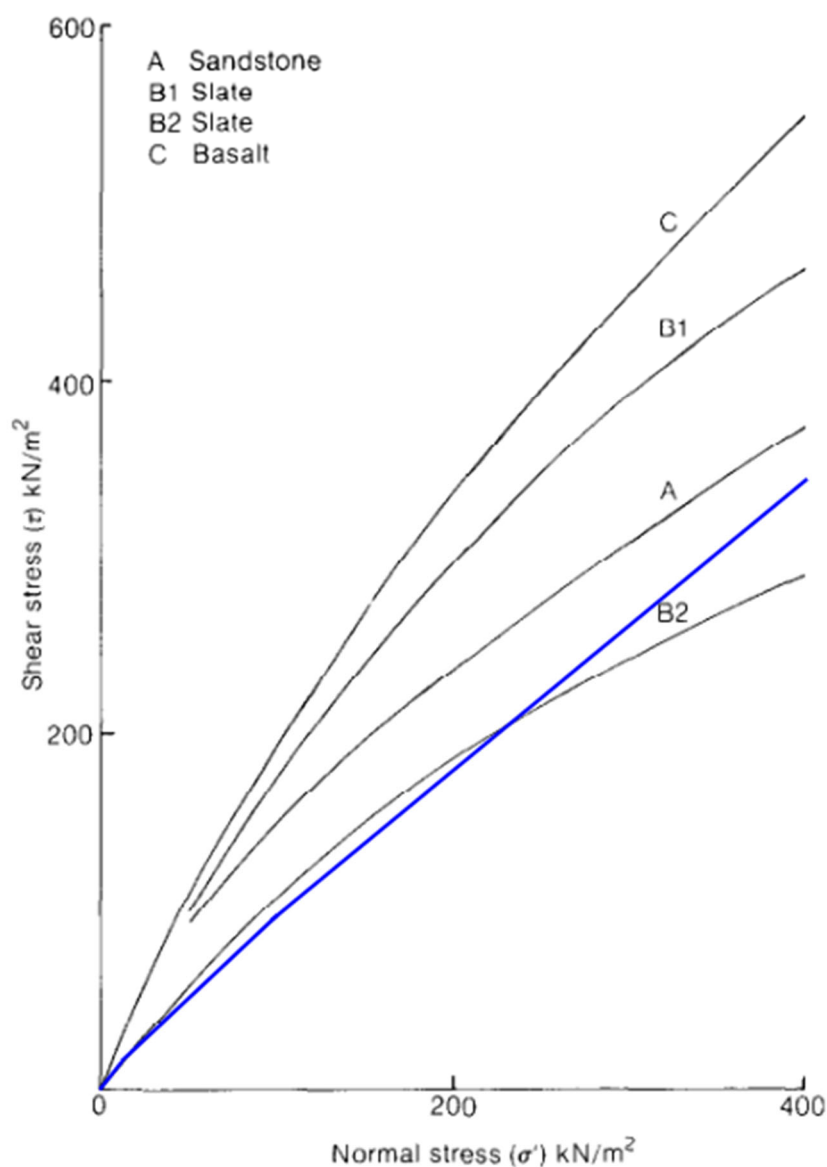
Figure 7: Annotated excerpt from Charles and Watts (1980) [7] showing adopted strength overlain for comparison.

Additionally the adopted model was compared against the strength model presented in Charles and Watts (Watts, 1980) which was based on large scale triaxial testing of heavily compacted rockfills. Charles and Watts noted that 'the weak, soft slate (B2) might have been rejected as unsuitable for rockfill in many civil engineering works'. The approximate shear stress values converted from selected ϕ values on Figure 7 have been overlain for comparison.

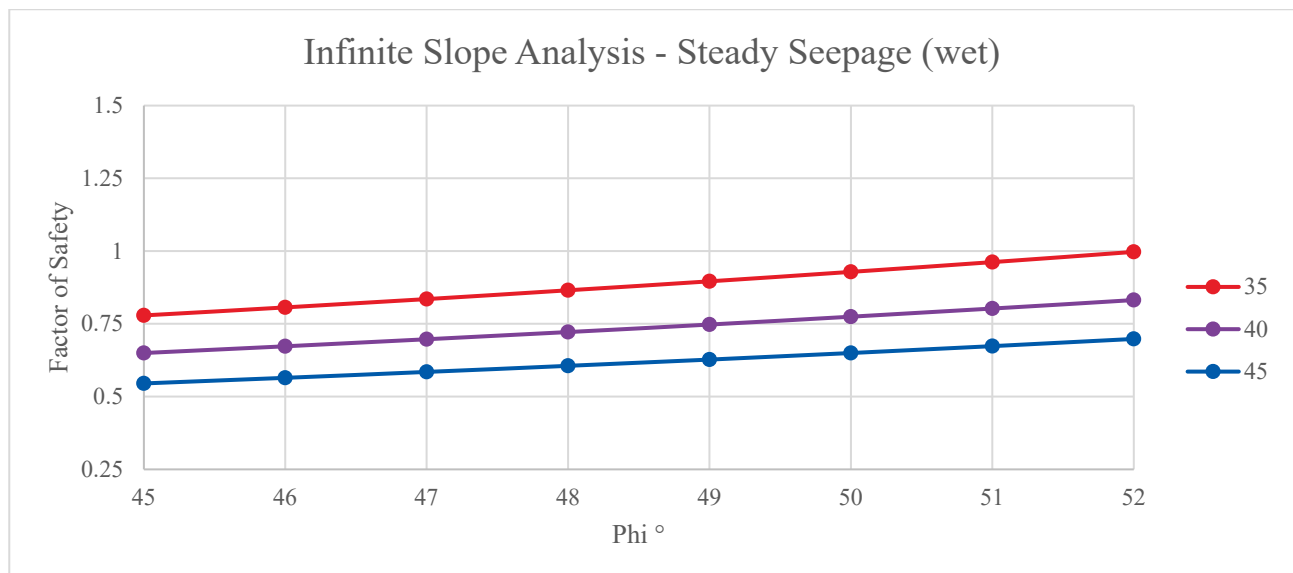
Figure 8: Results of Infinite Slope Analysis – Steady State Seepage (wet)

Infinite slope analysis both with and without steady state seepage (i.e. wet and dry) are presented in Figures 8 and 9 respectively. The analysis has been carried out for slope angles of 35°, 40° and 45° with a range of ϕ angles from 45° to 52° being the expected range of ϕ within about 5m depth. The results are discussed below:

The ‘wet’ slope arrangements analysed all have a low FoS, typically below 1. Indicating that further movements are to be expected, especially during periods of high rainfall. Given the performance of the slopes over varying slope angles and climactic conditions it is considered unlikely that operative friction angles below 50° are possible for near surface material within the expected depth of the saturated slip plane. This is supported by reference to published literature.

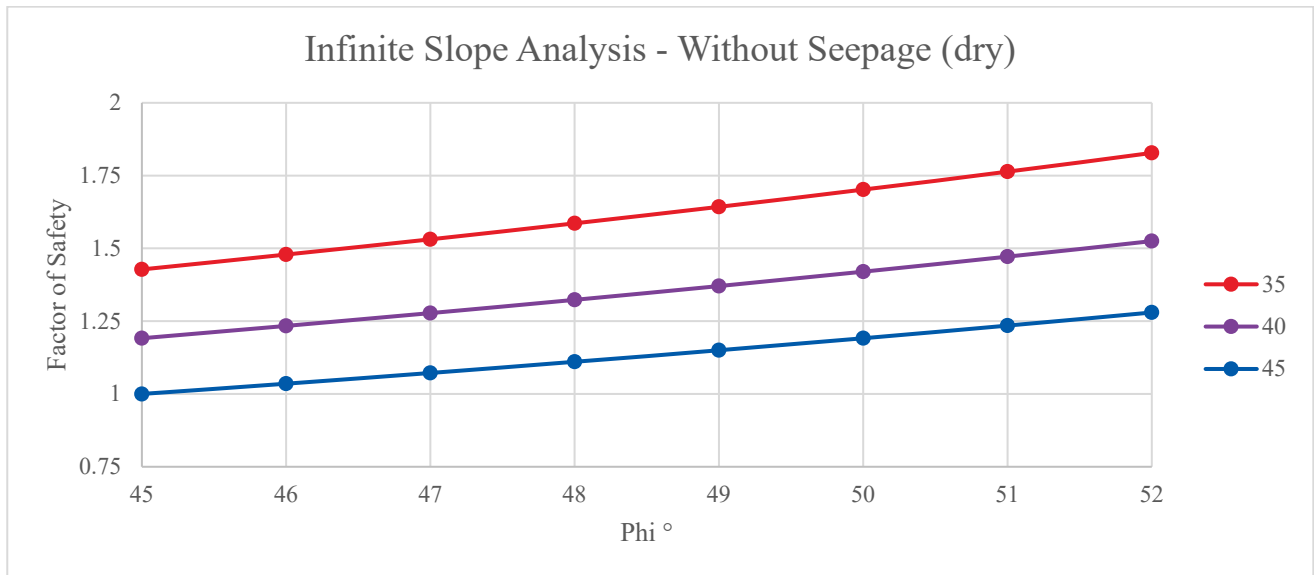
Figure 9: Results of Infinite Slope Analysis – Without Seepage (dry)

- The ‘dry’ slope arrangements analysed showed:
 - The FoS for $\phi = 52^\circ$ had a factor of safety above 1.25 for all slopes angles analysed.
 - The factor of safety reduces with increased slope angle or reduced ϕ value. The sensitivity analysis indicates the FoS is less than 1.25 for a slope angle of 40° and ϕ of less than 47°, and a slope angle of 45° and ϕ of less than 52°.

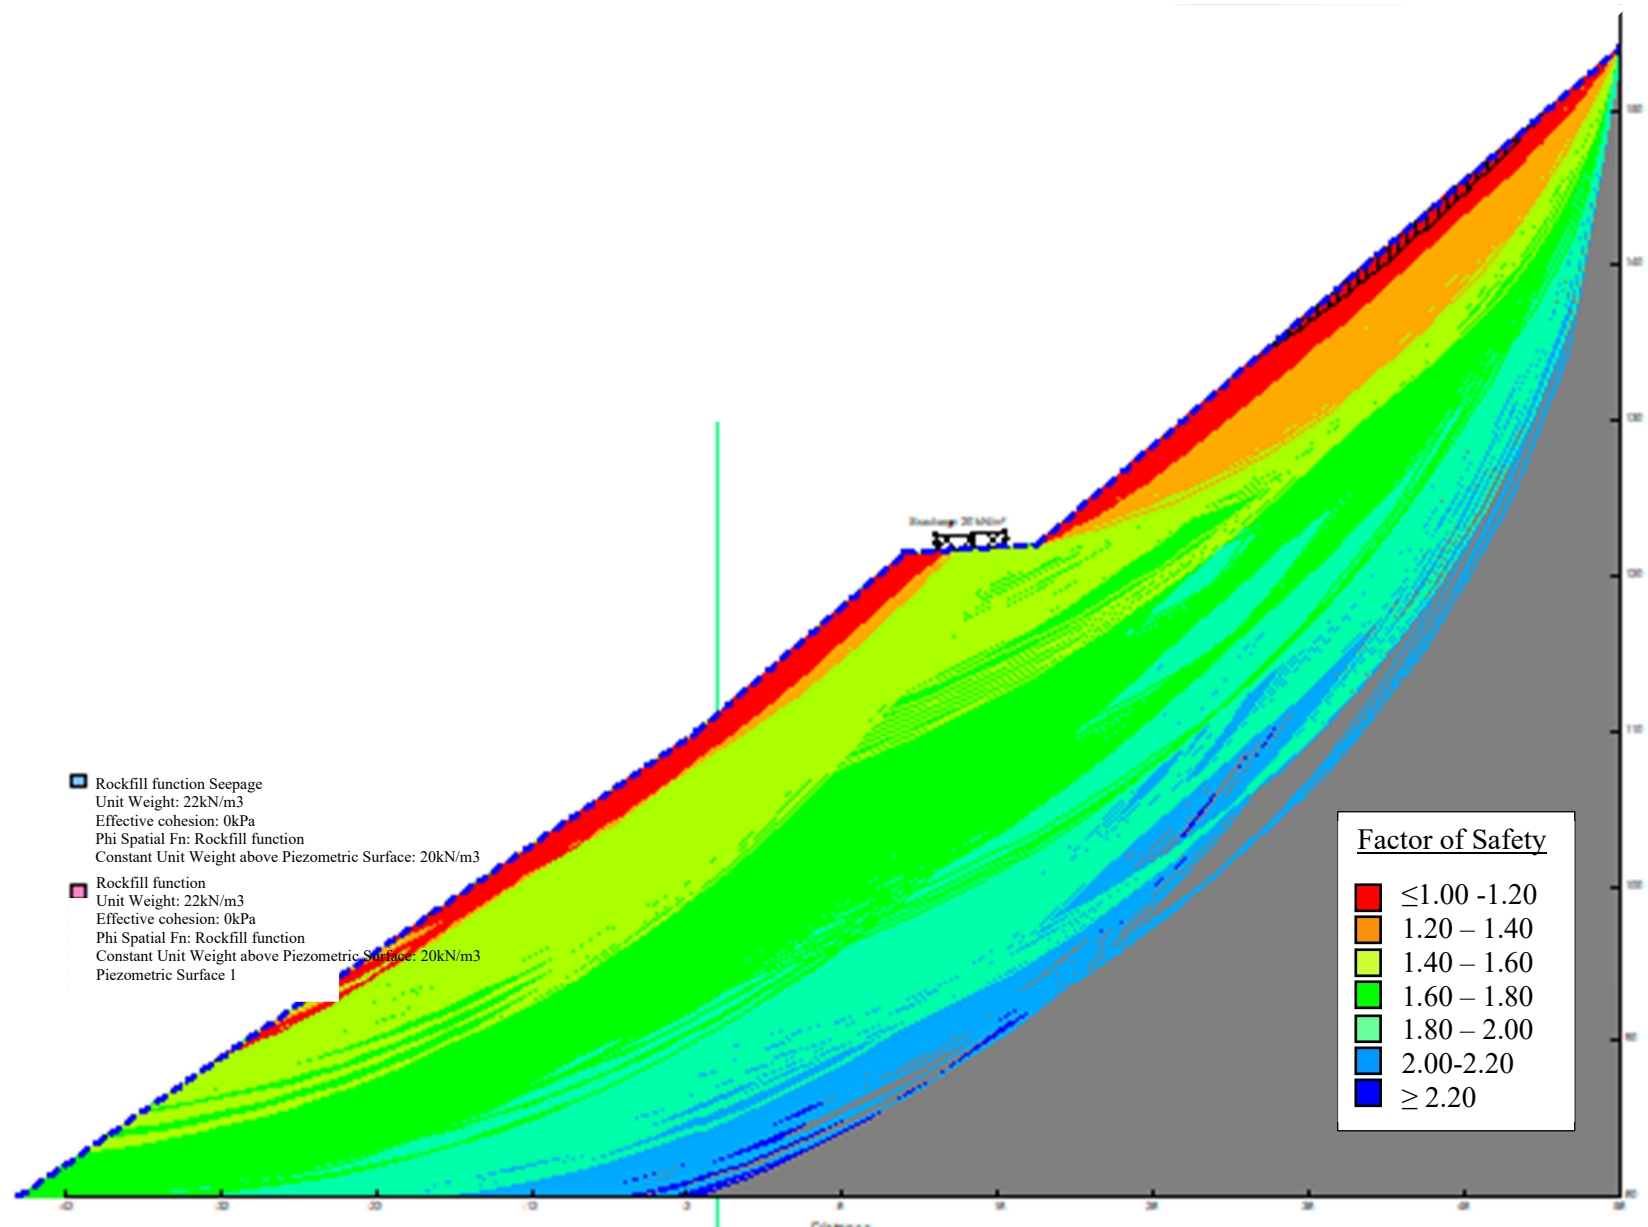
Figure 11: Slope/W Result for 'Wet Shallow' Slope Analysis

Analysis Scenario	FoS
Wet shallow	0.37
Wet deep (i.e. minimum 3m slip surface depth)	1.24
Dry	1.32

- The ‘wet shallow’ slope is marginally stable. Further shallow movements are to be expected both up and down slope, especially during periods of significant rainfall. This will reflect any surface saturation moving any loose rocks down the surface. Similar movements can be observed currently on site.
- The ‘wet deep’ slope has an adequate a FoS, i.e. above 1.2.
- The ‘dry’ slope has an adequate FoS, i.e. above 1.25.
