*rehabilitation*  
**plan**

**Gills Bridge Creek  
SOUTH KEMPSEY NSW**

**Final July 2007**

## Rehabilitation Plan Gills Bridge Creek, South Kempsey, NSW

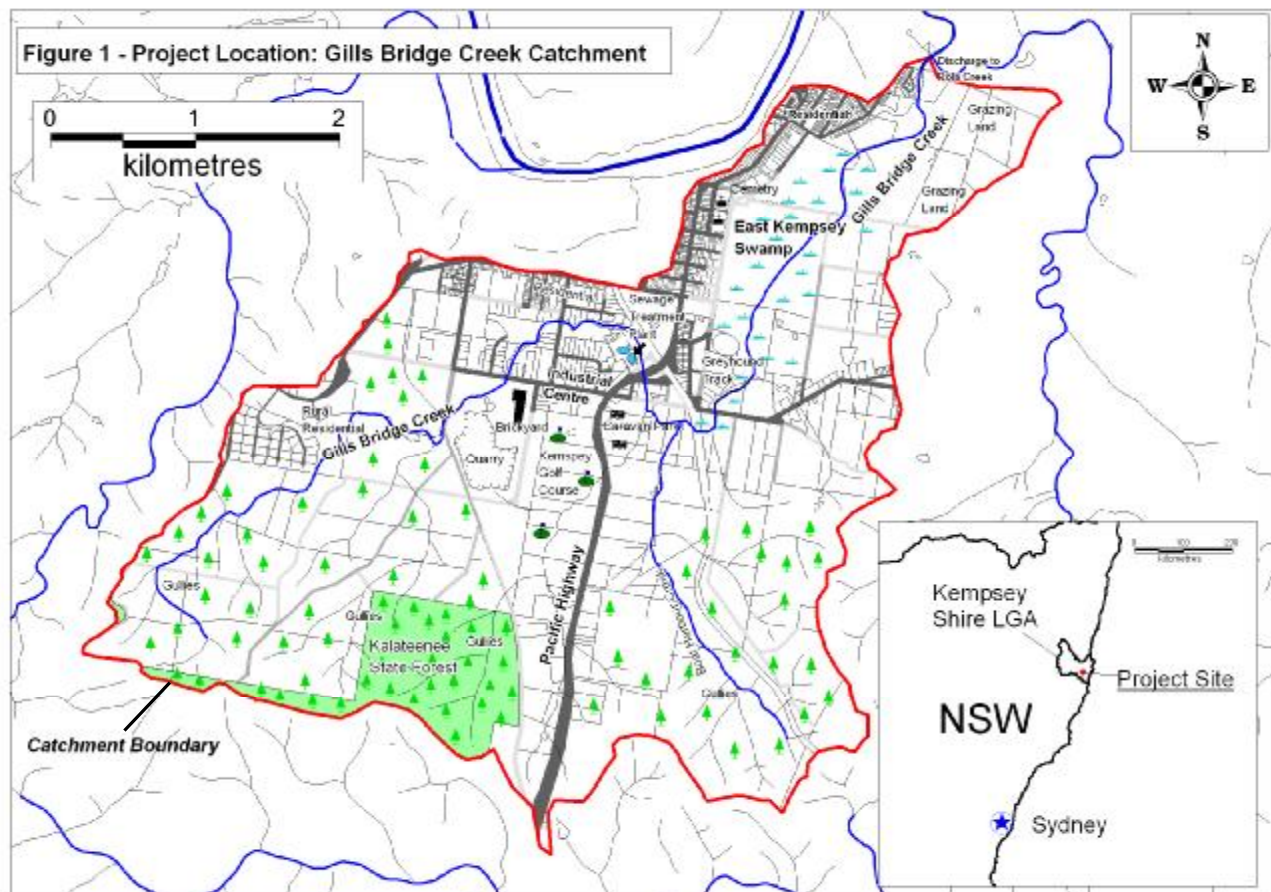
The Gills Bridge Creek Catchment is a sub catchment of the broader Macleay River Catchment. It is located in the southern to central portion of the Kempsey Shire Local Government Area (LGA) on the Mid North Coast of NSW (see Figure 1 below).

The main arm of Gills Bridge Creek originates from the headwaters in elevated terrain (up to 100 mAHD) located approximately 5 kilometres to the south west of the Kempsey CBD. The creek then flows through the main industrial area in South Kempsey and into East Kempsey Swamp, before discharging into Pola Creek, approximately 2km east of the Kempsey CBD. Gills Bridge Creek flows through, or adjacent to, a number of different land use zones including rural, residential, industrial and a special uses zone designated for the South Kempsey Sewage Treatment Plant, and as such is exposed to a wide range of potential impacts from human activities.

FIGURE 1 – PROJECT LOCATION: GILLS BRIDGE CREEK CATCHMENT.....2

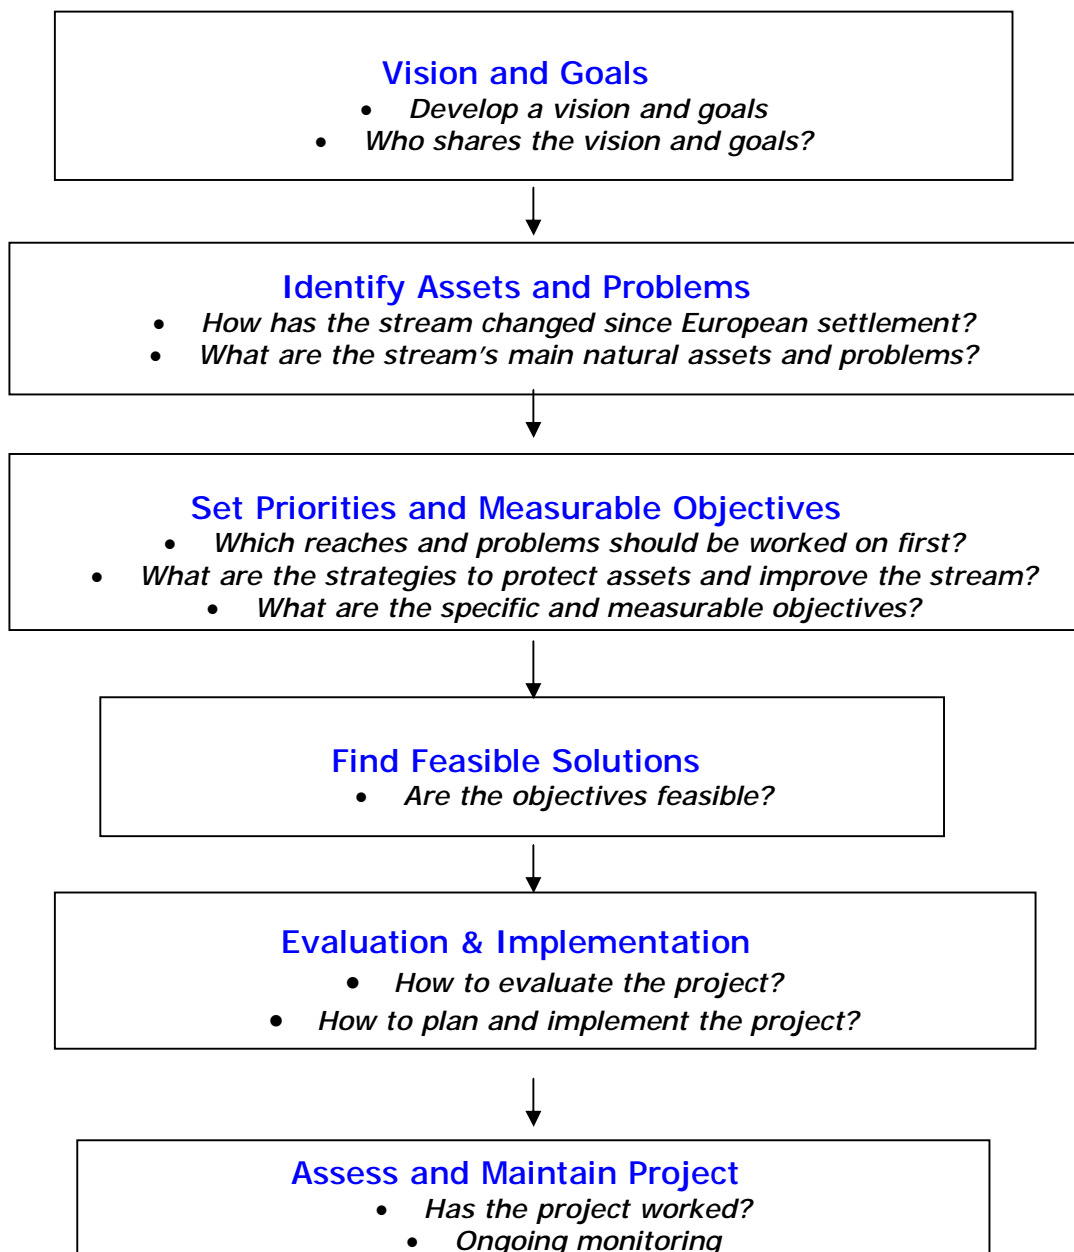
#### Project Outline

The flowchart presented below provides a project outline of the broad steps to be taken during the rehabilitation plan. Each of these broad steps has then been divided into a number of smaller steps, which provide more detailed directions for achieving the rehabilitation plan.

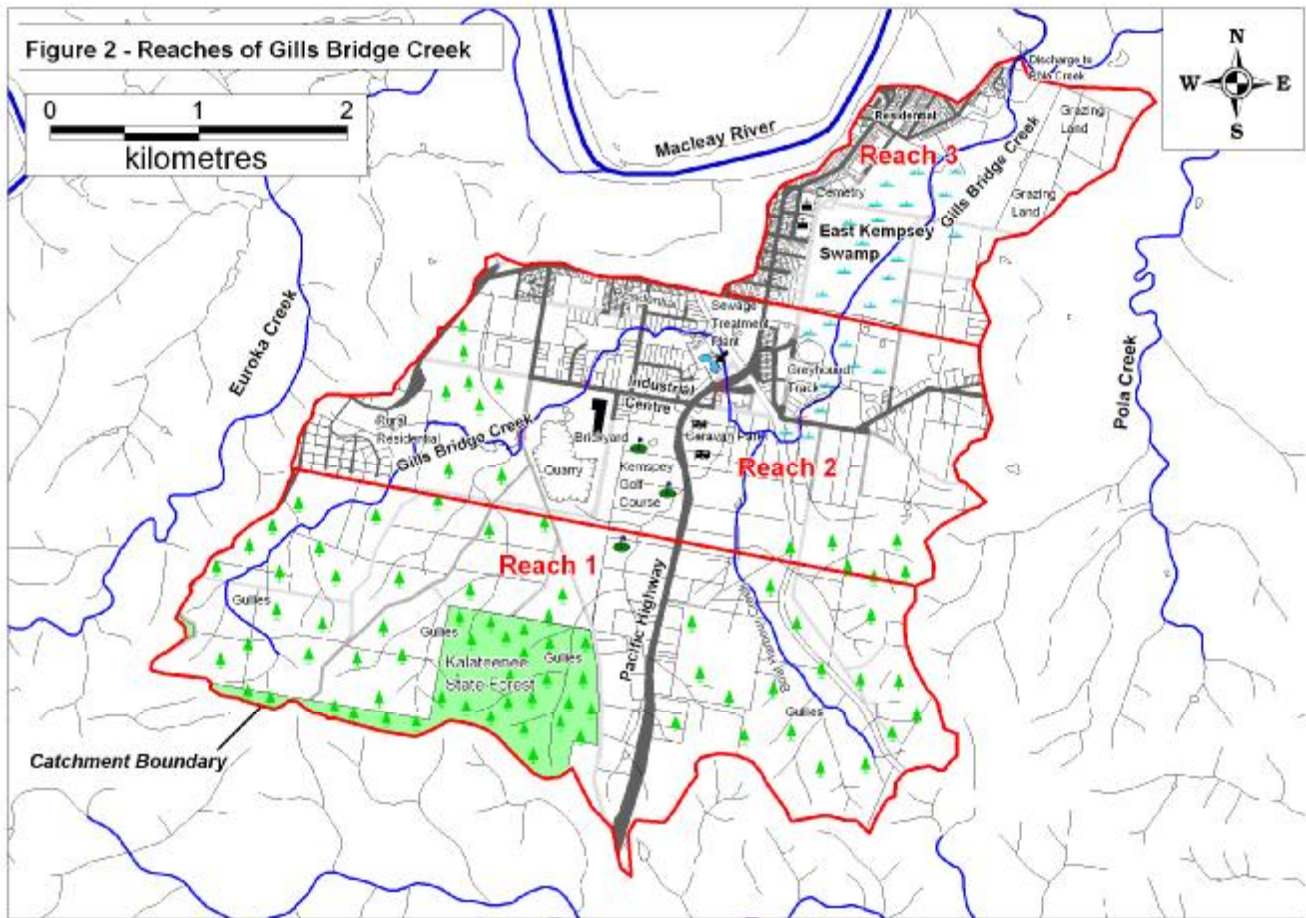
The first task undertaken was to break the creek into reaches based on natural attributes and surrounding land uses. The catchment was subsequently broken into 3 main reaches, based on stream orders as proposed by Strahler (1964):

- **Reach 1** – Predominately comprising the upper sections of the catchment, with 1<sup>st</sup> order streams (headwaters) of the main arm and tributaries of the creek. Reach 1 is largely undeveloped with land uses including rural grazing and forestry.
- **Reach 2** – Comprises the central portion of the catchment, with both 1<sup>st</sup> and 2<sup>nd</sup> order streams and is characterised by a mix of residential, commercial and industrial land uses.
- **Reach 3** – Lower portion of the catchment, comprised mainly of a 3<sup>rd</sup> order stream, incorporating the wetland system of East Kempsey Swamp. This reach is characterised by predominately rural land use with some residential land use.

Refer to *Figure 2* for breakdown of catchment into reaches.

FIGURE 2 – REACHES OF GILLS BRIDGE CREEK.....7
