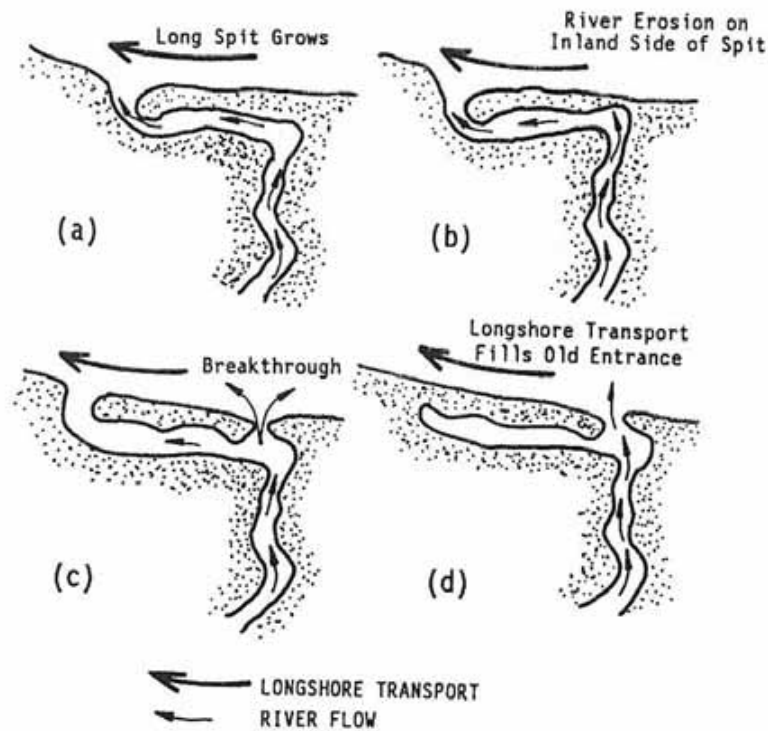
Diagram 6. Spit development and entrance breakthrough (source: NSW Government, 1990)

A major flood in 1893 broke through to the ocean north of South West Rocks. By 1901 this new entrance had been formalised by extensive channel excavations by Public Works and the closing of the original entrance, although it is not clear whether closing of the entrance referred to physical closing or closing for shipping movement. The parish maps of the early 1900's show the river to still enter the ocean south of Grassy Head, as well as at South West Rocks, yet there is no mention of the entrance remaining open in the historical description by Telfer (2005).

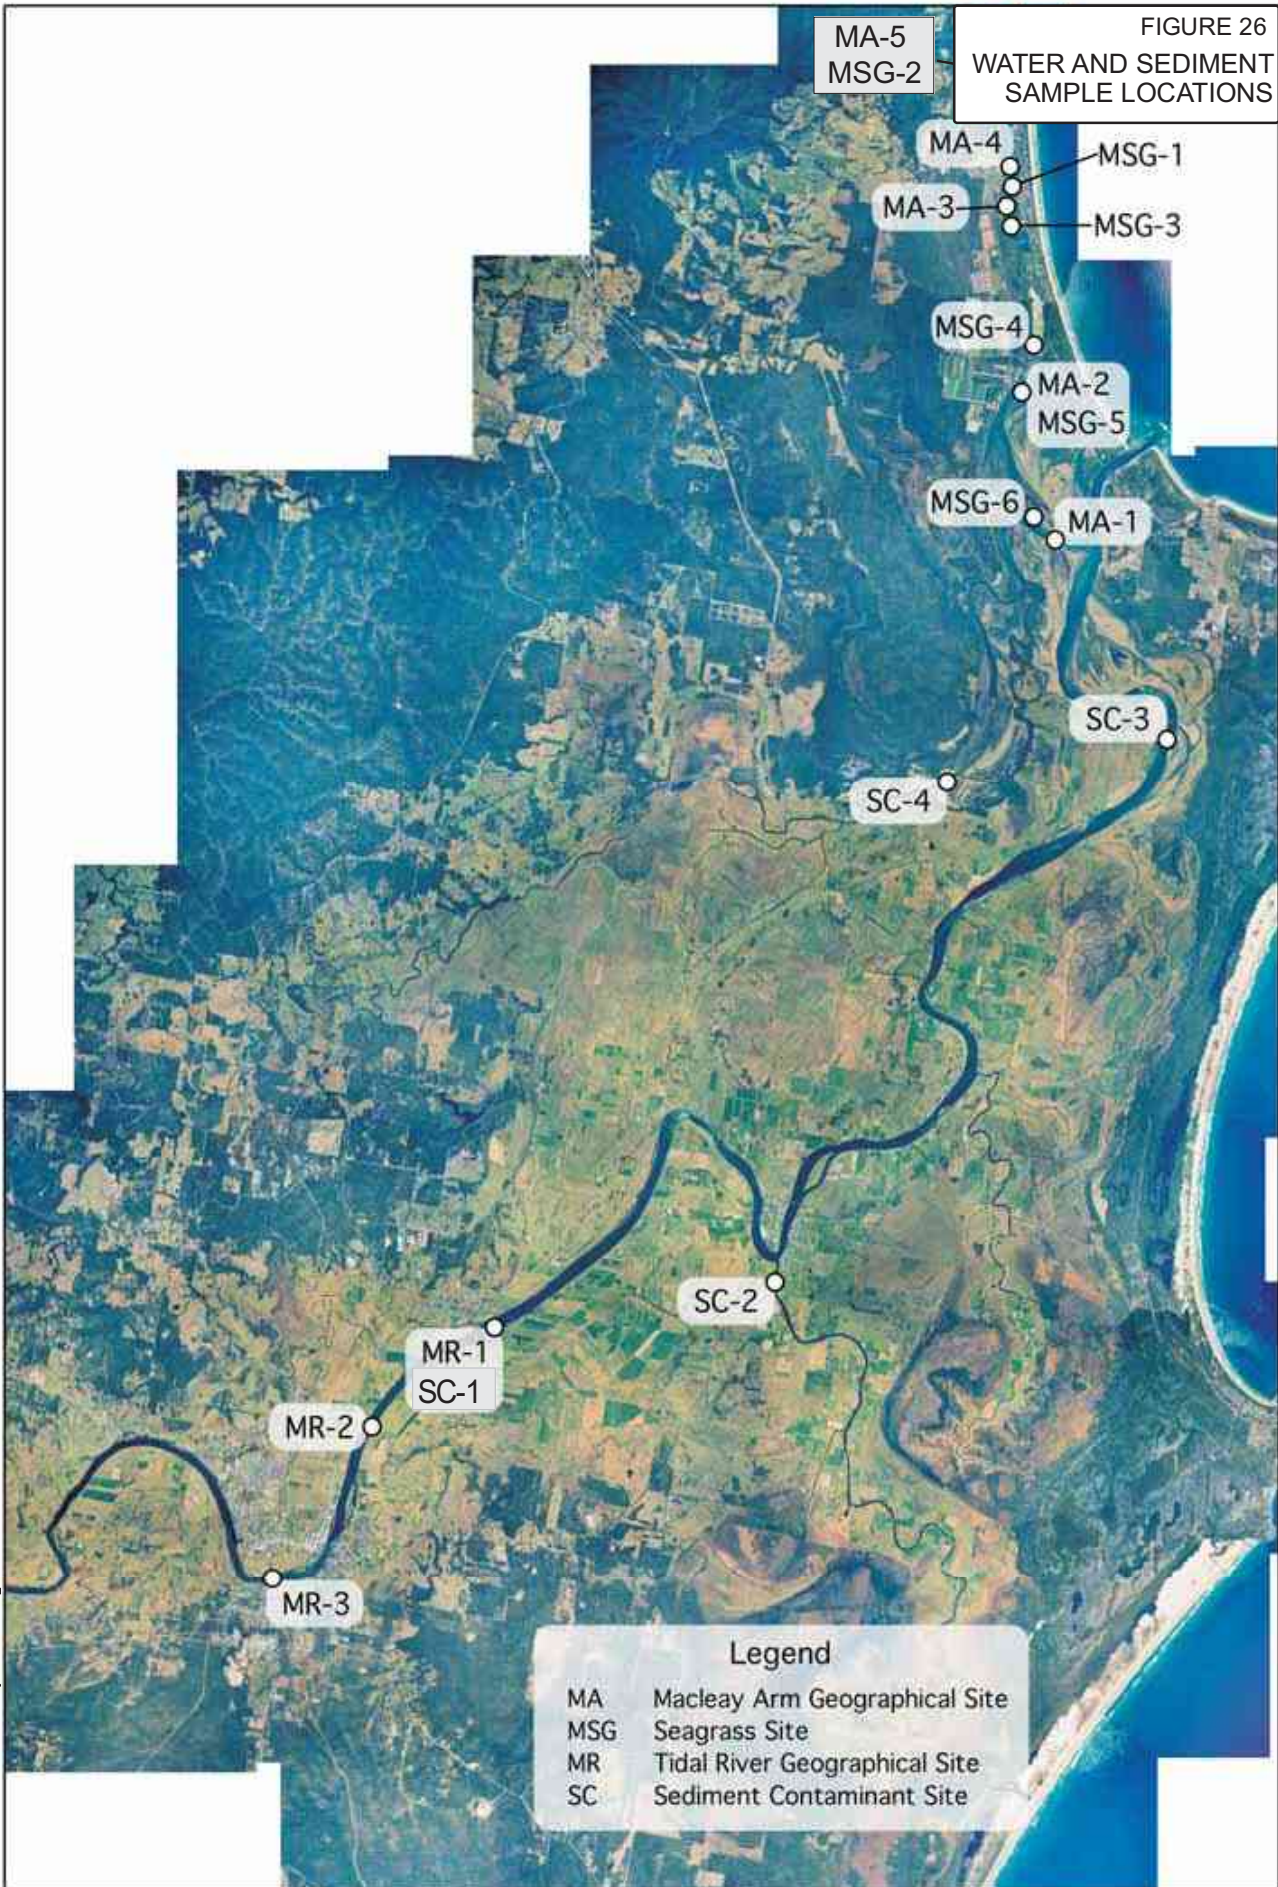
FIGURE 26
WATER AND SEDIMENT
SAMPLE LOCATIONS

Twelve monthly sampling runs were undertaken from September 2006 to August 2007 along both the Macleay Arm and main arm of the Macleay Estuary. Sampling runs in the Macleay Arm were usually completed within about 1 hour and were timed to start at the seawater end member (saline end where the estuary joins the ocean) about 1 hour before high tide, and progress upstream. Sampling runs in the main river were usually completed within about 3 to 4 hours and were timed to start at the seawater end member at about high tide and progress upstream with the high tide crest to the freshwater end member (freshwater end). In the Macleay Arm, 5 samples were collected at geographical locations (Figure 26). In the Macleay River, samples were collected at different salinity concentrations, equivalent to intervals of approximately 2 to 3 on the Practical Salinity Scale, from seawater to freshwater along the axial salinity gradient of the estuary. Additional samples were also collected at geographical locations in the tidal river between Smithtown and the Kempsey railway bridge when saltwater did not intrude this far (Figure 26).

Delta ^{15}N was measured in 6 seagrass samples collected along the Macleay Arm, as shown in Figure 26 (page 69). Sediment seagrass samples were wrapped in aluminium foil and placed in plastic bags and stored on ice until frozen at $-20\text{ }^{\circ}\text{C}$ in the laboratory. The seagrass samples were freeze-dried, ground to a powder and weighed to appropriate weights (i.e. approximately 0.20 mg for total carbon and 0.10 mg for nitrogen) and sealed in tin capsules. Capsulated samples were analysed by Continuous flow - Combustion - Isotope Ratio Mass Spectrometry (CF-C-IRMS). The CF-C-IRMS system is comprised of a Thermo FlashEA 1112 (combustion column at $1020\text{ }^{\circ}\text{C}$, reduction column at $650\text{ }^{\circ}\text{C}$, GC column at $45\text{ }^{\circ}\text{C}$, He carrier gas at a flow rate of approx. 100ml/min) interfaced through a Thermo Conflo-III to a Thermo Delta V Plus IRMS. Calibrated reference gas (CO_2 and N_2) was introduced via Conflo-III interface at the start of each run. Certified reference materials (NBS-19 and NIST 8457) were analysed at the start, middle, and end of each run as required by laboratory working standard AT-1 (Acetanilide, -1.58 ± 0.2 delta ^{15}N ; -26.04 delta ^{13}C ($n=20$) calibrated against above certified reference materials).

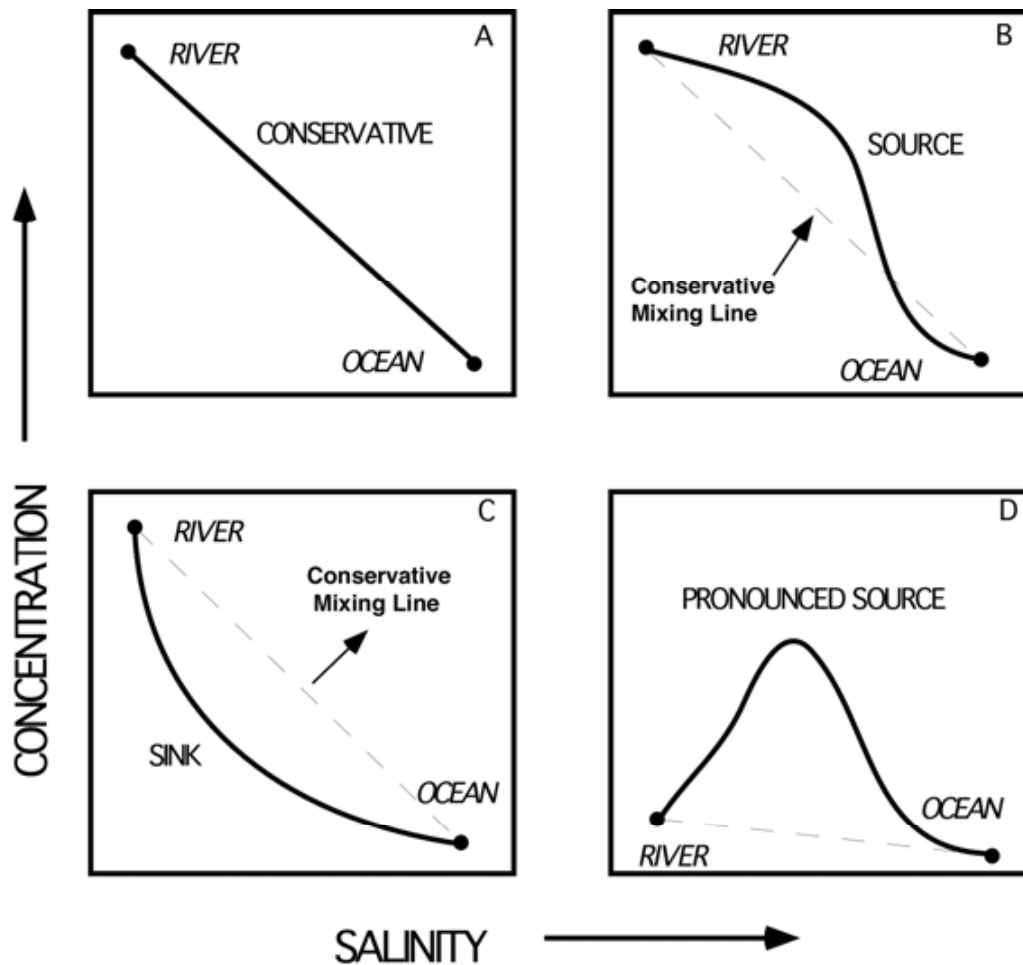
Diagram 7. Schematic representation of mixing plots showing the mixing of concentration-rich river water with concentration-poor seawater. (A) expected distribution of a substance that decreases in concentration as it moves through the estuary only due to dilution with concentration-poor seawater (i.e. it falls along the actual mixing line), (B) expected distribution of a substance if the estuary is acting as a source, (C) expected distribution of a substance if the estuary is acting as a sink, and (D) expected distribution of a substance if the estuary is acting as a pronounced source (i.e. where concentrations of the substance are higher in the estuary than the river and ocean).

Nutrient concentrations were plotted as a function of salinity (mixing plot) to determine if there is net gain or loss during mixing. If there is a net gain (internal/ external nutrient source) within the estuary the mixing plot will show an upward curvature above the actual mixing line, as shown in Diagram 7(B). Conversely, if there is a net loss (nutrient sink) within the estuary the mixing plot will show a downward curvature below the actual mixing line (Diagram 7(C)). Nutrients passing through the estuary conservatively (i.e. no net source or sink) will plot along the actual mixing line (Diagram 7(A)). The mixing plots were used in combination to interpret the major processes occurring in the estuary.

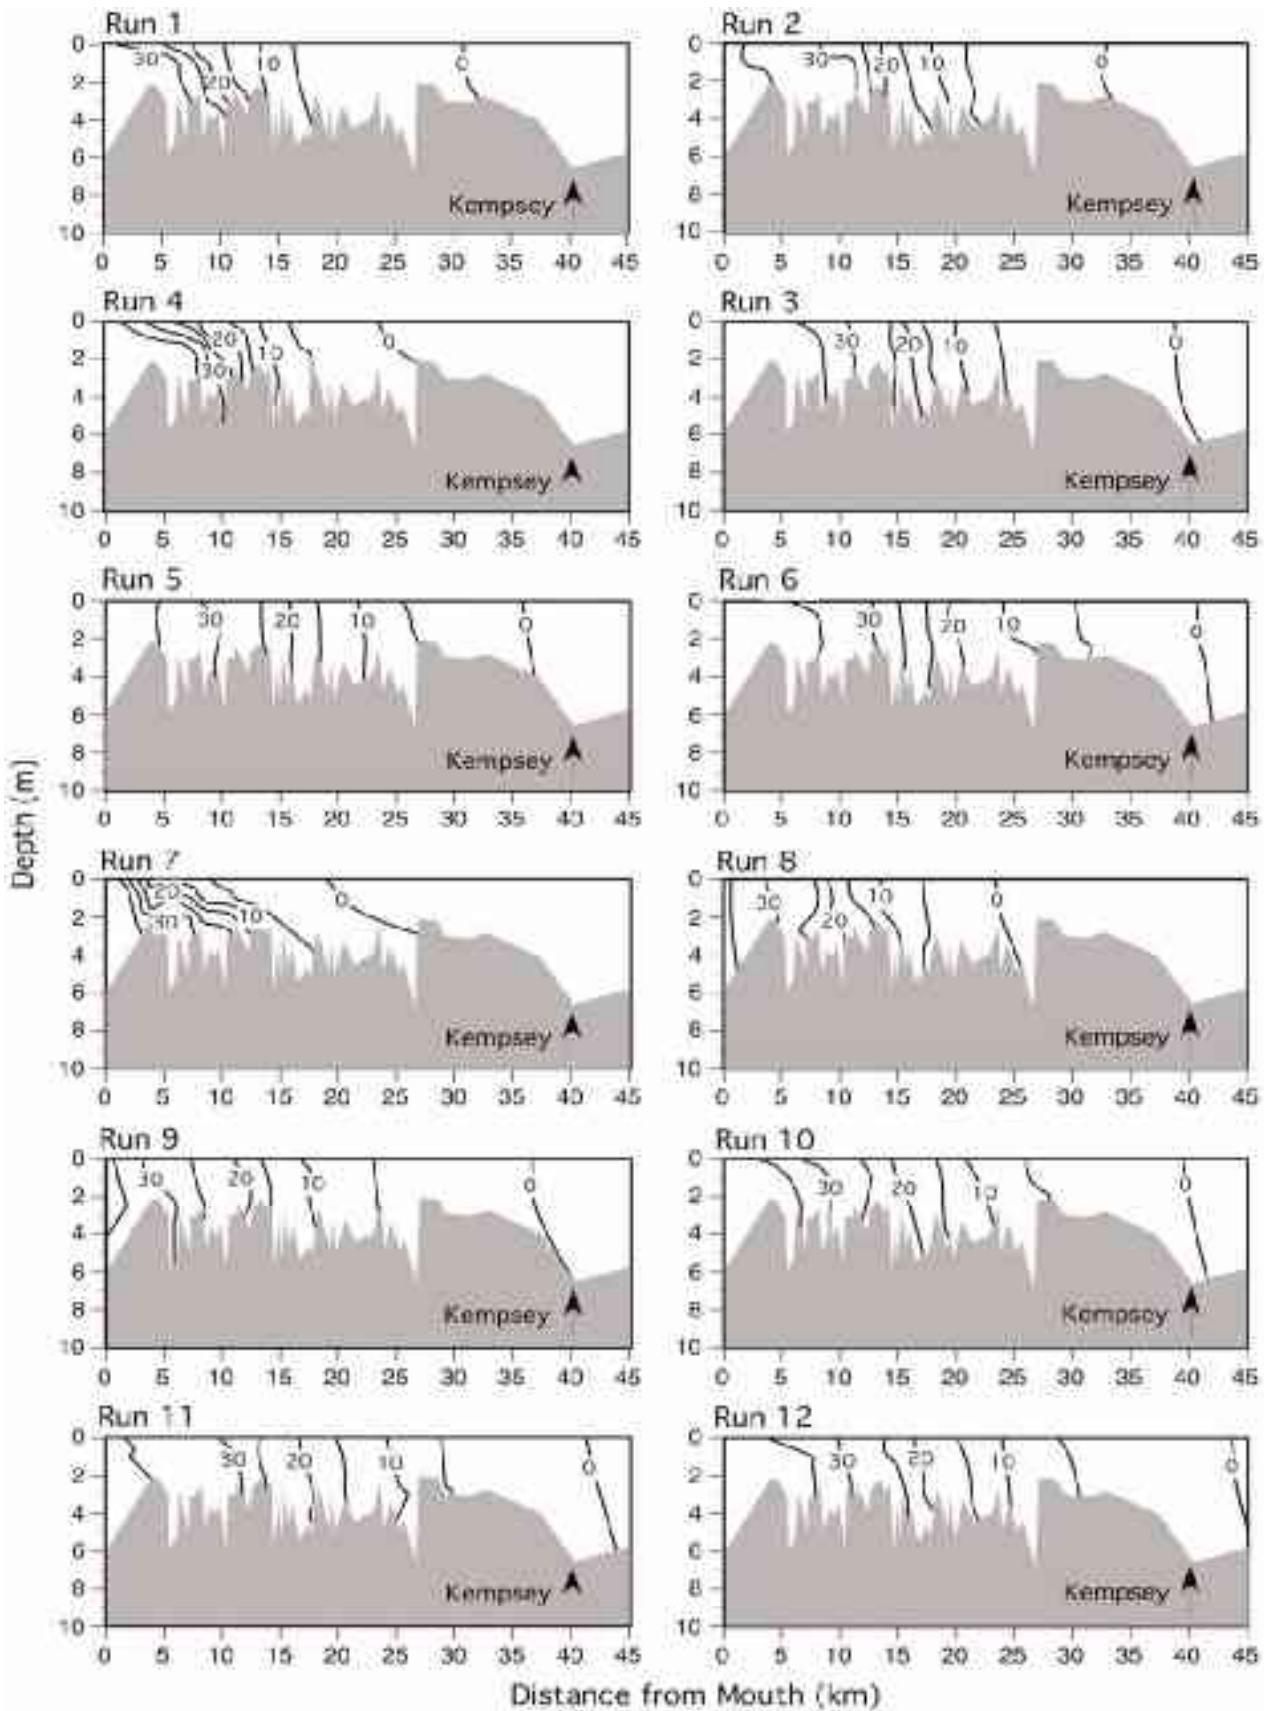
FIGURE 28
HIGH TIDE LONGITUDINAL SALINITY DISTRIBUTION IN THE MACLEAY ESTUARY DURING EACH OF THE SAMPLING RUNS

Salinity profiles undertaken in the Macleay Estuary during 2006/07 show a full spectrum of mixing regimes from highly stratified to well mixed (Figure 28). During a number of sample runs during low flows saltwater (salinity >0.1) intruded upstream of the Kempsey railway bridge (our last sampling location) at about 40 km from the mouth. Following the March 2007 flow event the salt-freshwater interface was pushed down to 30 km from the mouth, but can be pushed out to sea during larger floods (Eyre, 2000). A power curve was fitted to the 2006/07 data to develop an empirical relationship between the distance the salt/freshwater interface intruded from the mouth of the Macleay Estuary and the sum of the daily freshwater flow through the Turners Flat Gauging Station:

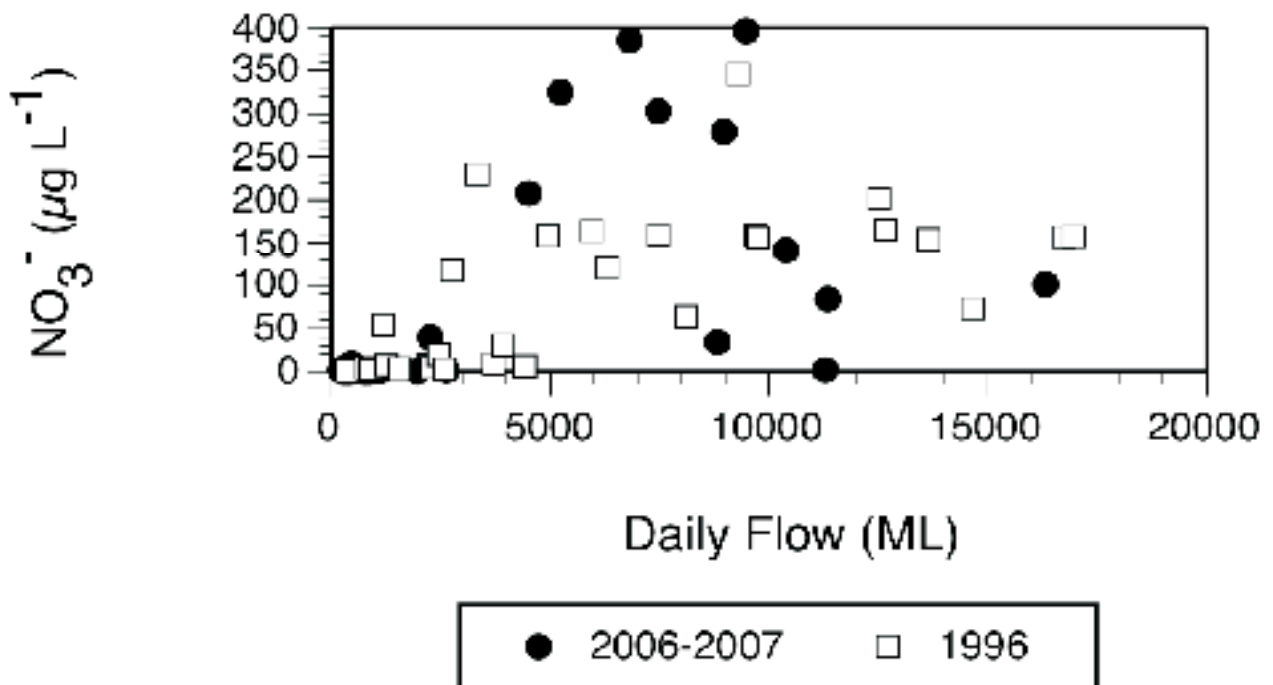
FIGURE 42
COMPARISON OF NITRATE (NO₃)
CONCENTRATIONS VERSUS FLOW
AT TURNERS FLAT BETWEEN 1996 AND 2007

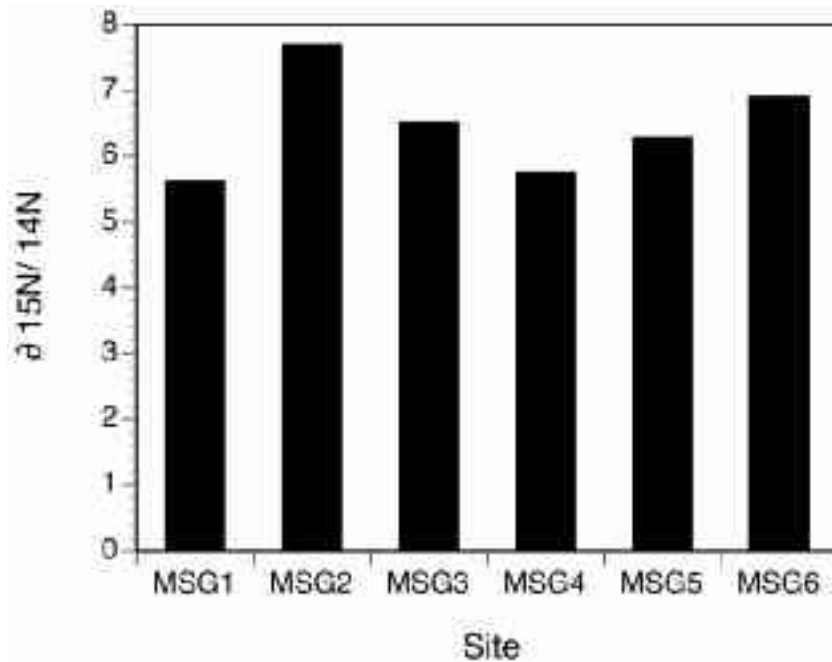
Diagram 10. $\delta^{15}\text{N}$ values in seagrass along the Macleay Arm.

The $\delta^{15}\text{N}$ (delta ^{15}N) signatures of seagrass in the Macleay Arm ranged from 5.7 to 7.7 (Diagram 10) which are 2 to 3 times higher than $\delta^{15}\text{N}$ signatures in seagrasses in Eastern Moreton Bay (Dennison and Abal, 1999), but similar to seagrass in the lower Richmond River Estuary away from the direct influence of sewage effluent (Eyre et al., 2007).
