# Macleay River Estuary

## Estuary Management Study

Prepared for: Kempsey Shire Council  
Project Manager: Tim Ruge  
Ref: 1352998  
Date: September 2010  
© GeoLINK, 2010

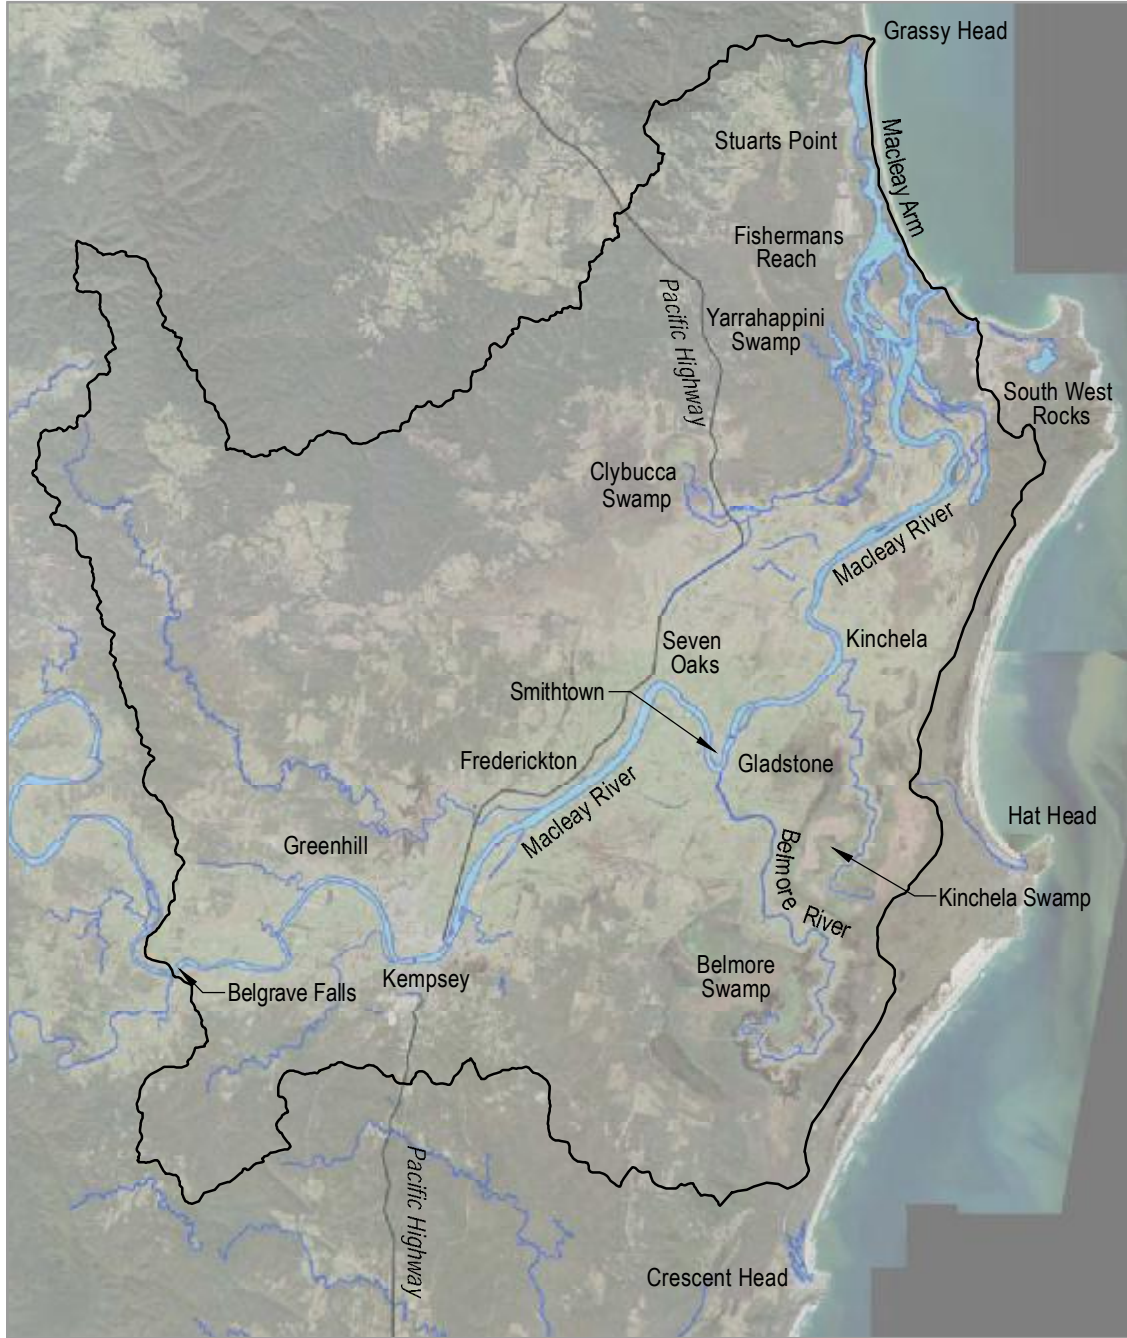
The study area includes the Macleay River estuary and its coastal floodplain. This includes the waterways and all tributaries up to the tidal limit, the entrance, foreshores, floodplain and adjacent land including towns, and the coastline. The study area also includes Back Creek (South West Rocks Creek). The extent of the Macleay estuary study area is shown in **Illustration 1.1**.

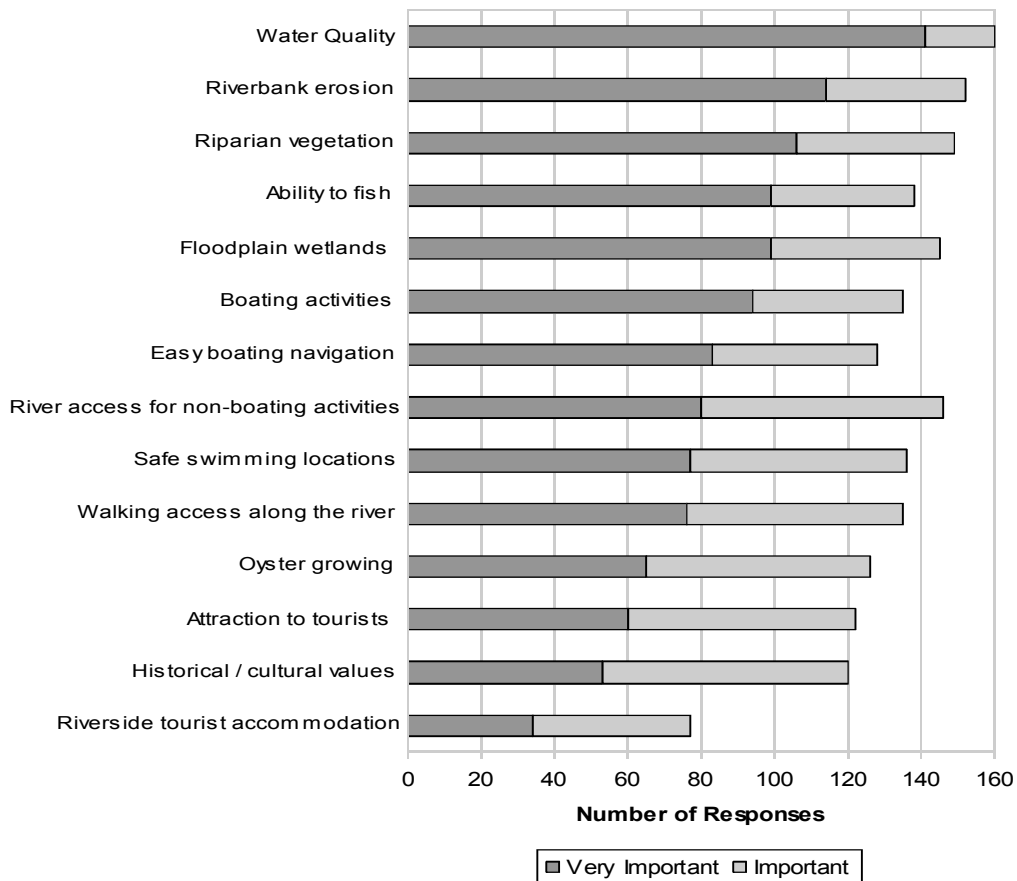
**Plate 2.1** Ranking of Values from Community Survey

The main physical attributes of the estuary that are valued by the community are water quality, riverbank protection (from erosion), riparian vegetation and floodplain wetlands. A ranking of values from the survey results based on the number of “very important / important” responses is shown in **Plate 2.1**.

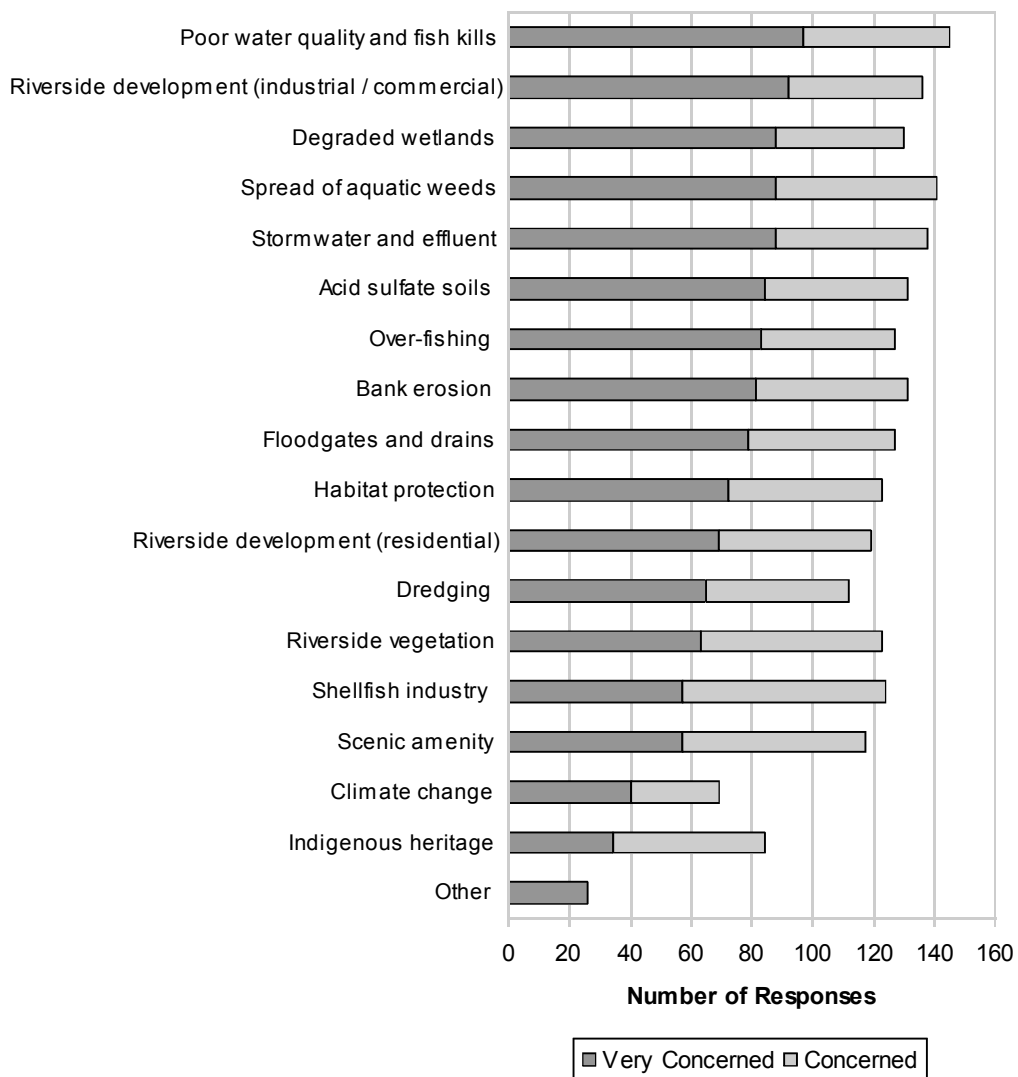
**Plate 2.2** Ranking of Concerns from Community Survey

The public meetings indicate that the main community issues concern water quality and the impact of sedimentation on boating navigation. This is based on the larger number of comments provided at the meetings in respect to these two issues compared with other issues. The community survey results support the finding that water quality is one of the major concerns for the estuary. The issue of sedimentation impacting on boating navigation was not highlighted in the survey results however this may be a result of the wording of the survey which asked if dredging was an issue. A ranking of concerns from the survey results based on the number of “very concerned / concerned” responses is shown in **Plate 2.2**.

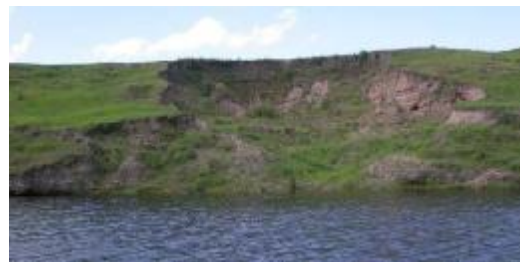
**Plate 3.1 Rotational Slump Failure**

- Slab type block failure resulting from inundation and subsequent slumping, with material generally not remaining in situ;
- Rotational failures and slumps related to either subsoil drainage or draw-down effects as water level drops with rapidly receding flood levels, with material generally remaining in situ; and
- Scour resulting from high velocity flows often acting on the bank toe. Material does not remain in situ. Scour associated with major flooding can remove the evidence of slab type block failures.

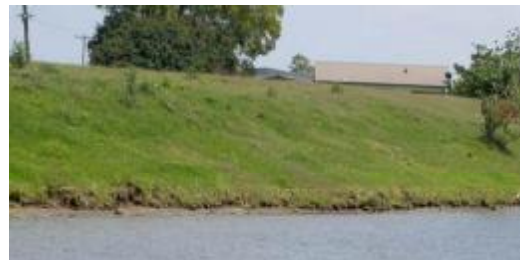
**Plate 3.2 Bank Notching by Wind / Boat Waves**

- Slab type block failure resulting from undercutting of the bank toe as a result of wave or wind action or scour, with material often remaining in situ;
- Notching of the bank toe or fretting as a result of wave action (wind or boat) and subsequent undercutting and failure; and
- Disturbance of banks through unmanaged stock access, inappropriate land use, or the removal and/or suppression of riparian vegetation.

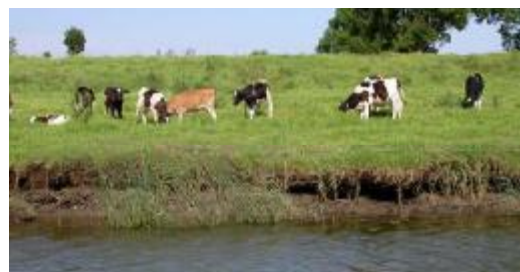
**Plate 3.3 Stock Impacts on Banks**

Although separating the types of processes facilitates explaining how erosion occurs in estuaries, in reality the processes are interrelated. For example, continuous effects such as unmanaged stock access can lead to suppression of the mangrove and river reed fringe which as a result of continuous wave wash from wind and boats can cause the banks to become undermined and susceptible to episodic damage from flood events.

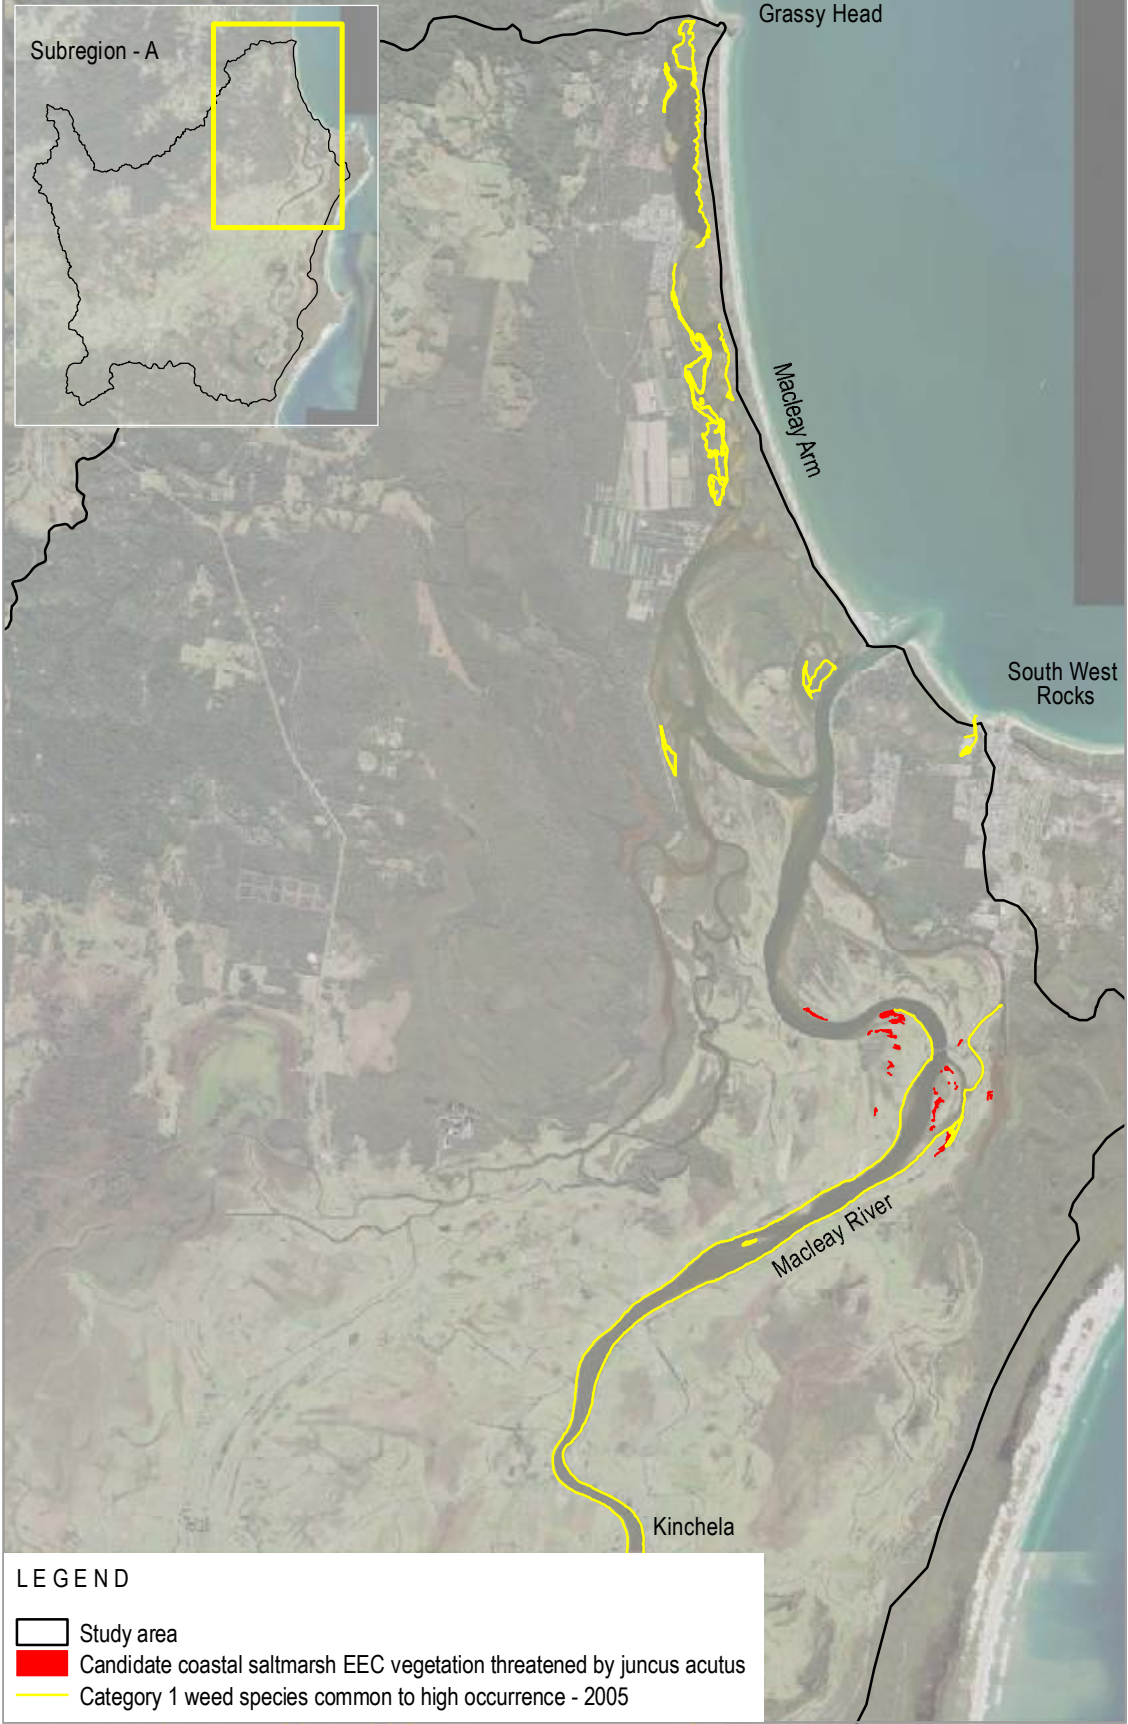
In 2005 it was estimated that some 193 km or 56% of riverbanks were mapped with common to heavy infestations of one or more Category 1 weed species. **Illustration 3.4** to **Illustration 3.6** shows the distribution of common to heavy infestations of Category 1 weeds as mapped in 2005 and the results of additional mapping of the extent of *Juncus acutus* as mapped in Birch and GeoLINK (2010).

Information shown is for illustrative purposes only

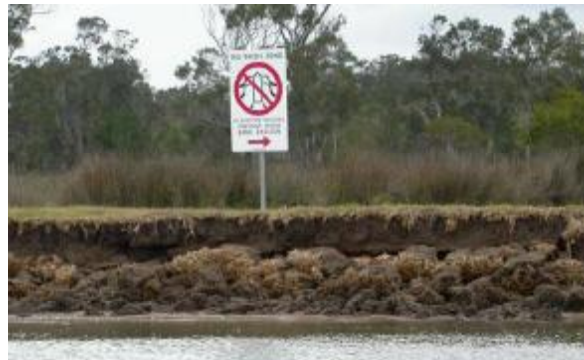
Source: Cohen, 2005

**Summary:** There are a plethora of signs indicating boat speed limits in areas deemed susceptible to boat wash erosion in the lower reaches of the estuary. Despite this, there are still areas which are being impacted by boat wave wash. In particular, areas within the Macleay Arm and Clybucca Creek are currently being impacted (Geco Environmental, 2005). In other areas, the contribution of wind waves versus boat wave wash is less certain but boat wash is still likely to be a contributory factor (eg. Kinchella Bend).

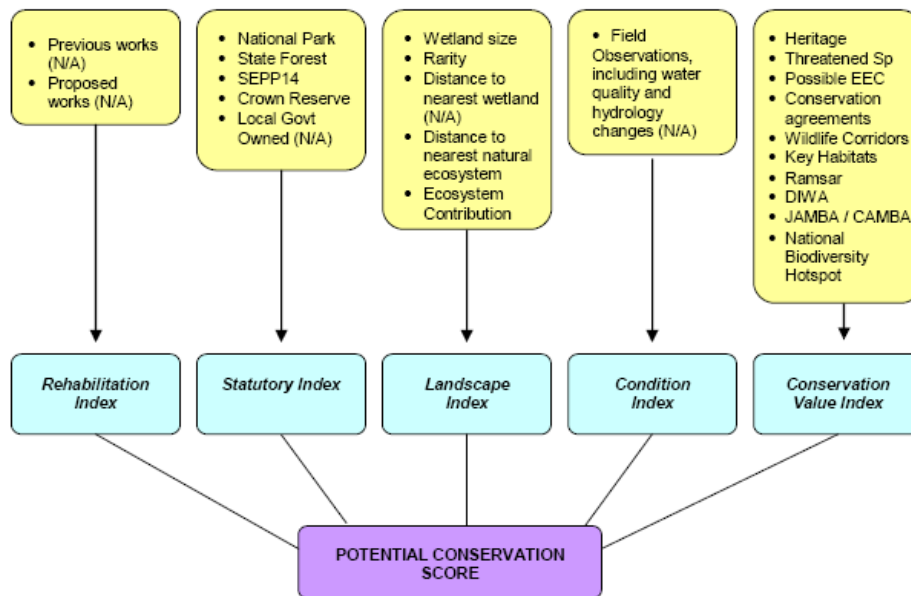
**Illustration 4.4** Wetland conservation prioritisation method used by WCA.

The wetland areas on the Macleay river floodplain have been prioritised for conservation in three separate studies (Pressey 1987, Parkhouse *et al.* 1999 and Burns *et al.* 2006).
