This study, the Korogoro Creek Data Compilation and Processes Study and Report, addresses Steps 3 and 4 in the Estuary Management Process.

PART 1 HISTORICAL CONTEXT – KOROGORO CREEK ESTUARY

1.1 Evolution of the Korogoro Creek Estuary

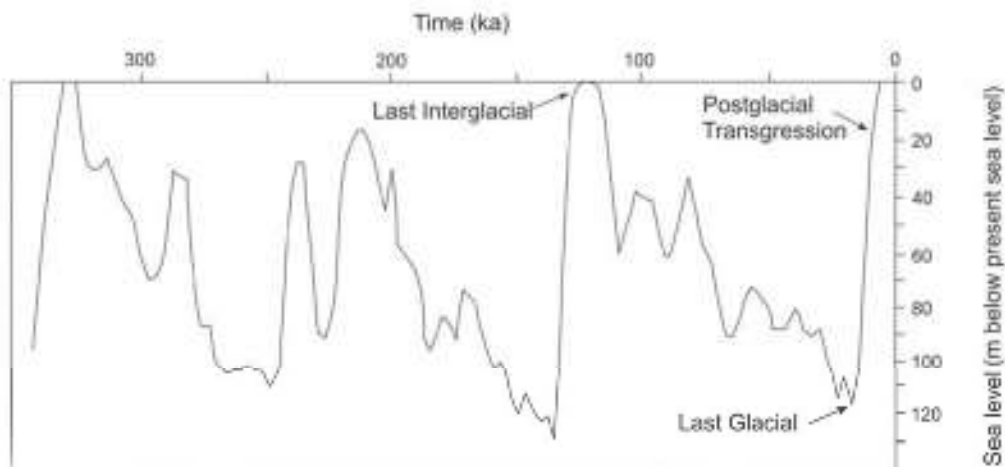
Figure 1-A Late Quaternary and Holocene sea level history for southeastern Australia (Roy and Boyd 1996. Source: Troedson et al., 2004)

Sea levels have fluctuated between about a maximum of 5 m above the present sea level during the last Pleistocene highstand (approximately 120 ka) and a minimum of 110-130 m below the present level during the Last Glacial lowstand (between 25 and 15 ka). Between about 20 ka and 6.5 ka the sea level rose rapidly reaching the approximate present sea level position (Figure 1-A). From 6.5ka to the present (mid to late Holocene highstand), the sea level has been relatively stable, remaining within 1-2 m of the present level (Figure 1-A; Troedson et al., 2004).

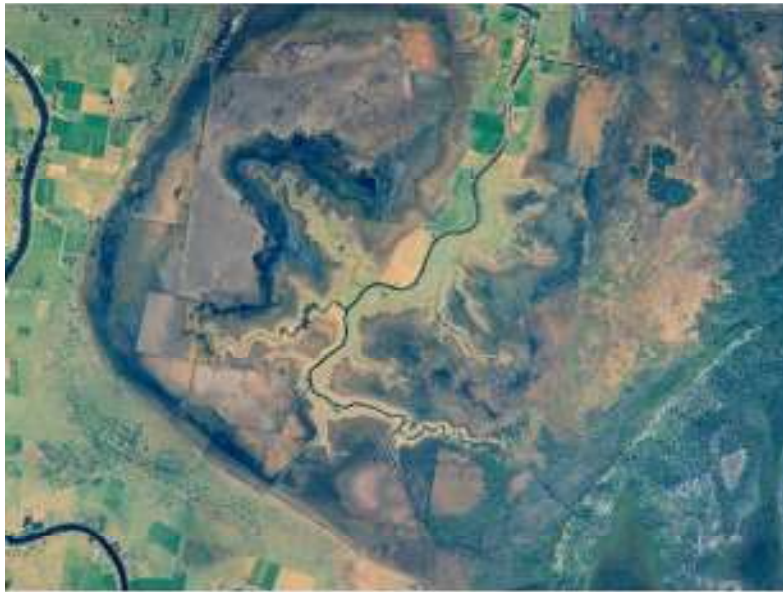
Plate 1 Birdfoot delta formation on Kinchella Creek (Source: LIP 2003 1:25000 aerial photography)

The approximate position of the coastline during the mid Holocene (~6-5 ka) is shown in Figure 1-B (page 7). The sand sheets indicate Pleistocene barrier systems and dunes that were most likely deposited during the last glacial highstand. These Pleistocene barriers connected what were at the time offshore islands including the headlands of Crescent Head, Hat Head, and Smoky Cape and impounded large lagoons between them and the paleo-shoreline indicated by the land mass (Atkinson, 1999). Soil and geological investigations reveal that the area indicated as the Macleay lagoon is underlain by extensive estuarine deposits that are the source of potential and actual acid sulphate soils today. These lagoons have progressively infilled during the late Pleistocene and the Holocene period with fluvial sediments, a process which is still evident in the birdsfoot deltas prograding into some of the last remnants of the lagoon such as the Belmore and Kinchella swamps (Plate 1).

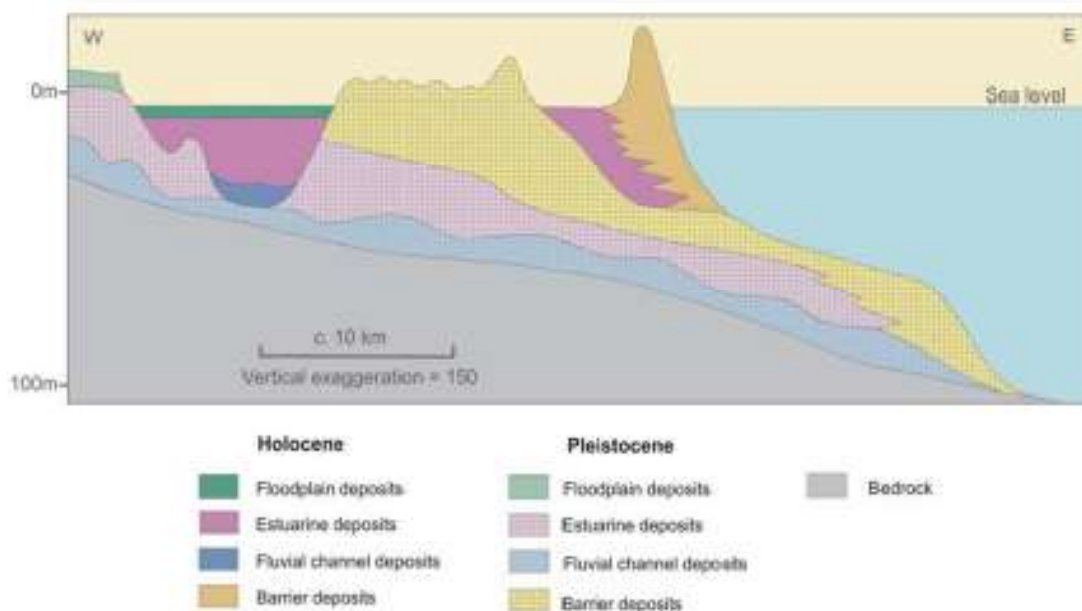
Figure 1-C Generalised schematic of the relationships between Quaternary coastal deposits in New South Wales, modified after Roy (1998) (Source: Troedson et al., 2004).

Korogoro Creek is located between an inner Pleistocene barrier and an outer Holocene barrier historically draining numerous saline and freshwater wetlands occurring in depressions along the coastal fringe and between the inland Pleistocene dune systems. Figure 1-C shows a stylised schematic of the likely stratigraphy of the quaternary sediments of the Korogoro Creek catchment.

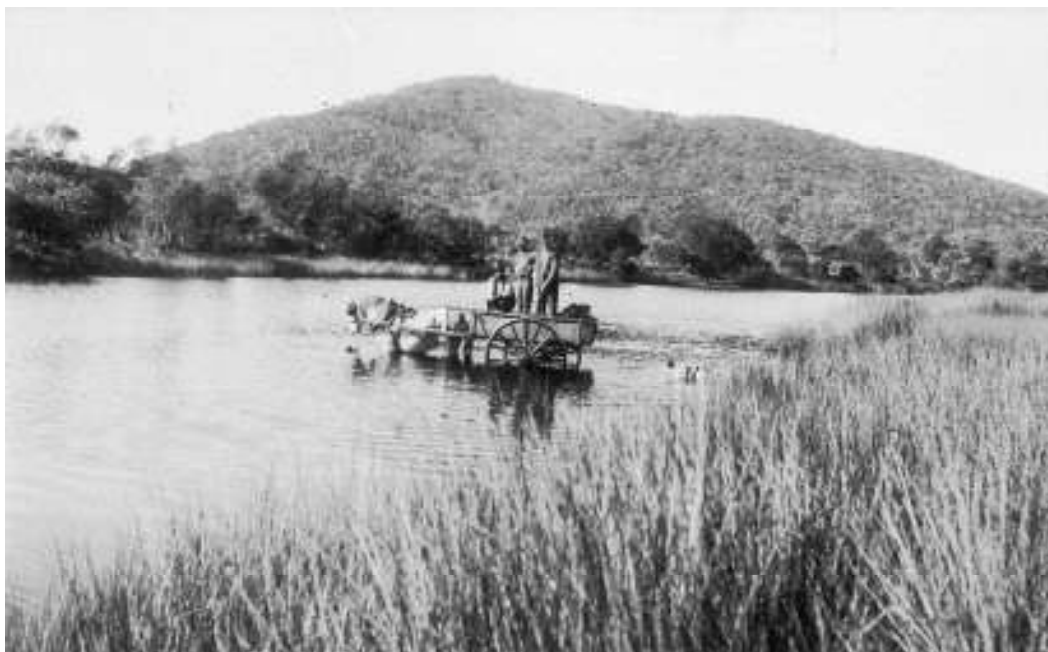
The earliest available records of Korogoro Creek and its natural surrounds show that Korogoro Creek has undergone major changes since the mid 1950s. Aerial photographs from the early 1940s and mid 1950s show that Korogoro Creek was a smaller and more sinuous and heterogenous estuary system (Figure 1-D, p.8). The creek does not appear to be naturally connected to the Swanpool through surface water flow although groundwater interaction may have occurred. The estuary was flanked on both sides by a dense mat of sedges and rushes which extended out into the water beyond the mangrove fringe (Plate 2).

Plate 2 Inscription on back of photo reads: [sic] "Crossing Korogora Creek at Hat Head, a little seaside resort between Smoky Cape and Crescent Head which will rival any beach along the coast, when a decent road is provided". 1925 (Photo by Magnus Everson, Source: State Library of New South Wales PICMAN database)

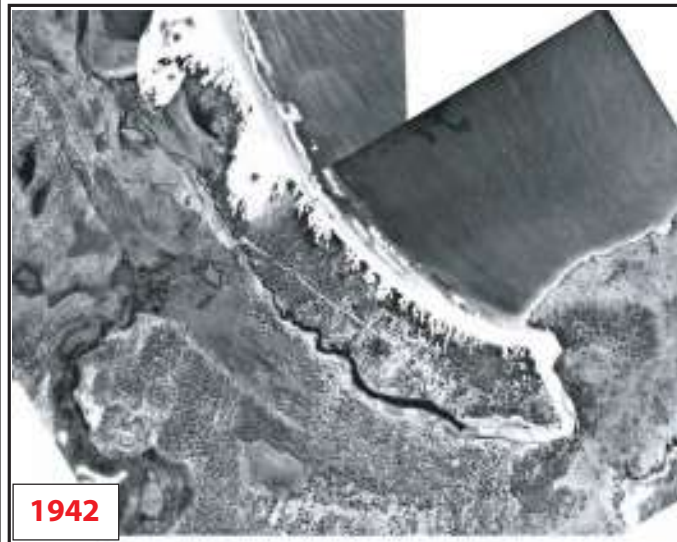
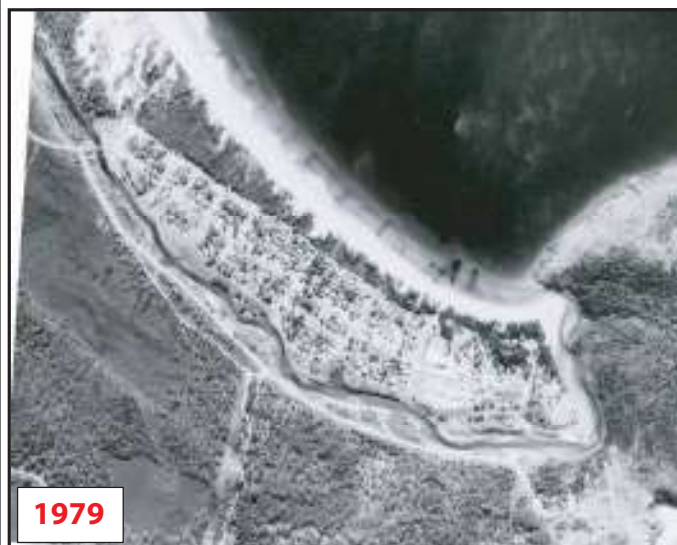
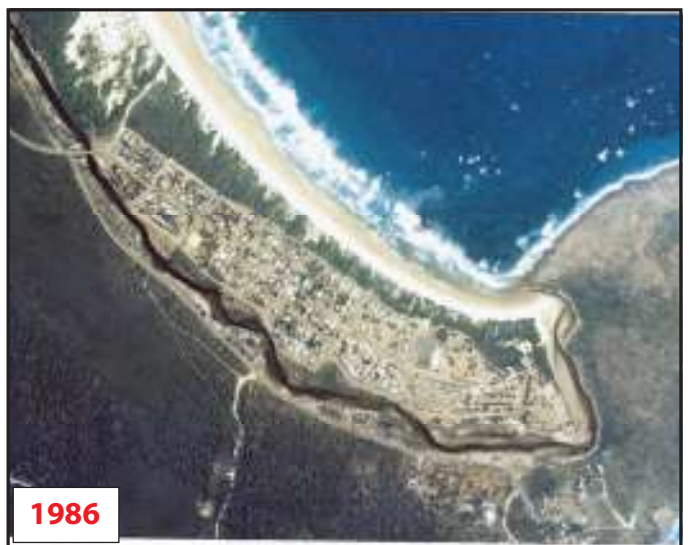
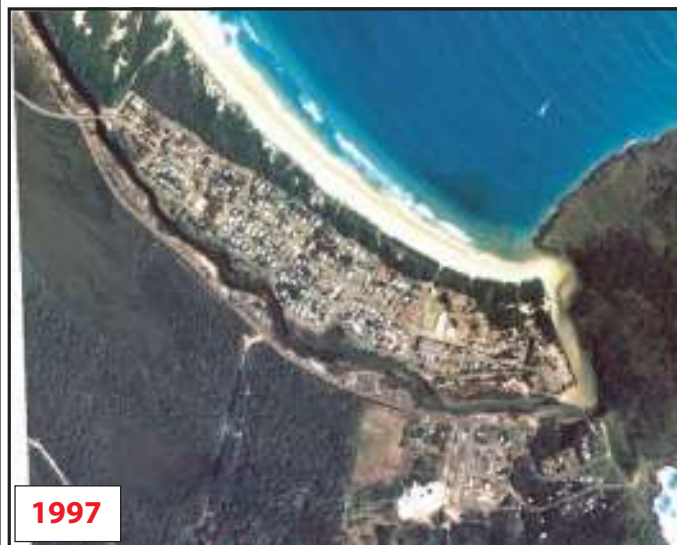
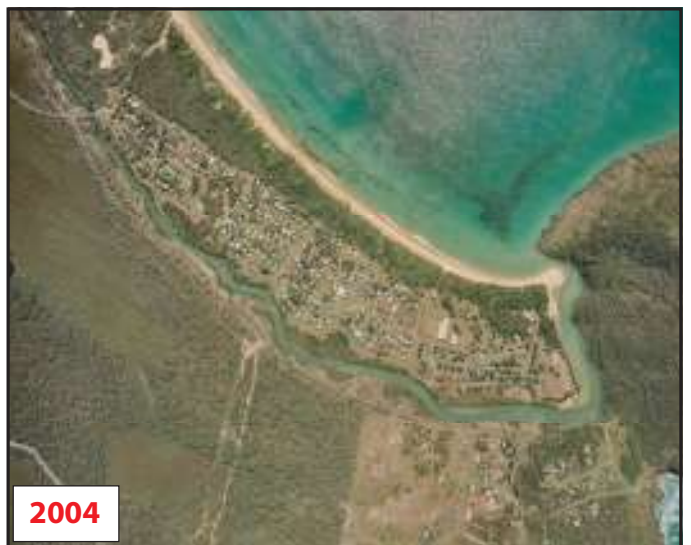
Korogoro Creek aerial orthophoto chronology 1942-2004

Figure 1-D (p.8) shows the alterations to the Creek that resulted from these works. Such works are now known to directly effect estuarine processes including tidal processes and sedimentation, geomorphology and aspects of estuarine ecology including floral distributions, faunal species richness and commercial fisheries production (Roy et al., 2001).
