Stormwater Management Strategy for Hat Head

Prepared as part of the
Korogoro Creek Estuary Management Plan

Prepared for: GECO Environmental
Project Manager: Tim Ruge
Ref: 1106618
Date: October 2008
© GeoLINK, 2008

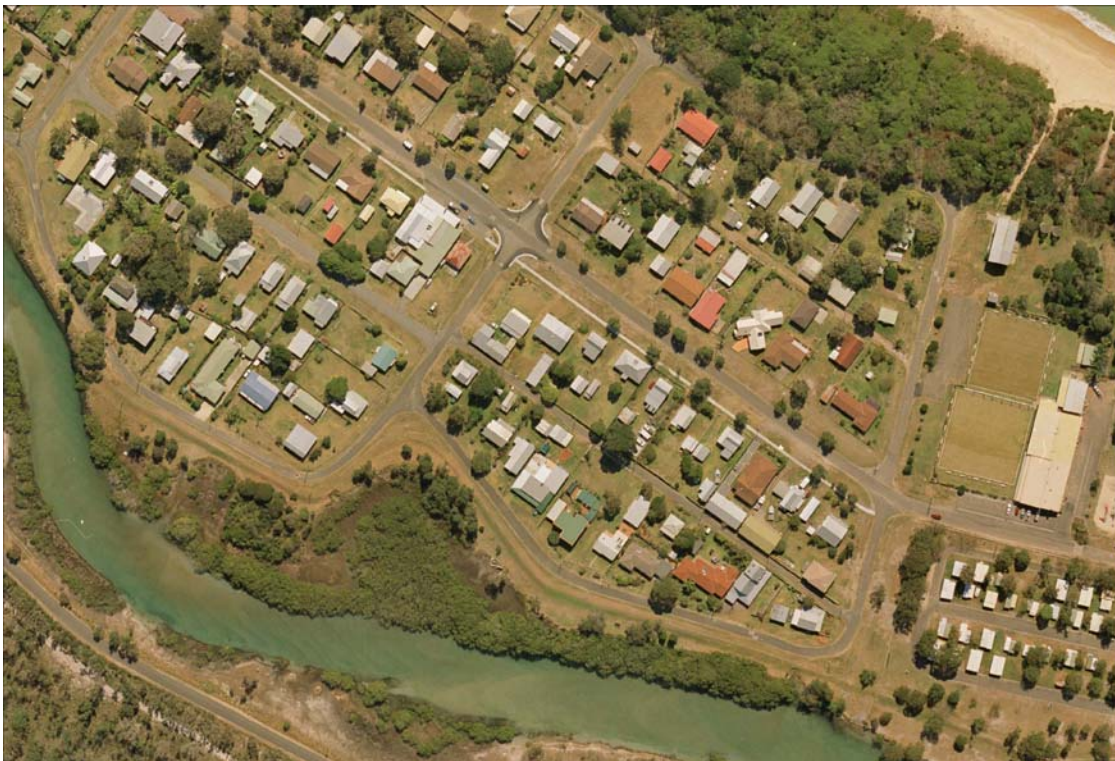
Plate 1.1 Aerial Photograph of North Hat Head

The village of Hat Head is zoned 2(v) Village under Kempsey Local Environmental Plan 1987. The zoning allows for mainly residential development, with opportunities for minor commercial development to service the local population. The village is predominantly low density single storey residential development. The population of Hat Head is approximately 300 persons. Generally, the urban character consists of little hard paving other than the road surface as indicated in **Plate 1.1** which shows a typical portion of North Hat Head.

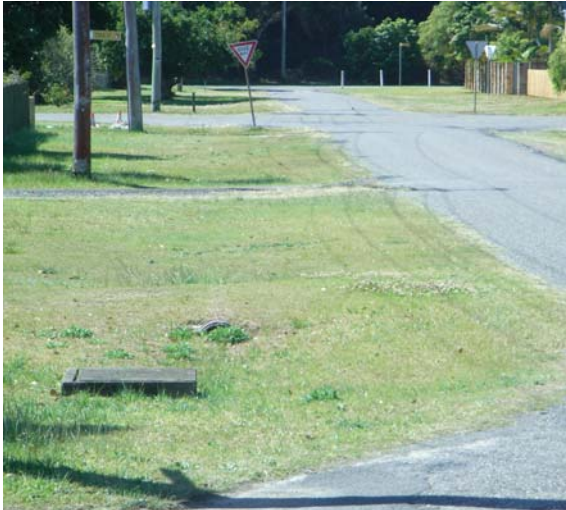
Plate 1.2 Typical Street Grassed Swale in North Hat Head

The layout of the existing drainage system is shown in **Illustration 1.1** and **1.2**. The drainage system in North Hat Head comprises grassed swale drainage systems with a network of inlet pits and pipes. The North Hat Head drainage system comprises approximately ten pipe drainage networks which discharge stormwater into Korogoro Creek through separate pipe outlets. A number of smaller sub-catchments exist comprising only swale drains with one pit and a pipe outlet. A total of approximately 17 pipe outlets discharge to Korogoro Creek from the North Hat Head catchment.

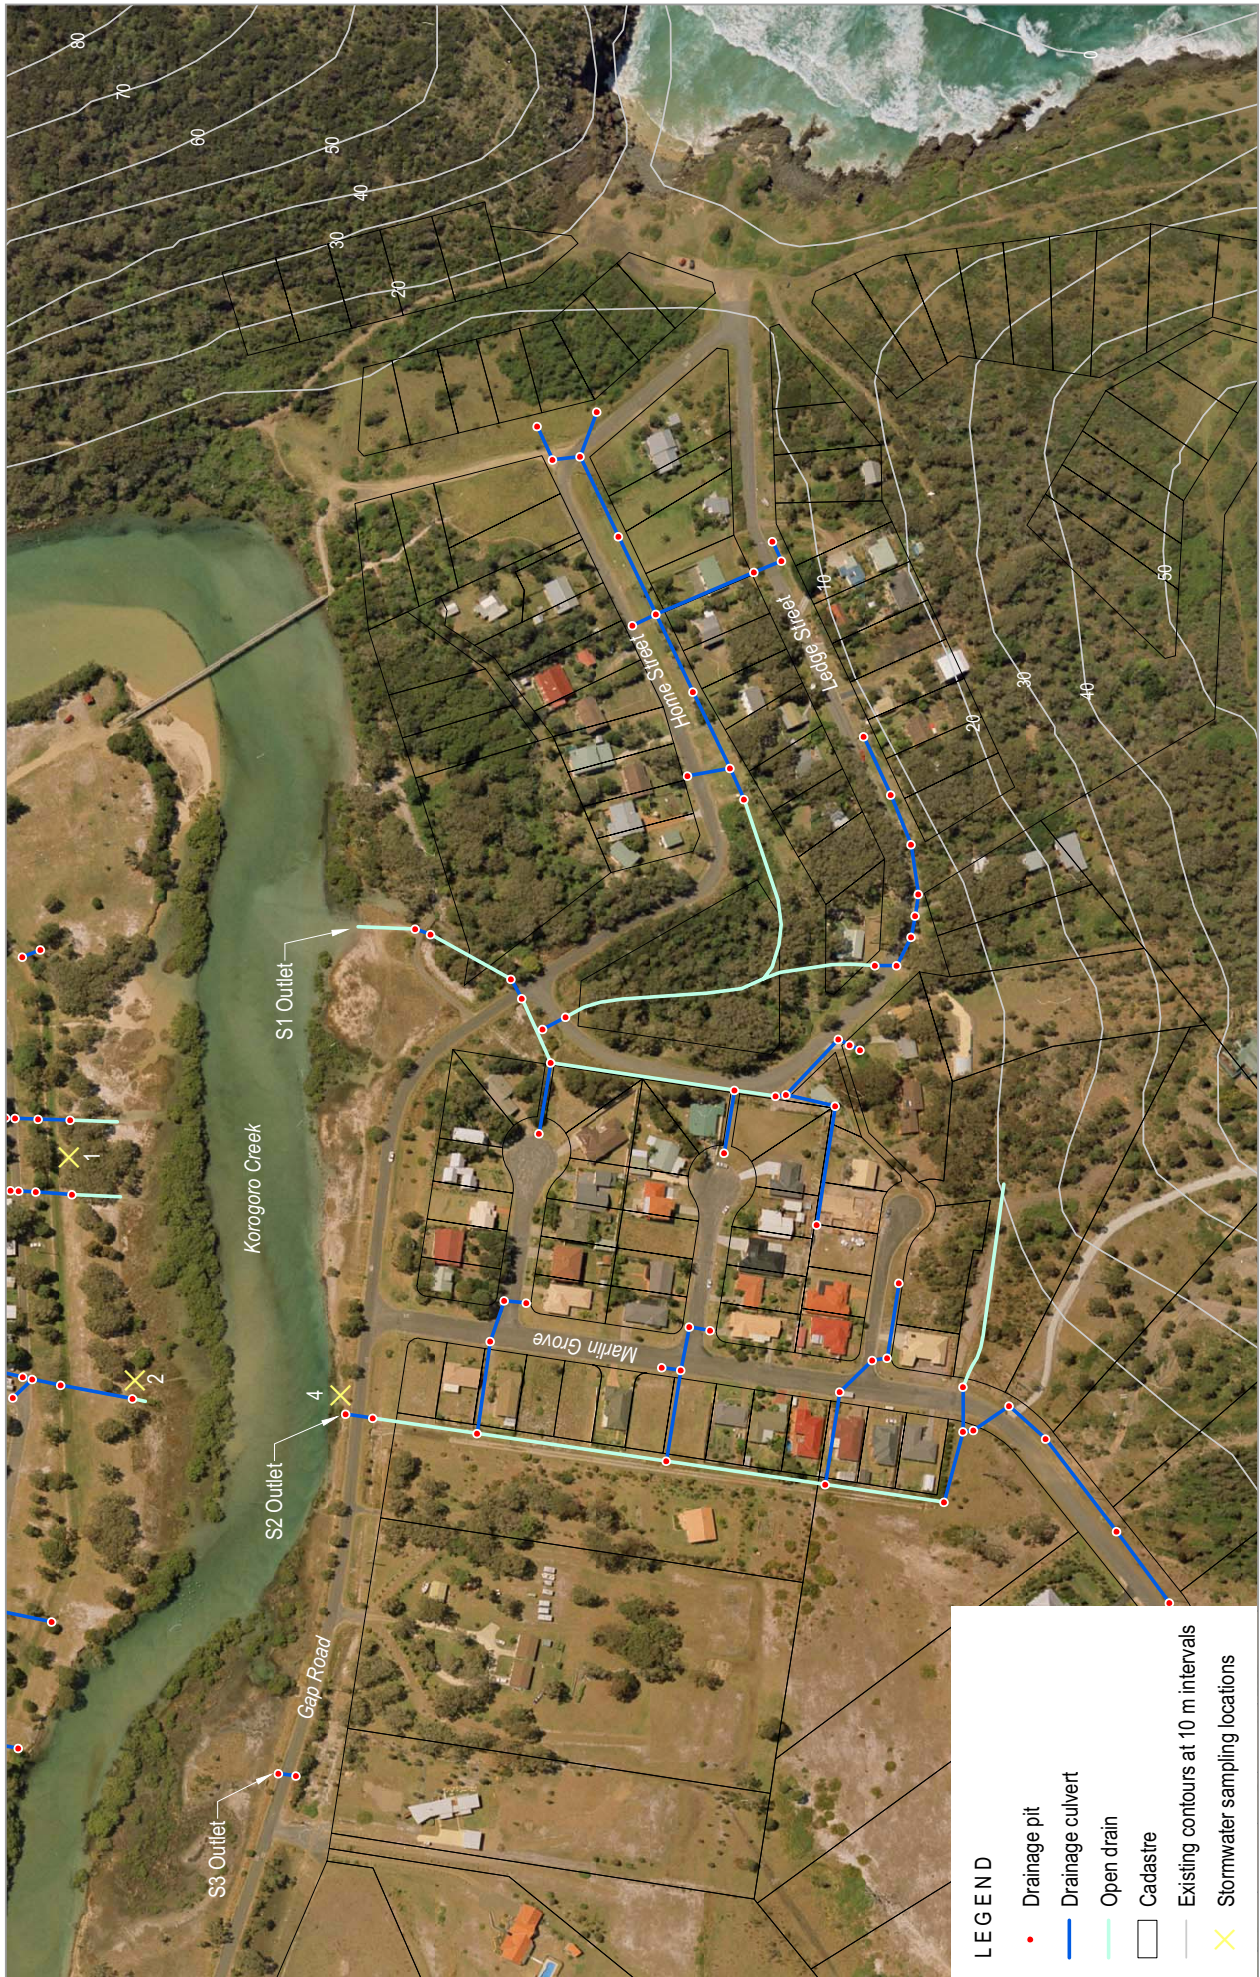
The South Hat Head drainage system comprises grassed swale drainage systems in the eastern portion of the residential area and standard kerb and gutter drainage in Marlin Grove and the connecting cul-de-sacs. The South Hat Head catchment discharges to Korogoro Creek at two pipe outlet locations. Drainage from Marlin Grove is directed to an open drain located behind the lots on the western side of the street. This open drain flows through a small pond section, shown in **Plate 1.4** overleaf, before discharging to Korogoro Creek. The eastern portion of the catchment drains to larger swale drainage lines which converge before discharging to Korogoro Creek.

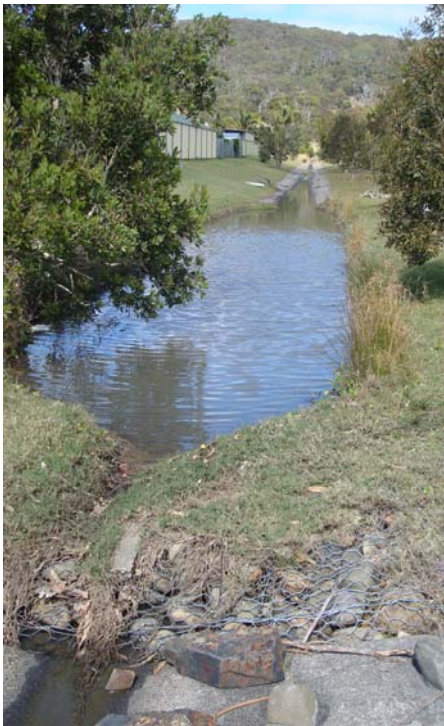
Plate 1.4 Open Drain and Small Pond

The catchment area of South Hat Head is partly defined by the high ridgeline to the south. The upper portion of the catchment comprises bushland which is located in Hat Head National Park. Drainage from the catchment discharges to Korogoro Creek at two defined locations.

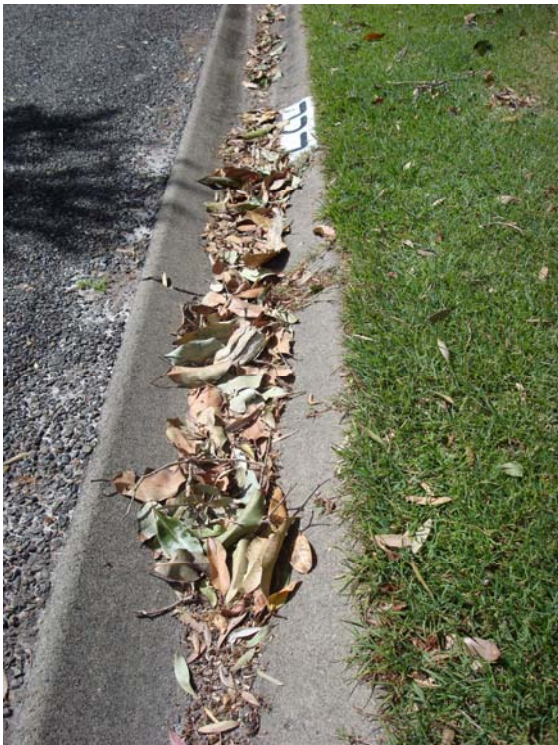
Plate 2.1 Leaf Litter in Caravan Park Drains

Potential sources of stormwater pollutants observed during a site inspection on 9 September 2008 include leaf litter and lawn clippings as indicated in the photographs below, and some minor incidences of litter such as plastic bags and drink cans. However the latter may be the result of littering directly along the creek bank.

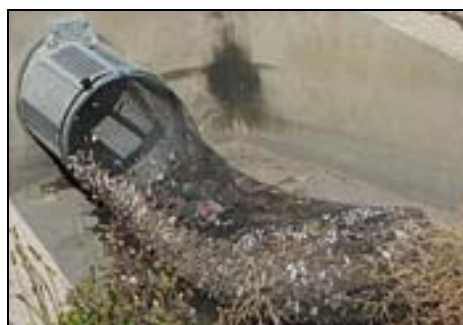
Source: http://www.stormwater.com.au/end_pipe.htm
Plate 3.1 **End of Pipe Litter Net**

The most appropriate type of GPT for Hat Head would be in the form of an end-of-pipe litter net as that indicated in **Plate 3.1**. These types of nets have a reported 50-75% pollution reduction efficiency.

Maintenance of the nets involves Council manually removing the nets from the pipes, emptying the nets into a truck and reattaching the nets to the pipe. This could be undertaken by manually lifting the nets due to the relatively small size required for each pipe outlet at North Hat Head.

The effectiveness of using a litter net at Hat Head is not considered high due to the following reasons:
