KEMPSEY SHIRE COUNCIL
MACLEAY RIVER ESTUARY PROCESSES STUDY

January 2009

MACLEAY RIVER ESTUARY PROCESSES STUDY

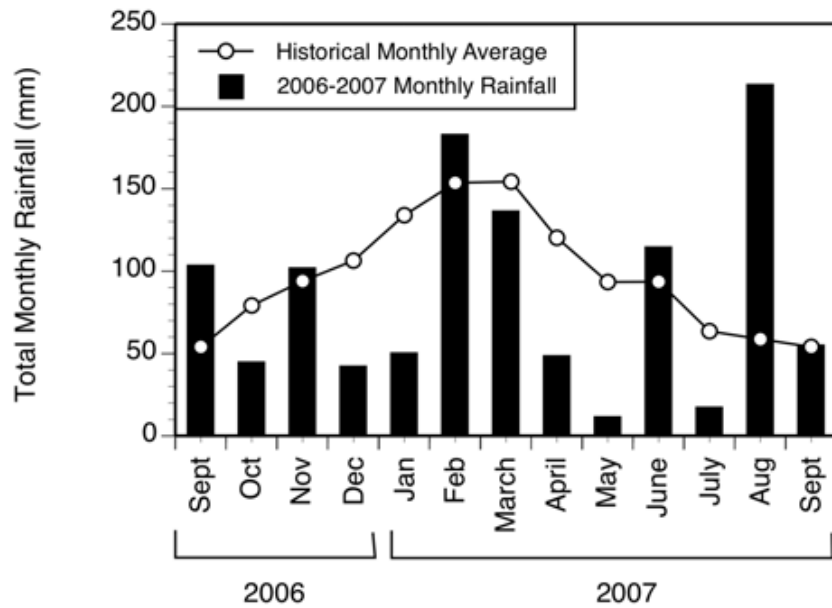
Diagram 8. Monthly rainfall during the 2006/2007 study period and the long term average monthly rainfall (1901 - 2007) for the study area.

Yearly annual rainfall during the 2006/07 study period (1065 mm) was about 12% lower than the long-term yearly average between 1901 and 2007 (1205 mm). The lower annual rainfall during 2006/07 was due to six very dry months (Oct and Dec 2006 and Jan, April, May and July 2007), which received well below their average monthly rainfall, as shown in Diagram 8.
