Macleay River Estuary Data Compilation Study

A report reviewing the existing data adequacy and data and information needs for the Macleay River Estuary Management Plan.

Damon Telfer
GECO Environmental

August 2005

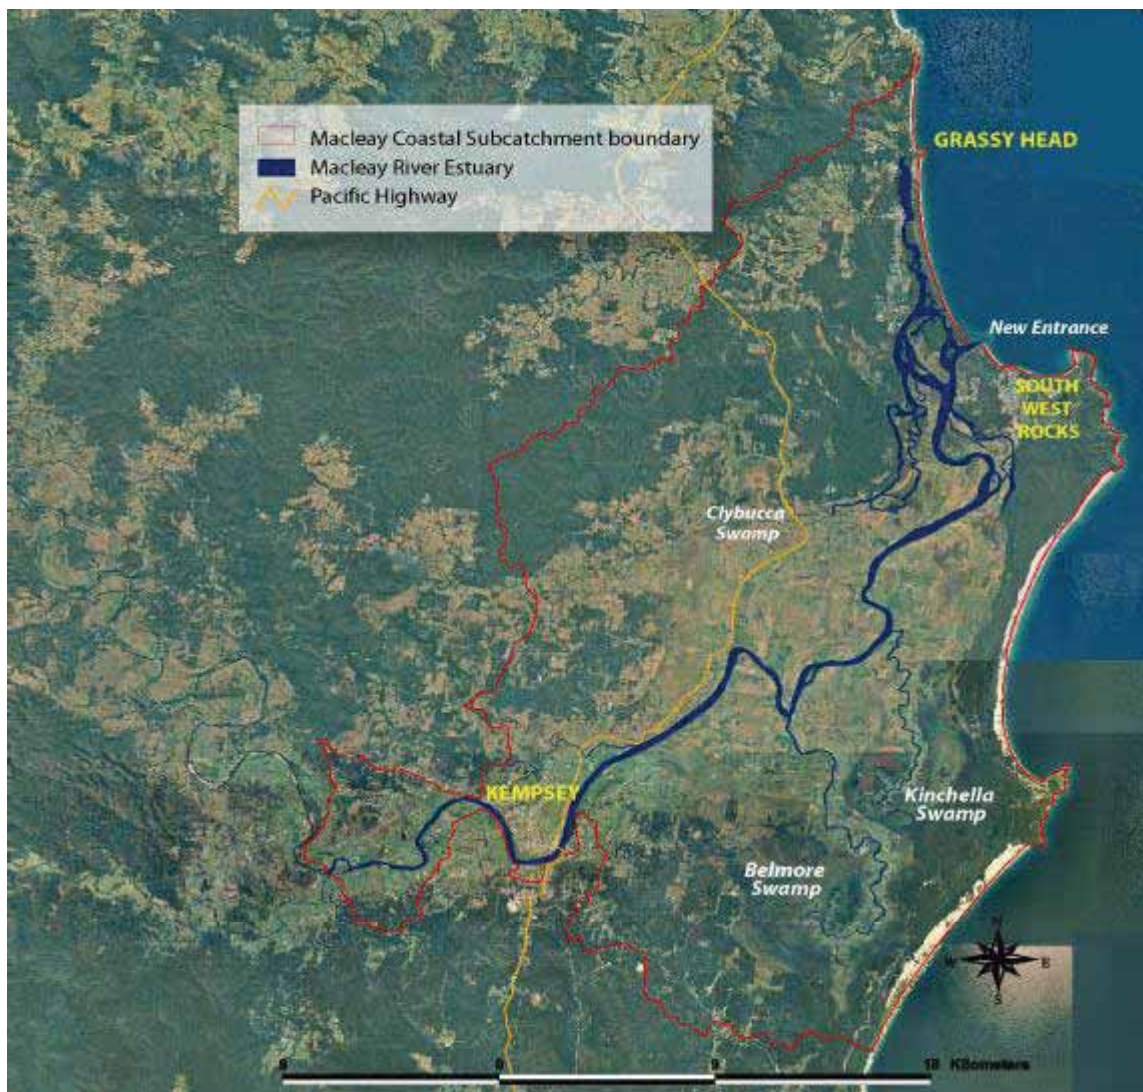
Figure 1.1 The Macleay River estuary and coastal subcatchment.

The Macleay River estuary extends some 54 km upstream from the ocean to the tidal limit at Belgrave Falls, about 10km upstream of Kempsey (Figure 1.1). The coastal floodplain has an area of approximately 400km² below Kempsey. The floodplain includes well defined natural levees up to 7 m above 0 AHD along the river and creeks below Kempsey, grading to large semi-permanent backswamps often <1 m above 0 AHD, and occasionally below sea level (Tulau & Naylor, 1999). These backswamps cover some 240km² representing approximately 60% of the floodplain.

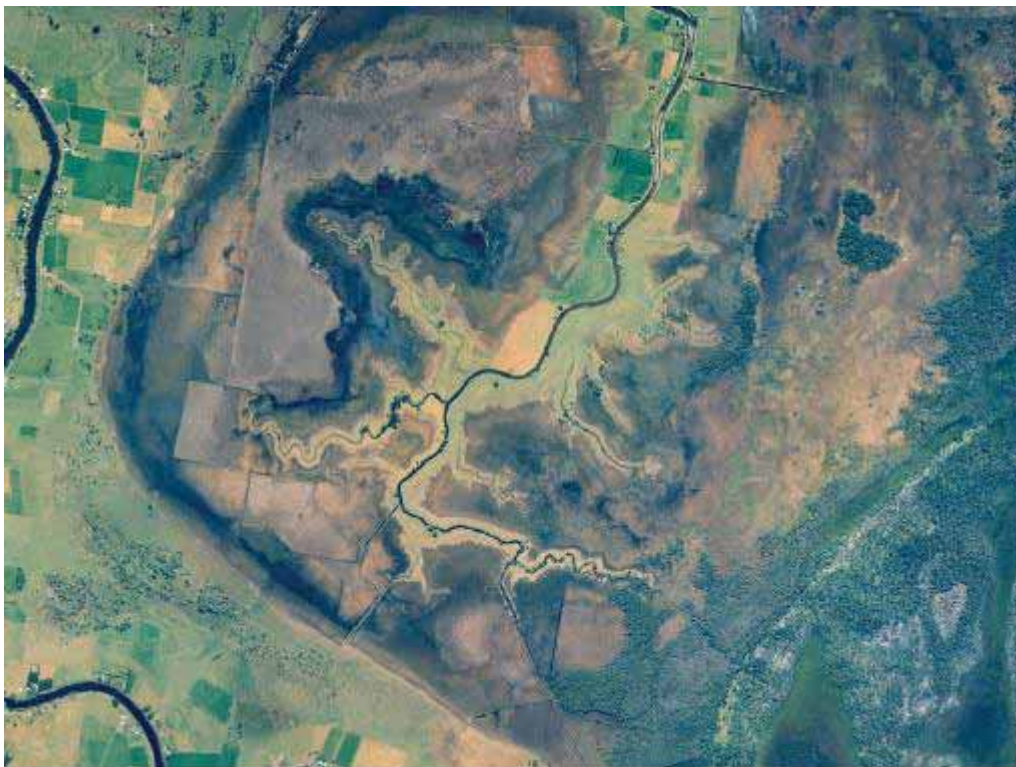
Plate 1 *Birdsfoot delta formation on Kinchella Creek (Source: LIP 2003 1:25000 aerial photography, orthorectified for this study)*

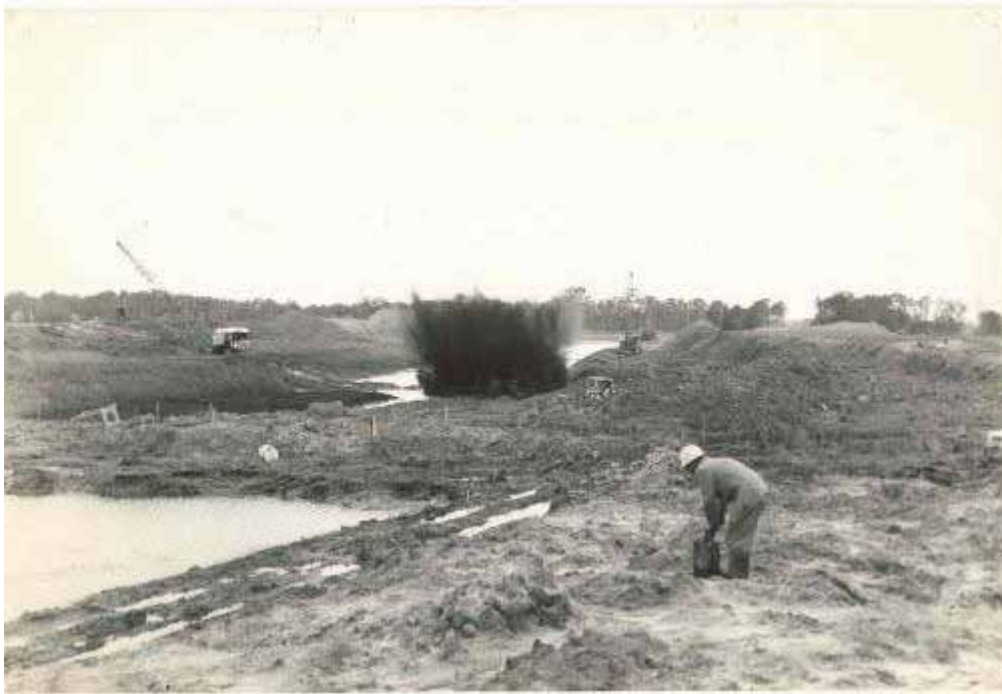
Plate 3 *Blasting of coffee rock along Andersons Inlet to create a new drainage channel which eventually would shortcut Clybucca Creek (Source: Kempsey Shire Council archives)*

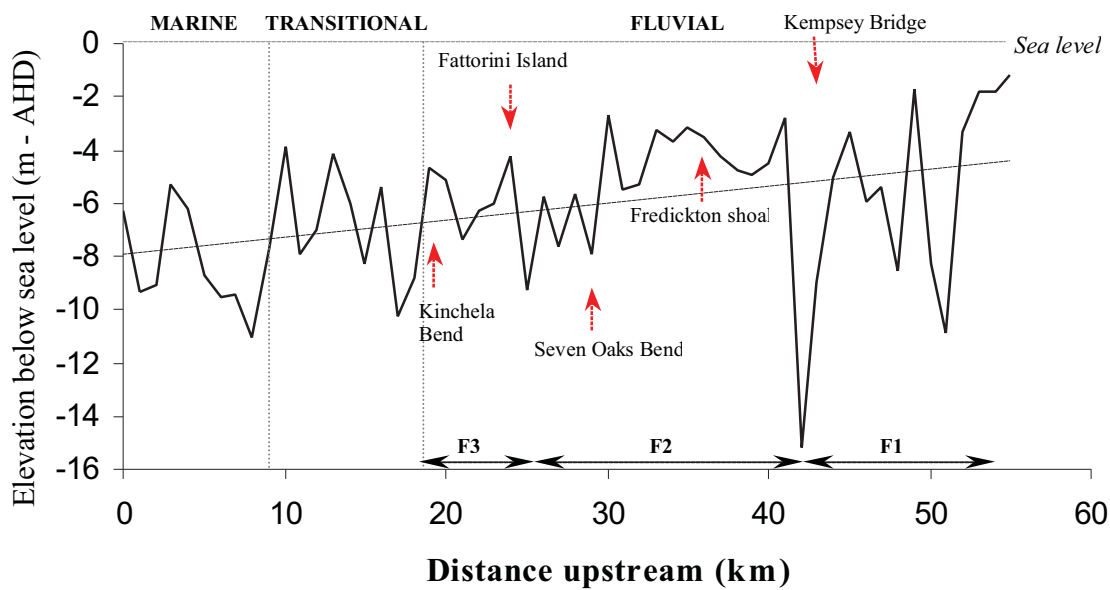
Figure 3.5 Longitudinal profile of the thalweg of the Macleay River trunk stream from Belgrave Falls to the mouth - with linear regression (slope = 0.0006). Topography derived from bathometric data (source: Dept of Commerce).

In order to provide a preliminary estimate of the sediment distribution in the estuary, bathymetric data collected by the Department of Commerce has been used to derive a longitudinal profile of the Macleay River trunk stream from Belgrave Falls to the entrance (based on cross-sections spaced at 1 km intervals; see Figure 3.5)

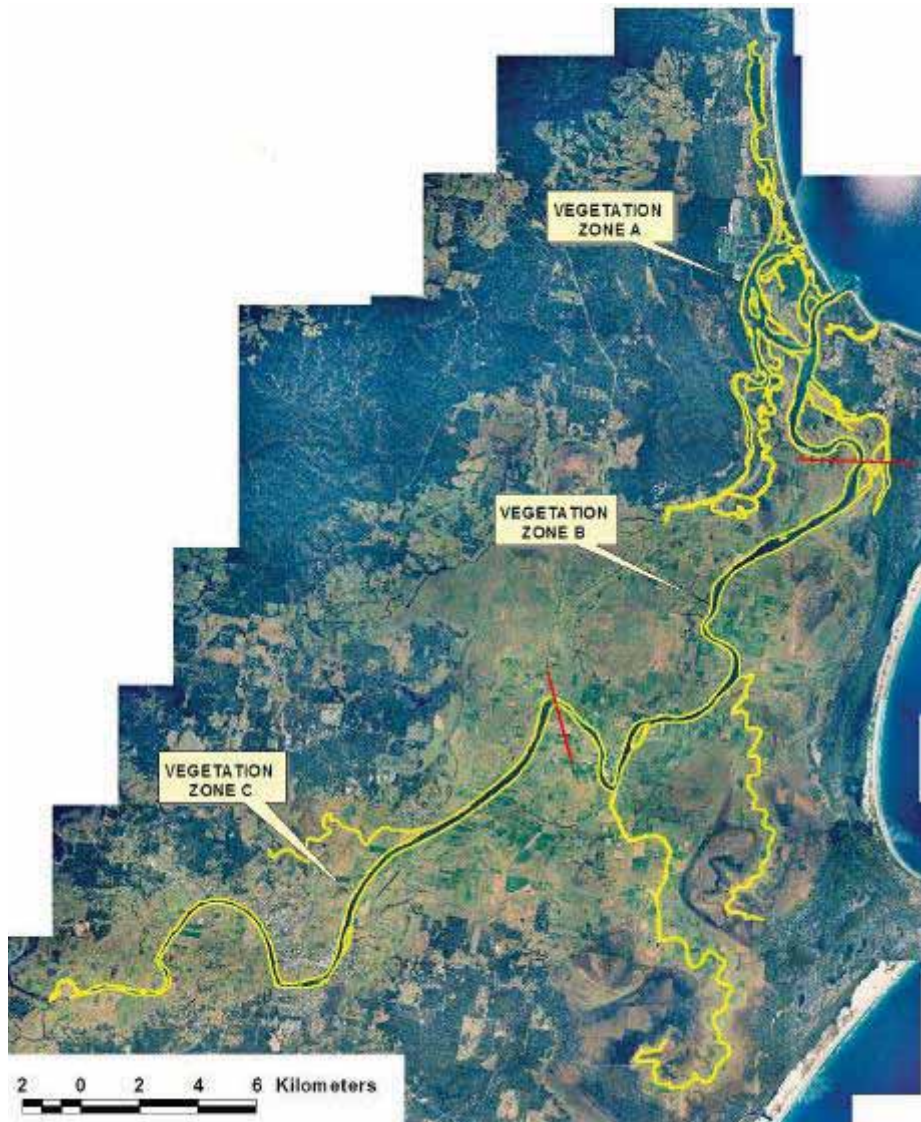
Figure 3.6 Macleay River estuary vegetation zones.

Three general *Vegetation Zones* have been identified. Factors affecting the distribution of vegetation along the estuary include the degree of maritime influence such as salt laden winds and saline waters and levels of tidal fluctuation. The spatial extent and location of the vegetation zones correlate reasonably with the Geomorphic Process Zones described in the previous section. The three zones identified are (see Figure 3.6 *Vegetation Zones*);

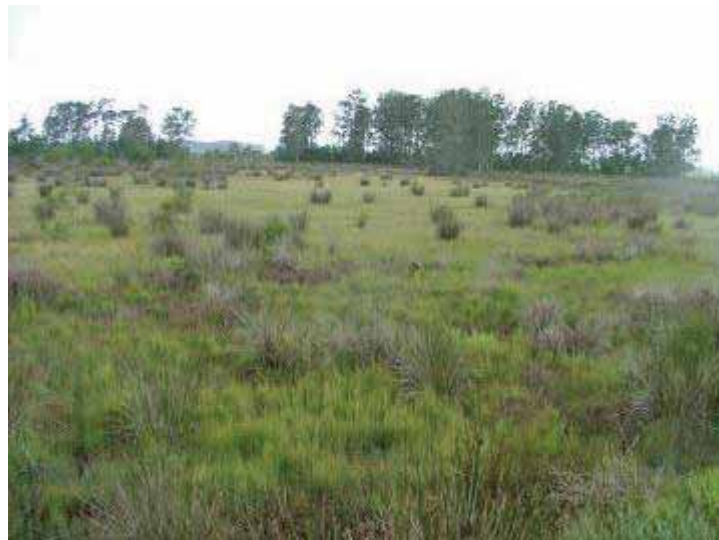
(6102) **Samphire – Sand Couch** *Sarcocornia quinqueflora* – *Sporobolus virginicus*
Forms a shrubland (often termed Saltmarsh) on estuarine mudflats inland of Mangroves, inundated by high spring tides. Maritime Rush *Juncus kraussii* is common and forms an inland intergrade.

Samphire- Sand Couch along Clybucca Creek

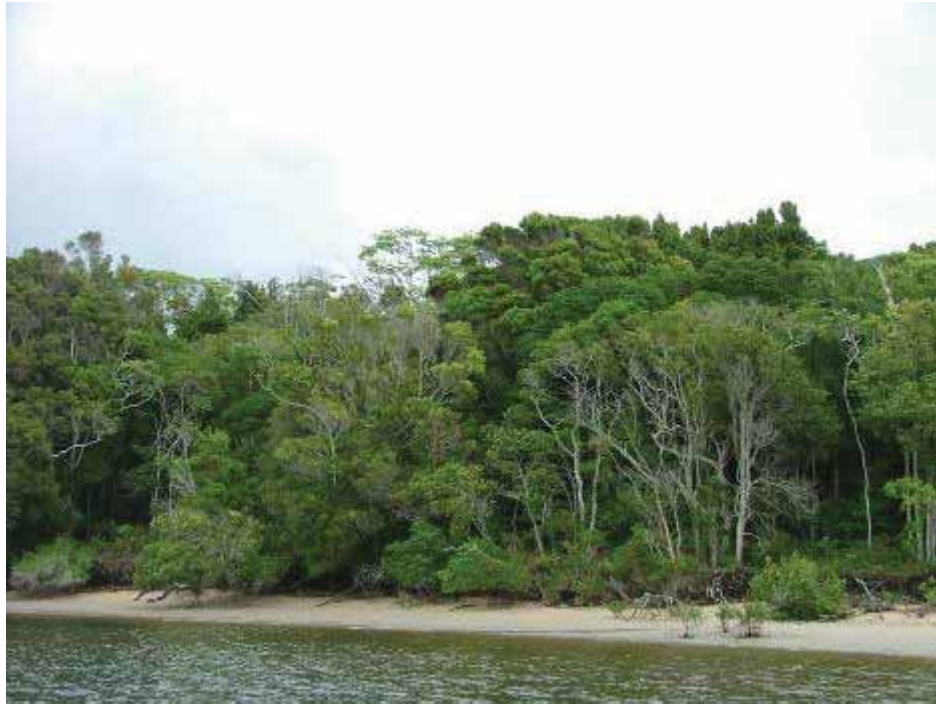
Shark Island Littoral Rainforest

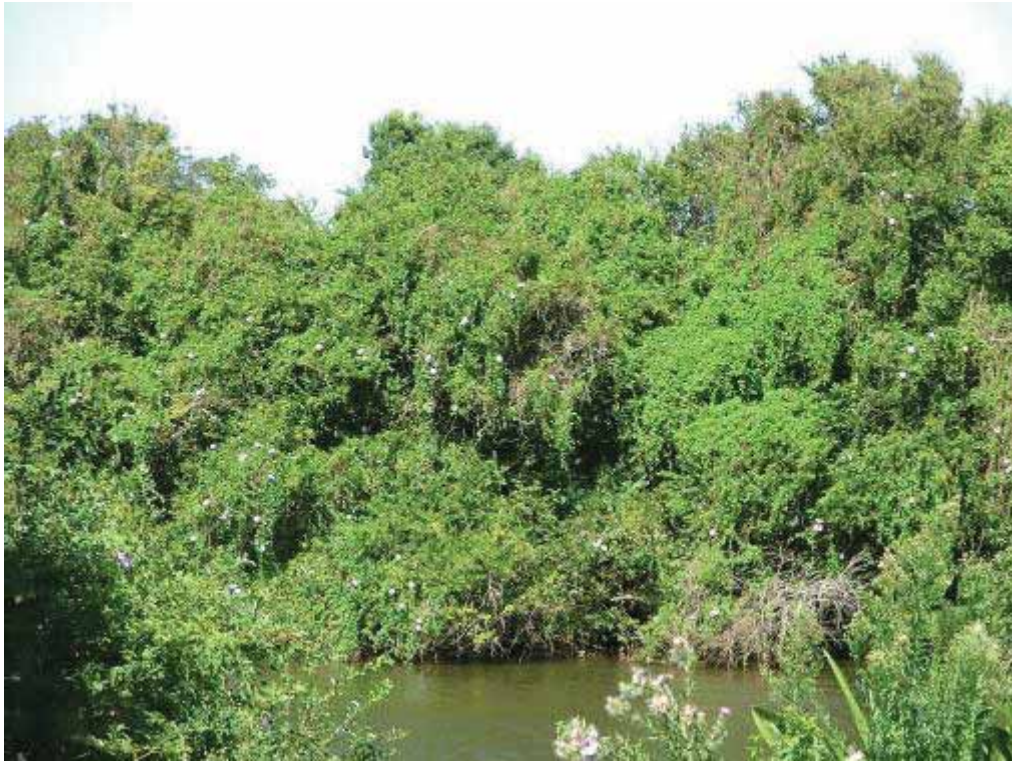
Belmore River – 5-leaf Morning Glory (a Category 2 Weed) smothering native trees.

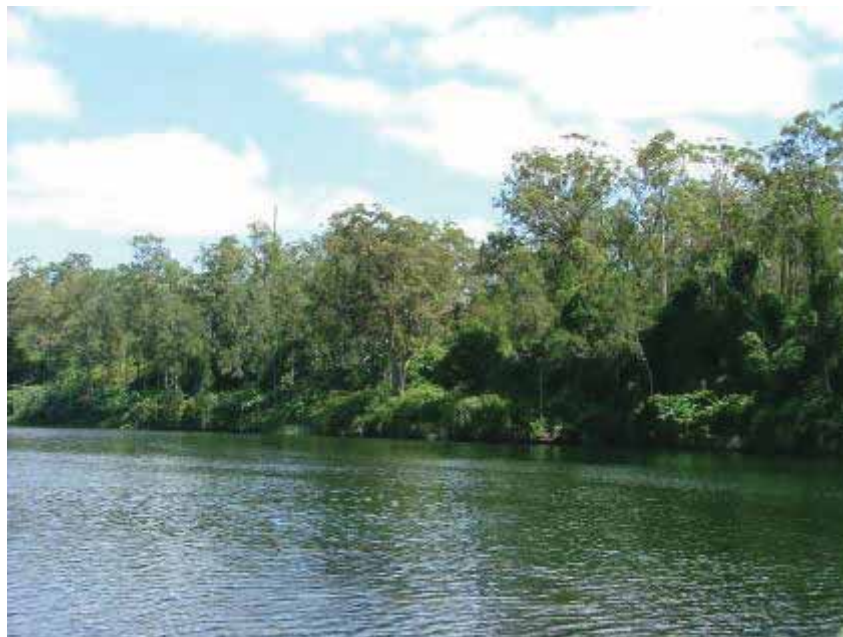
Area 14 (north of Kempsey) – Heavy Weed infestations

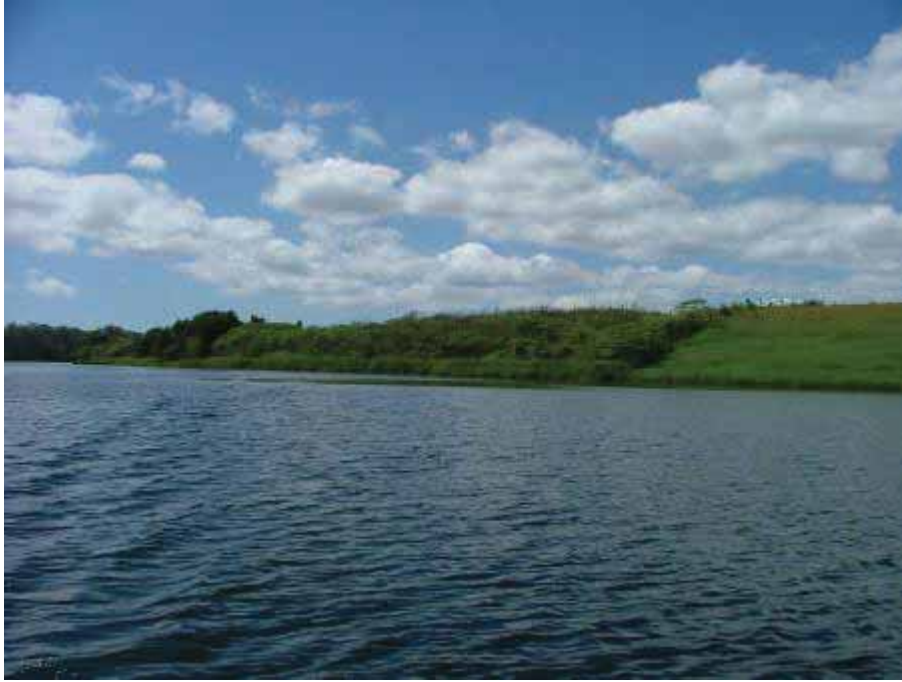
Comparison of bank treatment in older Works upstream of Kempsey – showing fenced and revegetated (left), fenced with weed growth, no fencing. (ArcView Site #16)

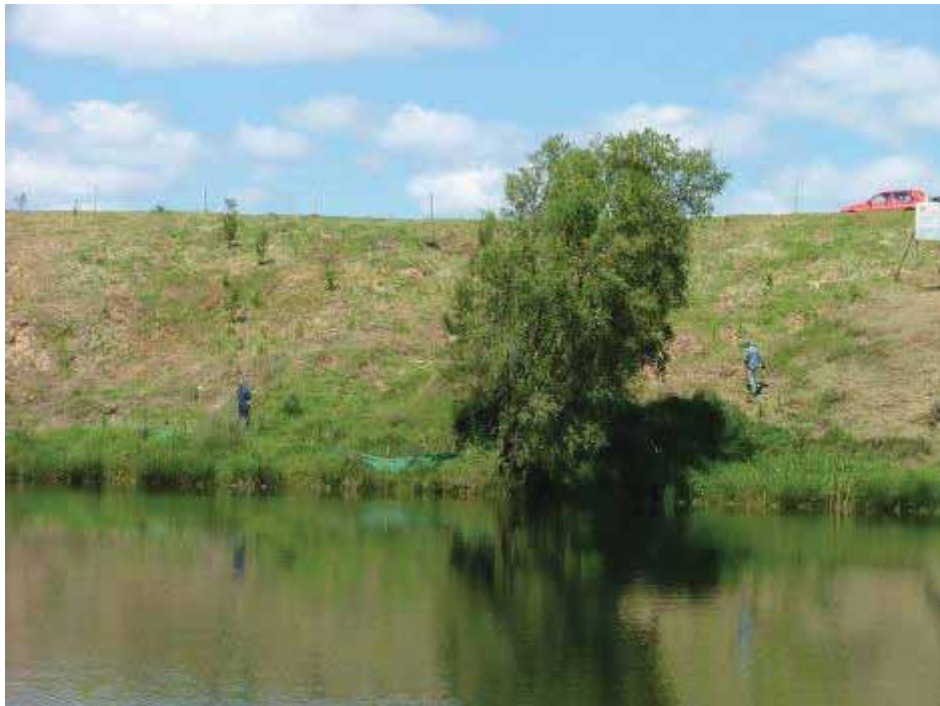
Bass Kempsey – Bank battering, revegetation works adjacent Mary Bay (ArcView Project # 12 / 17)

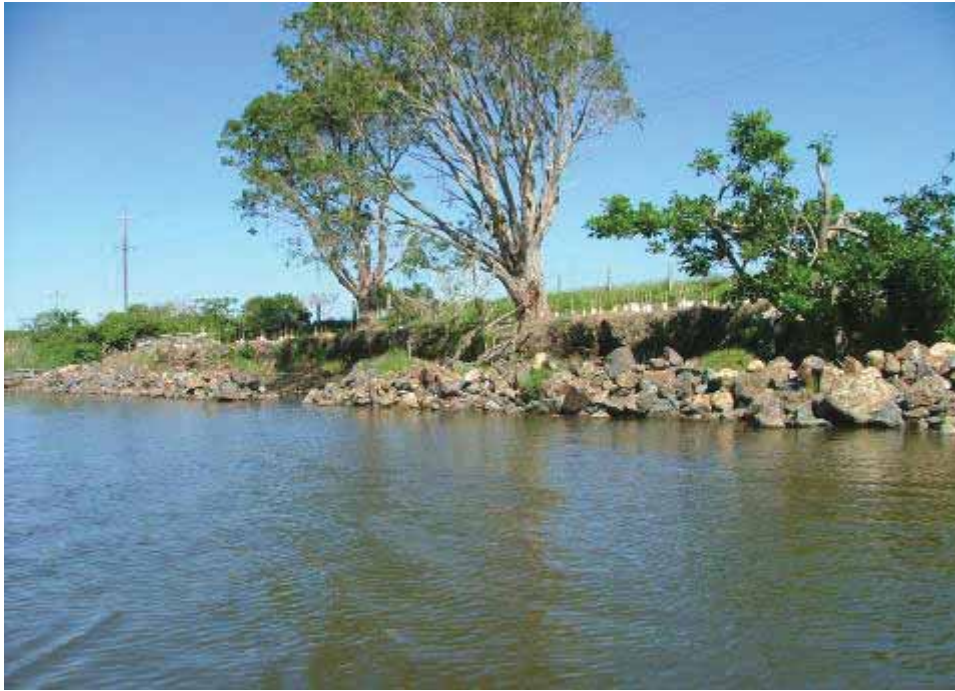
Voluntary Streamcare Grants Scheme Project on the Macleay River . Rock wave barriers, planting and fencing . (E – 0497278, N – 6569866) (ArcView Project # 10 and 14)

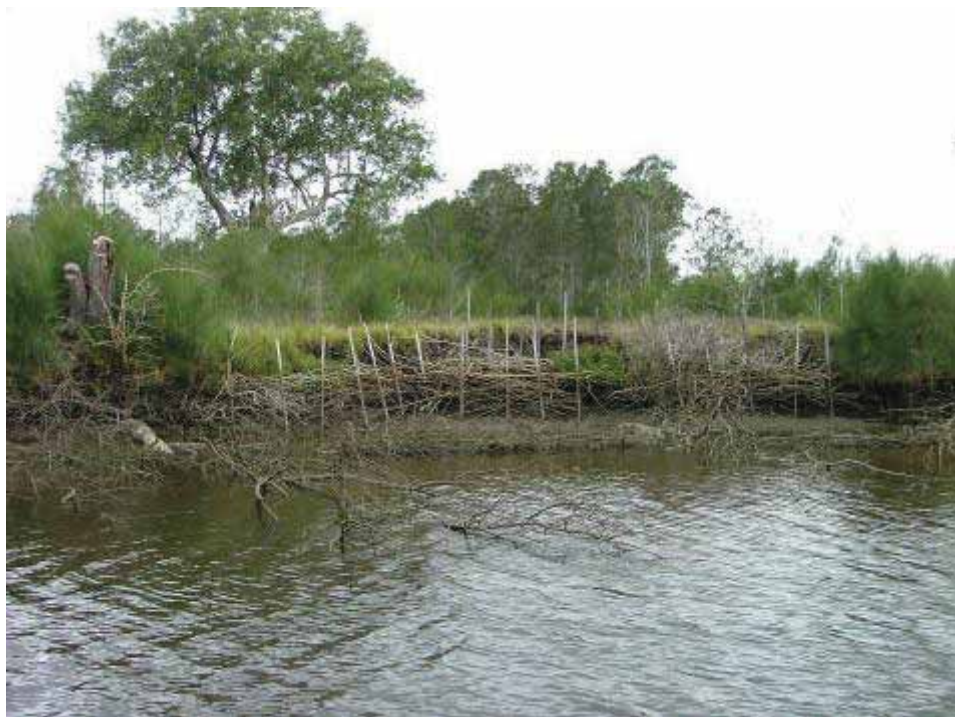
Voluntary Streamcare Grants Scheme Project. Brush groyne erosion control works along the bank of Clybucca Creek. (E – 0500000 N – 6578100)

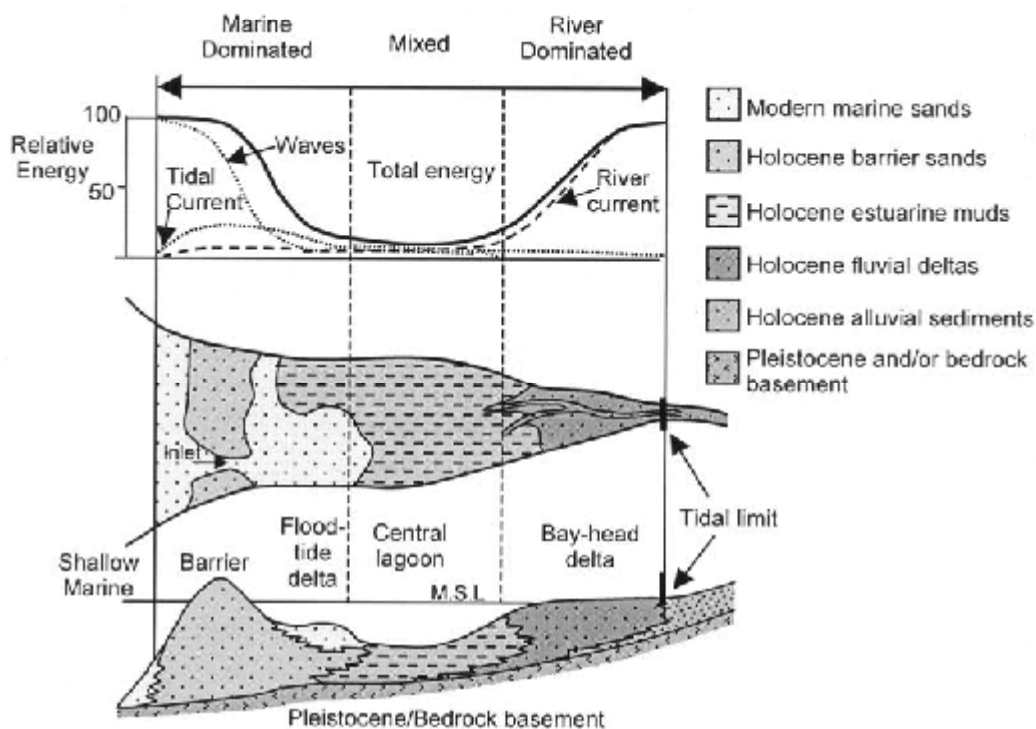
Figure 1 Distribution model of energy and morphological tripartite facies distribution (after Dalrymple et al., 1992).

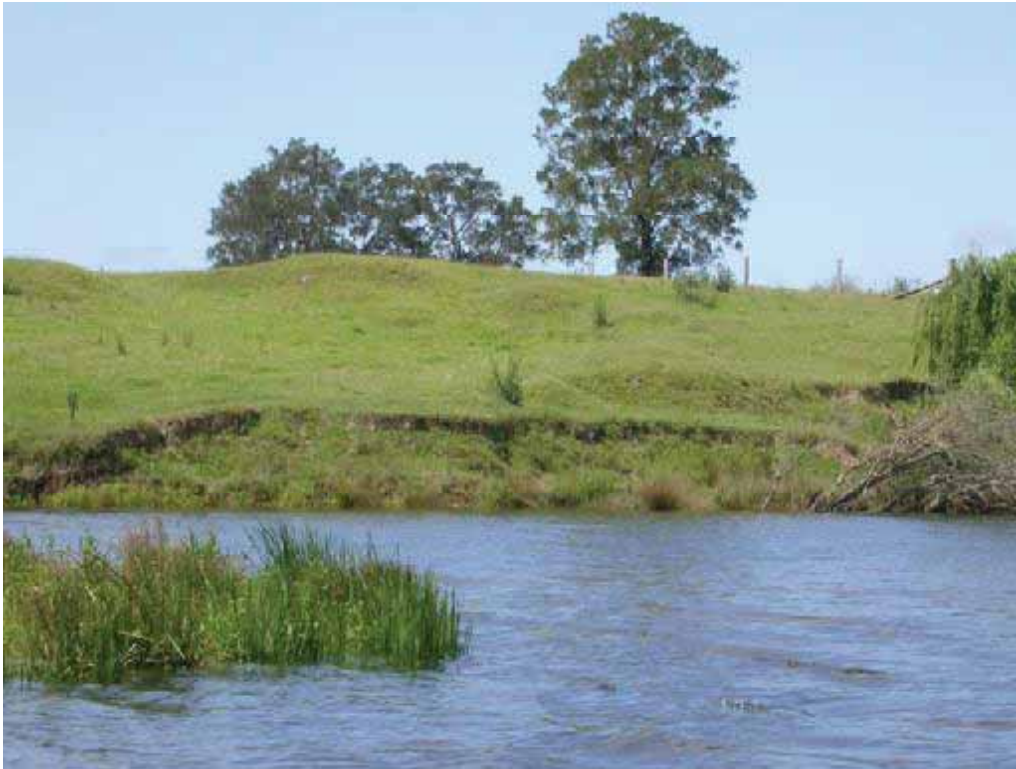
Figure 4 Failure scars (dormant shallow slip) on the toe of the stepped channel margin in Fluvial Reach 1. This stepped bank form is a result of valley confinement and steep gradients producing erosional and depositional units set within the current floodplain.

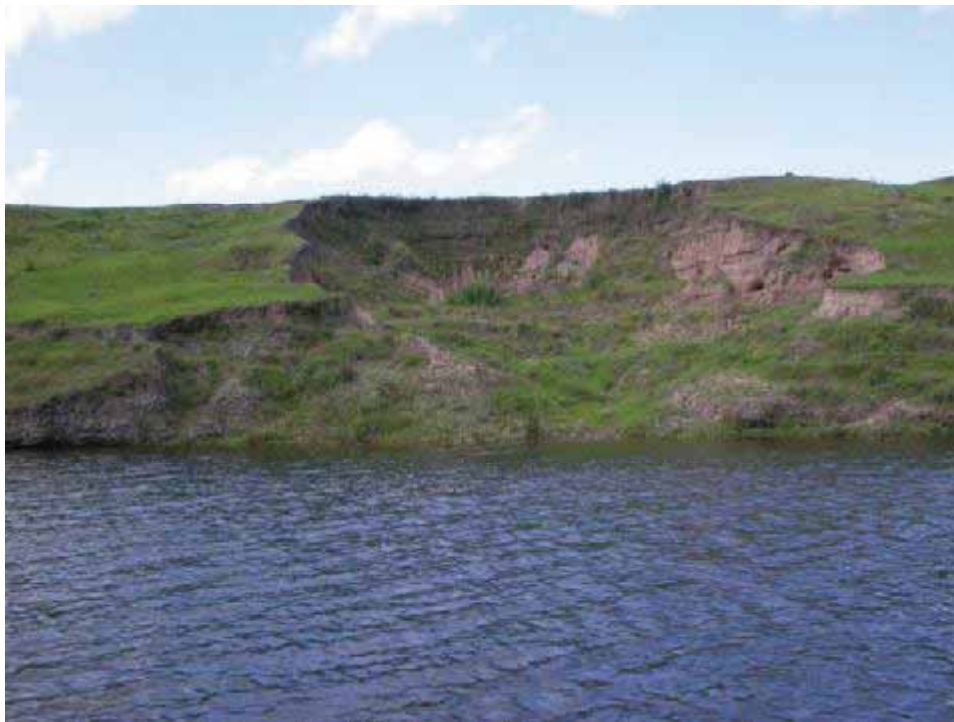
Figure 6 Mass failure (rotational slump) of banks downstream of Belgrave Falls. Bank strength of the Alda Villa and Huntingdon terrace material has been markedly reduced by the replacement of structurally diverse native vegetation with pasture species. Piping and gullying of the slumped zone, along with continued stock access, makes the banks susceptible to ongoing erosion.

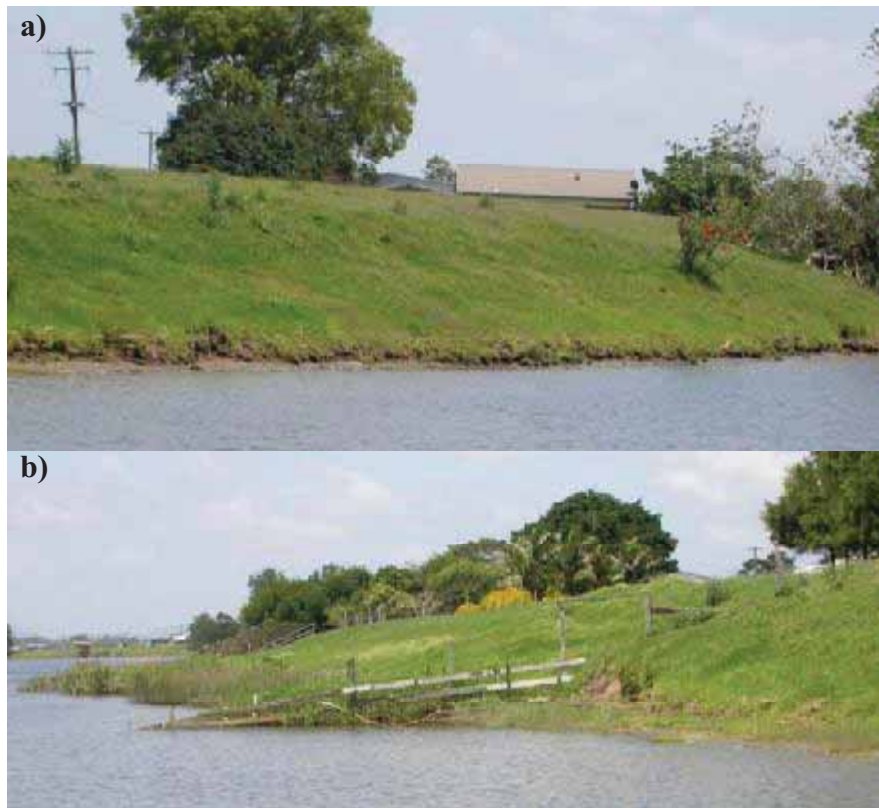
Figure 7 a) Notching of bank toe by wind and/or boat waves in Fluvial Reach 2 **b)** The impacts of stock on macrophyte growth and toe erosion with varying land use of the channel margin. Property on left has fenced off stock from the channel margin.

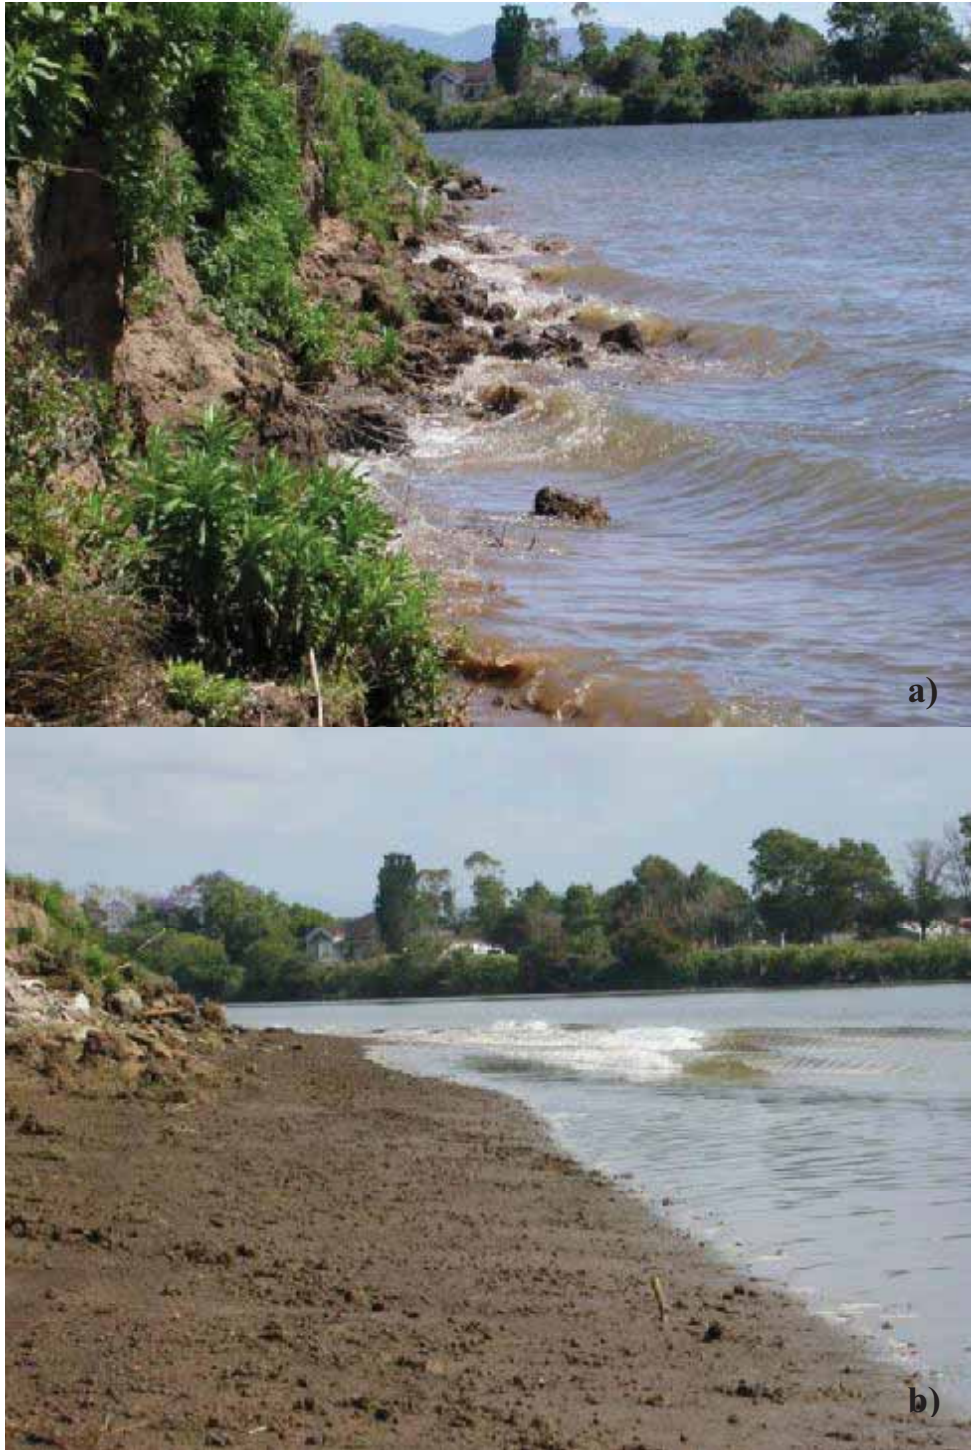
Figure 9 a) Bank erosion on the inside of Kinchela Bend at high tide**b)** The local hydraulics and basal estuarine clay has resulted in the development of a more subdued sub-water topography with ongoing erosion occurring at mid-high tide only

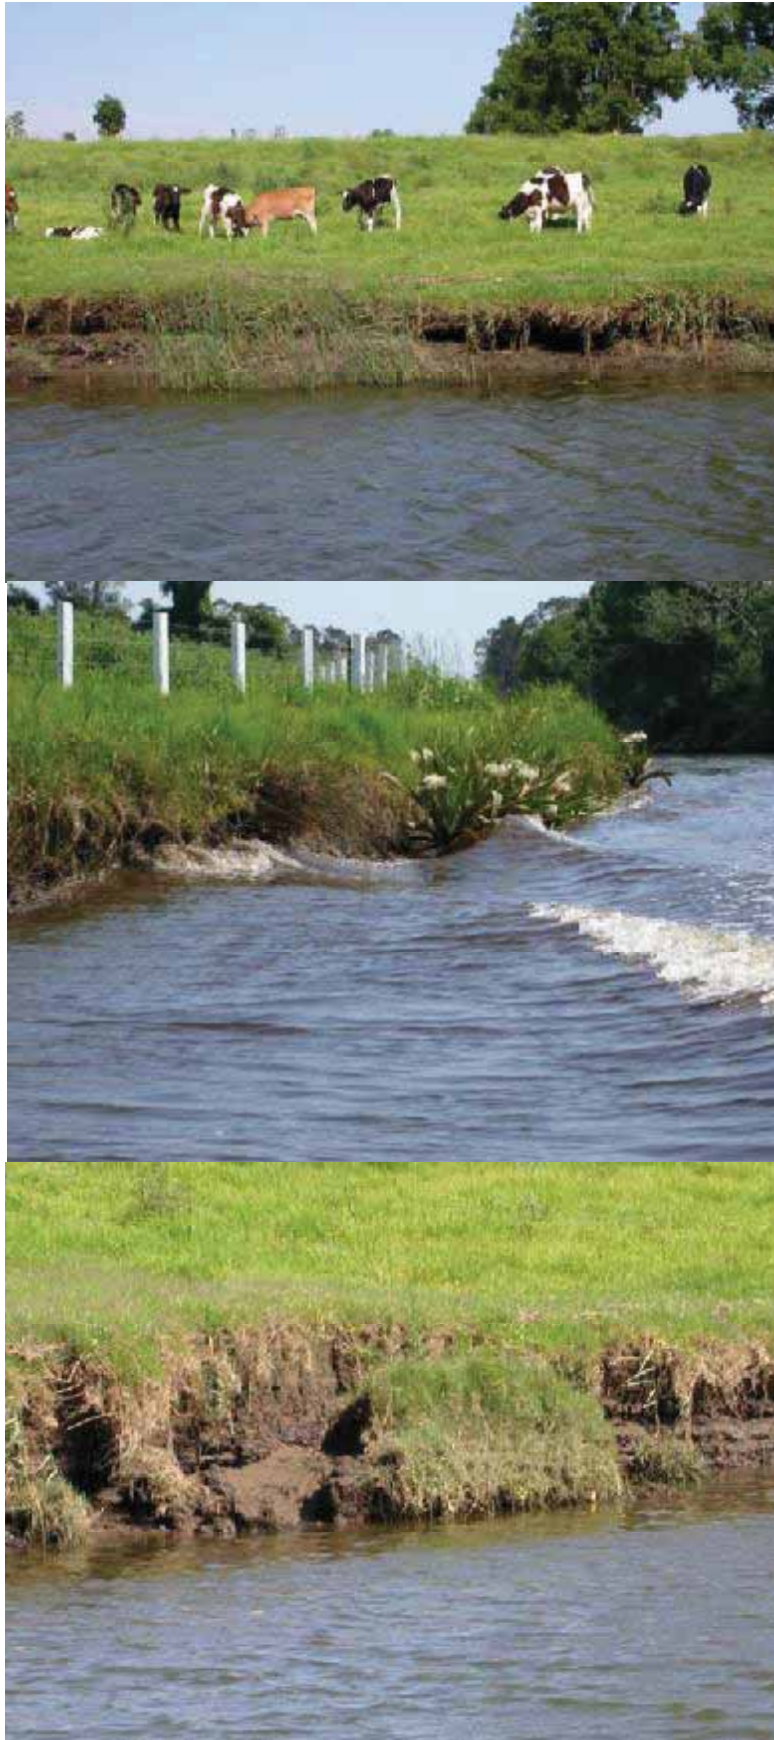
Figure 10 Stock impacts on Belmore River resulting in reduced bank strength and increased susceptibility to wind and/or boat waves leading to slab-type block failure

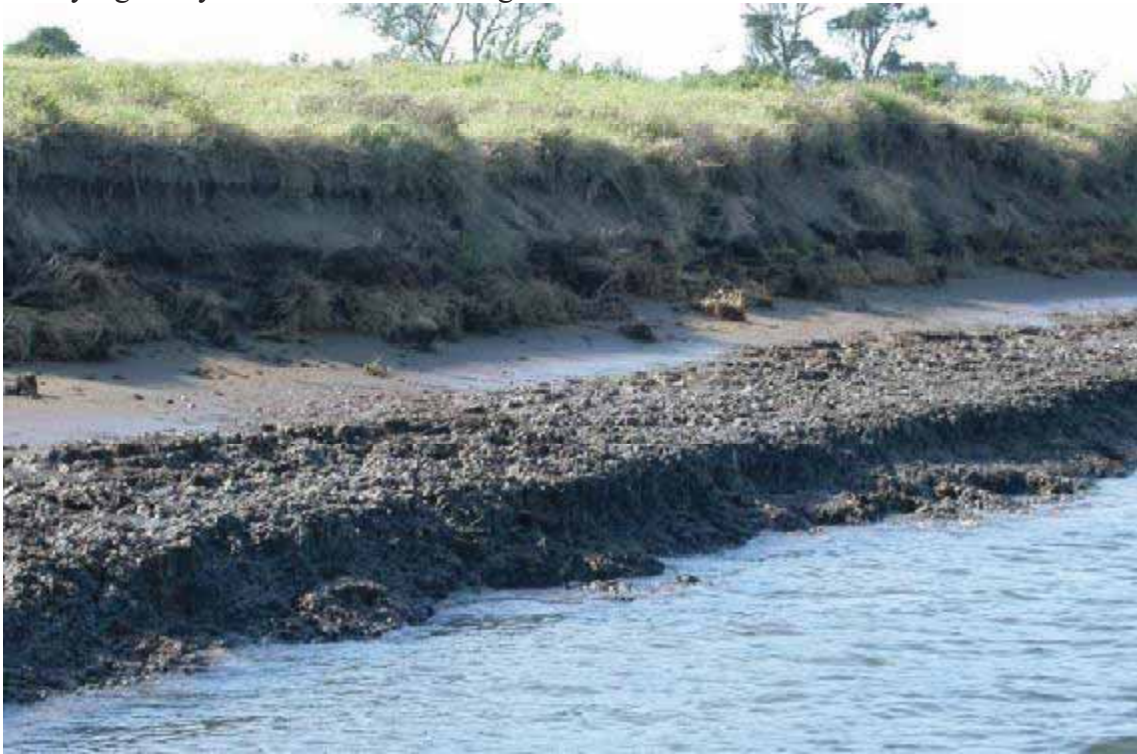
Figure 12 Bank erosion of a ‘deep-water’ profile at Pelican Island – low tide. Note the crab pellets of the basal clays resulting in the basal clay ledge being pre-conditioned to wind/boat wave erosion.

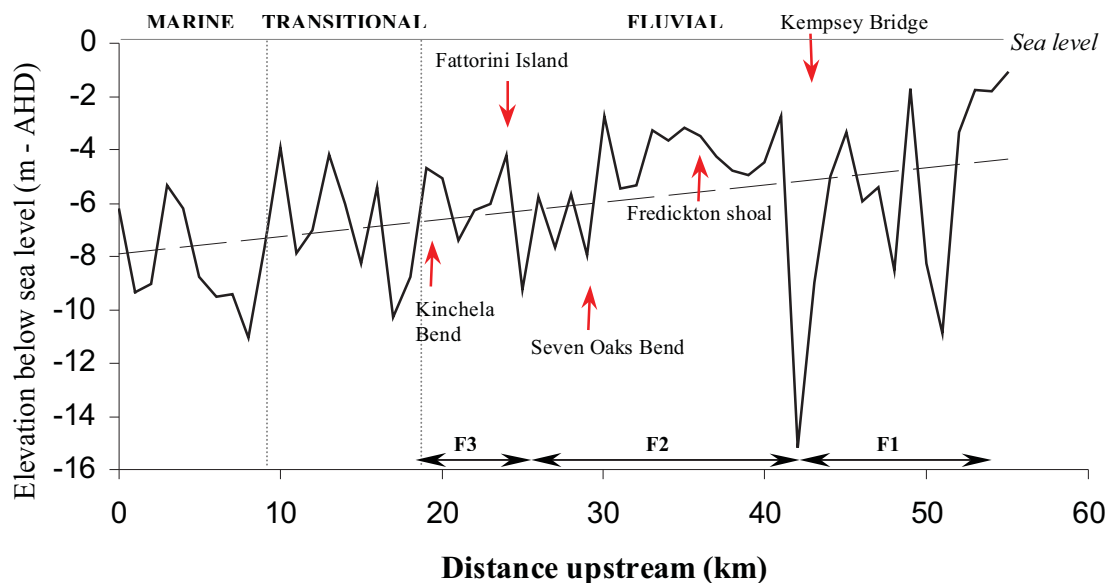
Figure 17 2003 Longitudinal profile of the thalweg of the Macleay River trunk stream from Belgrave Falls to the mouth — with linear regression (slope = 0.0006). Topography derived from bathometric data (source: DIPNR).

to erode from fluvial processes and from wind and/or boat waves at both low and high tide given the rocked outer margin, the evidence of bed aggradation upstream of Fattorini Island (Figure 17) and the current 'deep water' bank profile.
