Final Report

Killick Creek Entrance Management Plan

Kempsey Shire Council

3 March 2025

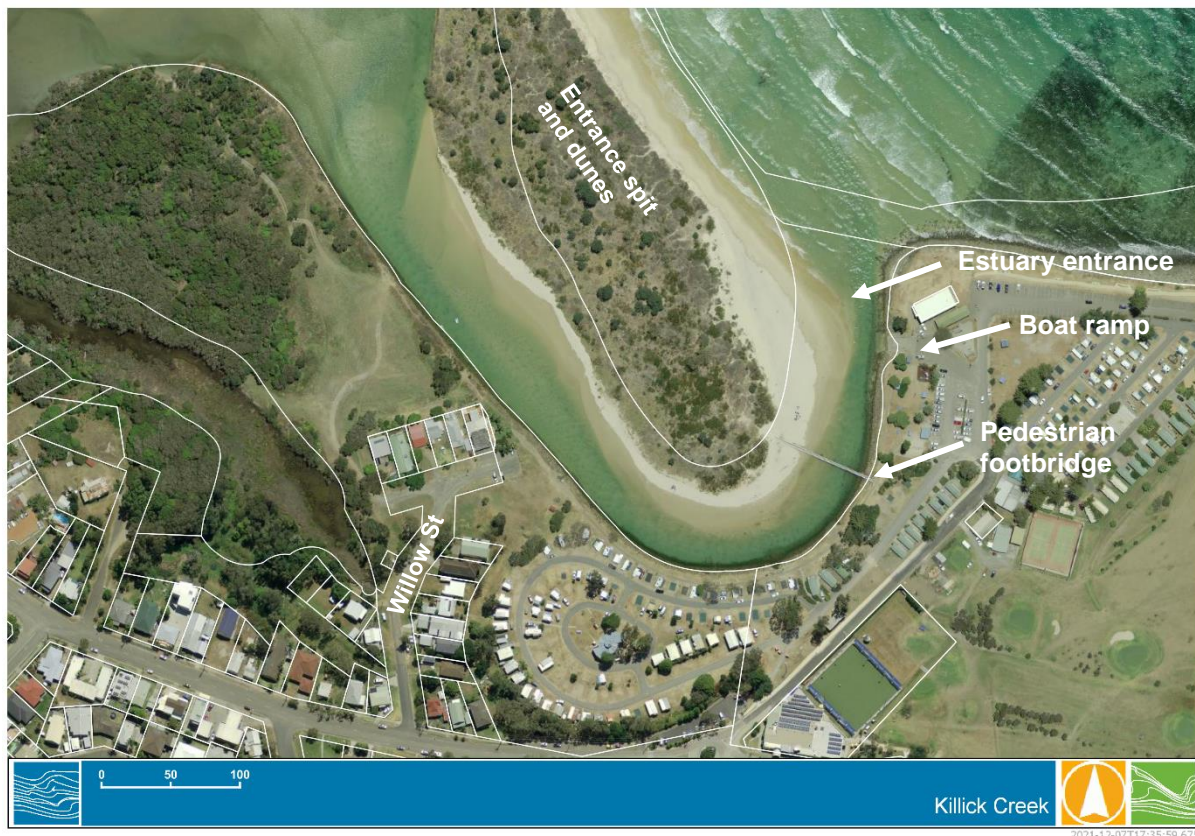
Figure 1-1 The area to which this plan applies

The site is located at the ocean entrance of Killick Creek estuary as it adjoins the ocean. The area covered by this EMP is shown in Figure 1-1. This EMP applies to the catchment of the estuary which comprises the waterway, foreshores and land adjacent to the estuary up to the tidal limit of the tributary creeks and the extent of the drainage catchment directly contributing to the estuary waterways. The area relevant to this EMP also includes the proposed access route for excavator access to the estuary entrance.

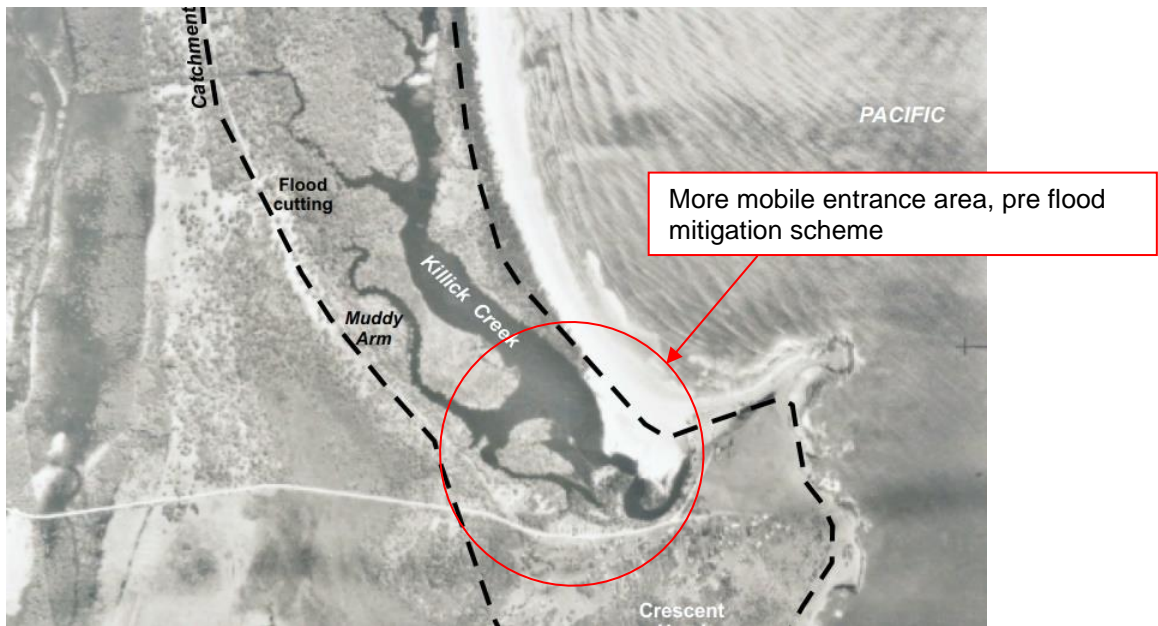
Figure 2-3 Killick Creek in an undisturbed state in 1942 (MHL, 2002)

Prior to the 1950's the natural condition of the estuary entrance was significantly more mobile and dynamic than its present state. A historical aerial of the estuary from 1942 is provided in Figure 2-3, and depicts a wide and variable sand berm, and meandering entrance channel.

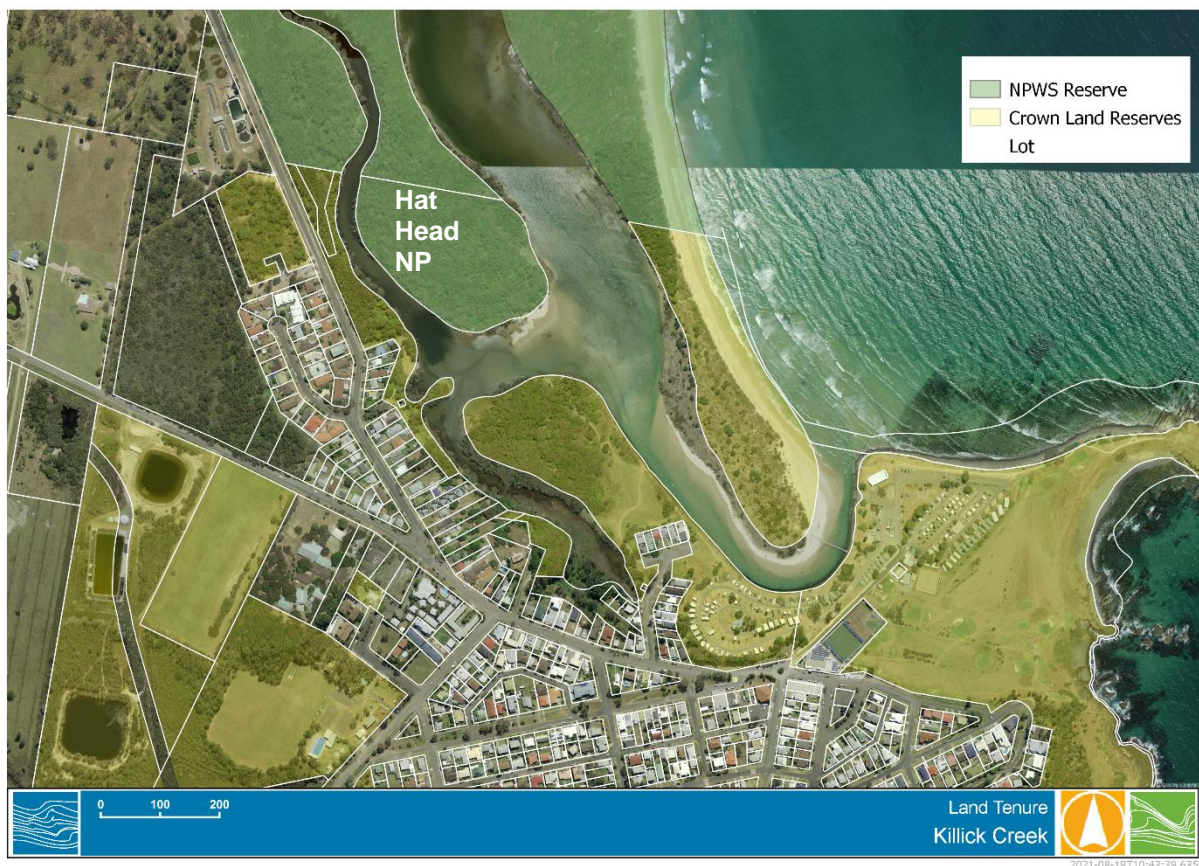
Figure 3-1 Land tenure at the Killick Creek entrance

However, any works within an ICOLL entrance may require approval depending on land tenure and the applicable planning framework. Artificial entrance management is generally assessed under Part 5 of the EP&A Act, where the determining authority (e.g., council or a public agency) is responsible for assessing the environmental impacts. Therefore, tenure needs to be clearly established to determine responsibility for entrance management and required approval processes (NSW DPI-Fisheries, 2020). A map of land tenure at the Killick Creek Entrance is provided in Figure 3-1, and it shows that:

- The estuary entrance and the entrance berm are located on Crown land waterway.
- The estuary entrance is bounded by Council-managed Crown land, and Hat Head National Park.

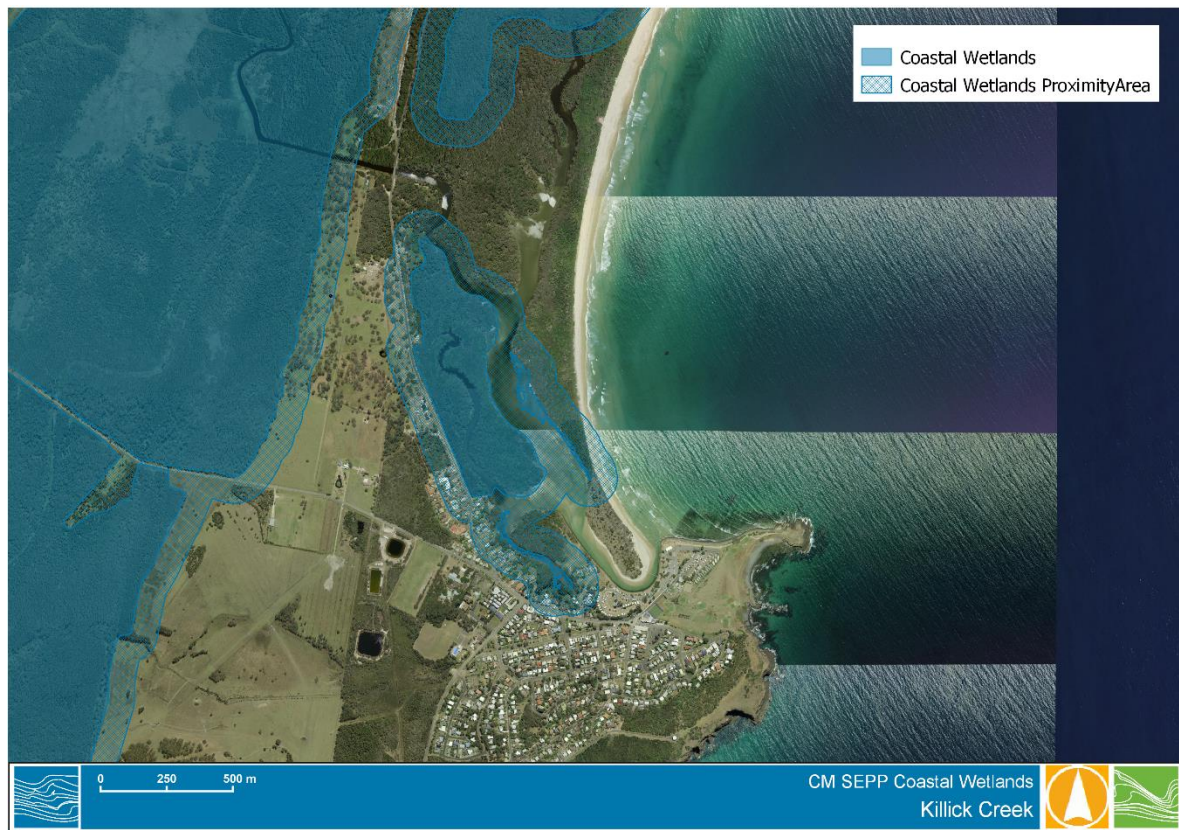
Figure 3-2 R&H SEPP mapping for Killick Creek

The CM Act establishes management objectives specific to each of these management areas, reflecting their different values to coastal communities. These coastal management areas are mapped as part of the *State Environmental Planning Policy (Resilience and Hazards) 2021 (R&H SEPP)* – and is depicted in Figure 3-2. This shows that:

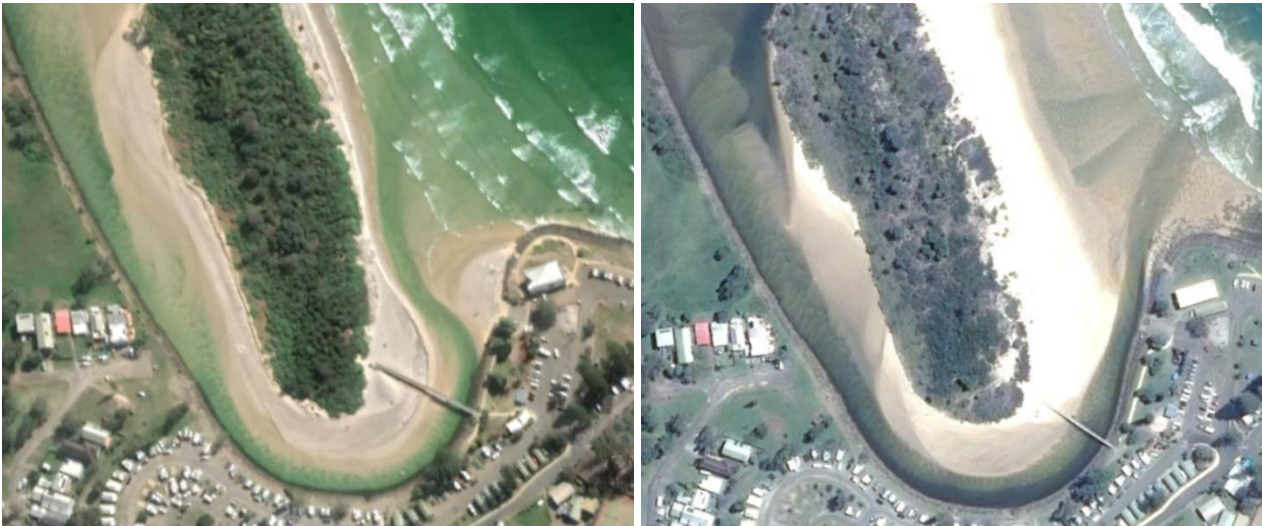
Figure 4-1 Killick Creek Entrance – northerly entrance meander (left), compared to a more typical north-easterly aligned channel (right)

As part of the works, the entrance channel is realigned to a more typical north-easterly aspect - see Figure 4-1. The works are undertaken in order to realign the channel only, and not to increase the channel depth or width.

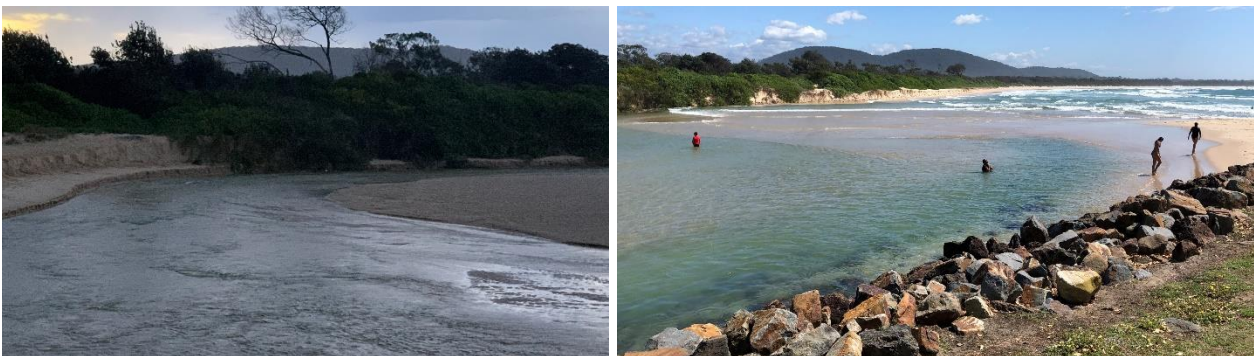
Figure 4-2 Examples of erosion of the Killick beach spit and dunes caused by the entrance meander

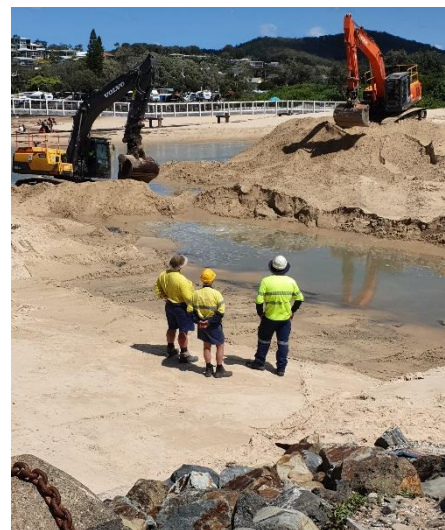
Figure 4-3 Entrance meander correction in September 2020

was the case during entrance meander correction works undertaken in September 2020, which was undertaken to protect the foundations of the pedestrian footbridge – see Figure 4-3.

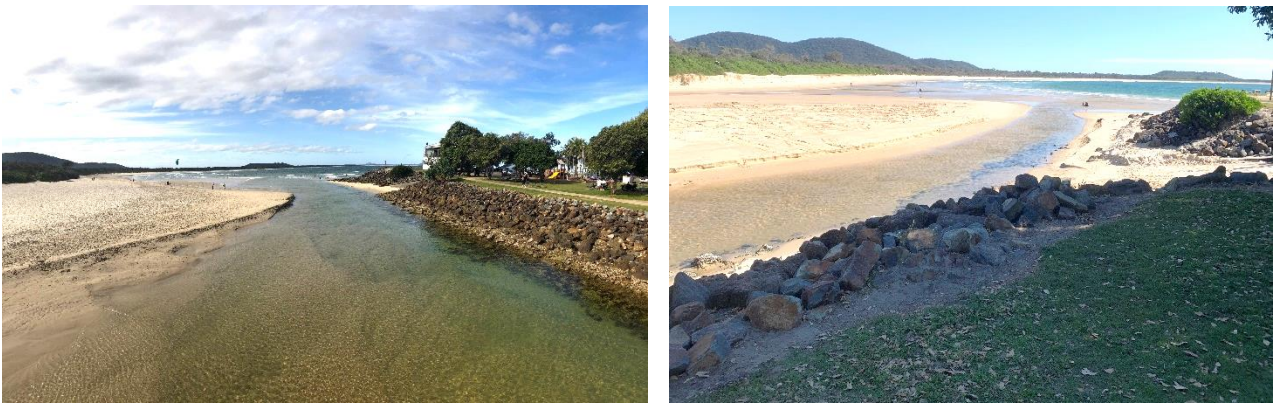
Figure 5-1 Entrance open (left) and almost closed with berm formation (right)

The natural dynamic connection and disconnection between the estuary and ocean is usually from the berm or sand barrier development formed at the final stages in an entrance closure. This is typically formed when sediment is deposited by waves, tides, flood flows and winds generally from the offshore to the entrance (DPIE, 2021). The estuary opens and closes to the ocean naturally in a constant but irregular cycle. Examples of open and (almost) closed entrance conditions are provided in Figure 5-1.

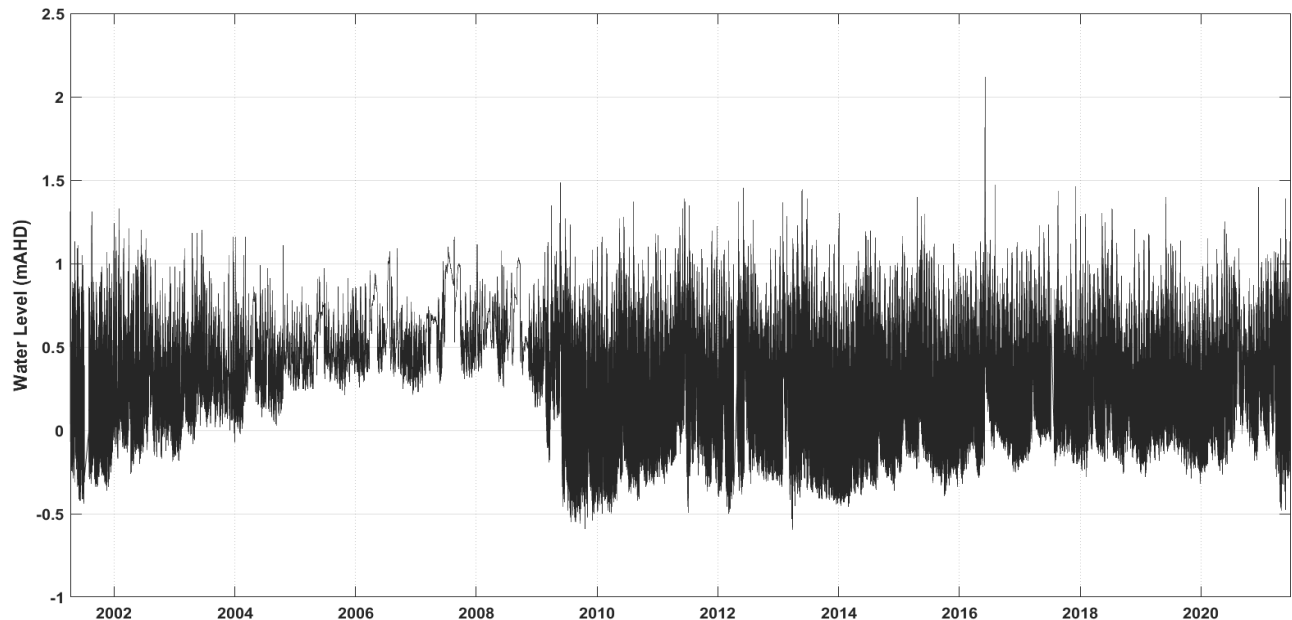
Figure 5-2 Estuary water levels from 2002 to 2021

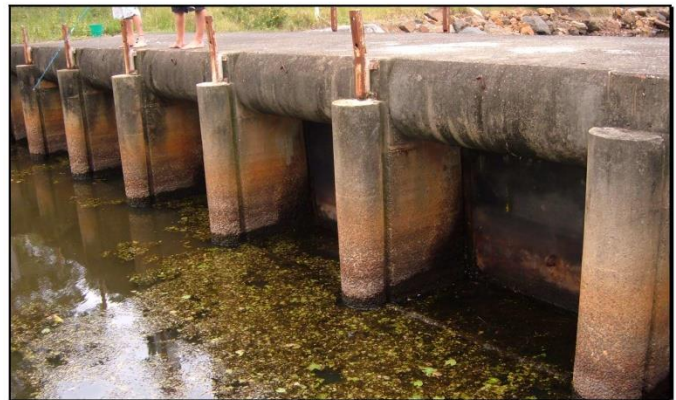
Figure 5-3 Killick Creek floodgates (WBM Oceanics, 2006)

The scheme includes the Killick Creek Floodgates which are used to reduce flooding on the Belmore River, including when Connection Creek joins the Belmore River (Connection Creek connects the Macleay and the Hastings River catchments in large floods). Killick Creek therefore provides an outlet for the water stored in the Belmore swamp areas (SES, 2017).

Water levels in the agricultural drains upstream of the Killick Creek floodgates are controlled by the position of the dropboards. Higher water levels are retained in the drains at times to assist with acid sulfate soil management within the floodplain. During other times, maximum drainage from the floodplain is required, particularly during Macleay River and/or Maria-Hastings River flood events or significant local rainfall within the Belmore Swamp area. Post-flood drainage is also critical for removing floodwaters from productive agricultural lands and minimising pasture losses due to extended inundation (WBM Oceanics, 2006).

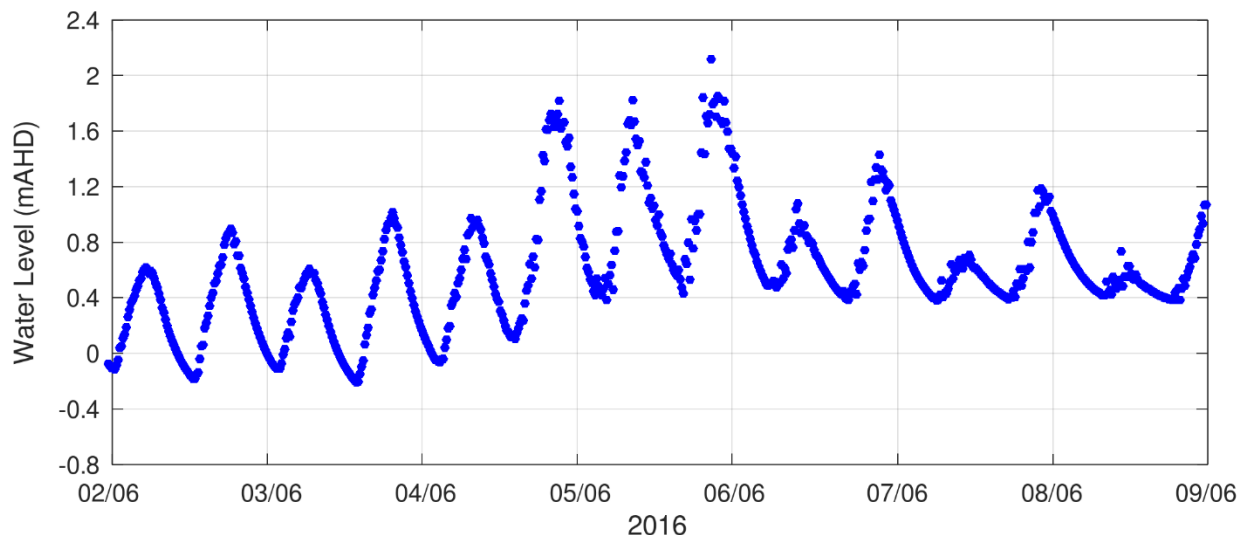
Figure 5-5 Recorded water levels during the June 2016 ECL event

The largest water levels recorded at the downstream gauge since 2002 were during the June 2016 east coast low event. During this event, a peak water level of 2.1 m AHD was recorded. This event was associated with over 250 mm+ of rainfall at the Kempsey Airport rain gauge in 48 hours, along with a storm tide level of +1.5 m AHD recorded at the Tweed Heads tide gauge (which excludes local wave set-up). This indicates that the observed water levels at the Killick gauge were the likely to be the result of combined coastal and catchment flooding.

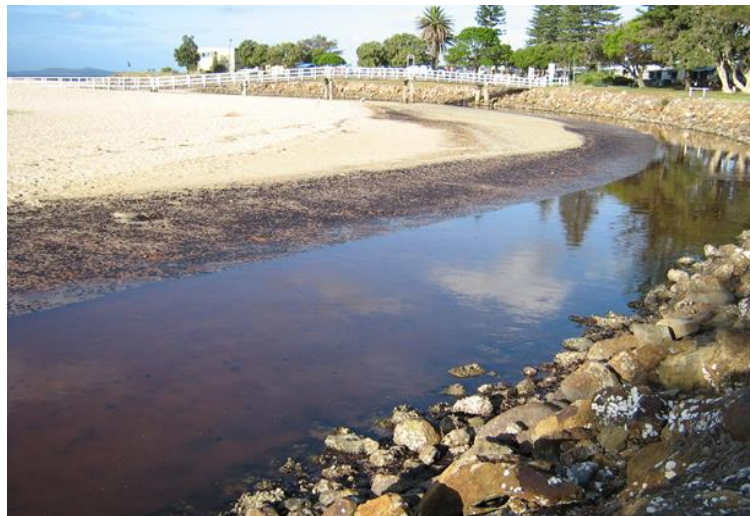
Figure 5-7 Example of brown tannin rich water in the creek (Source KSC)

Water within small ICOLLS systems like Killick Creek are commonly influenced by tannin-rich groundwater and wetland runoff inputs. Tannins are responsible for the 'tea-like' brown water appearing in these systems and should be regarded as a natural attribute of the system (DPIE, 2021).

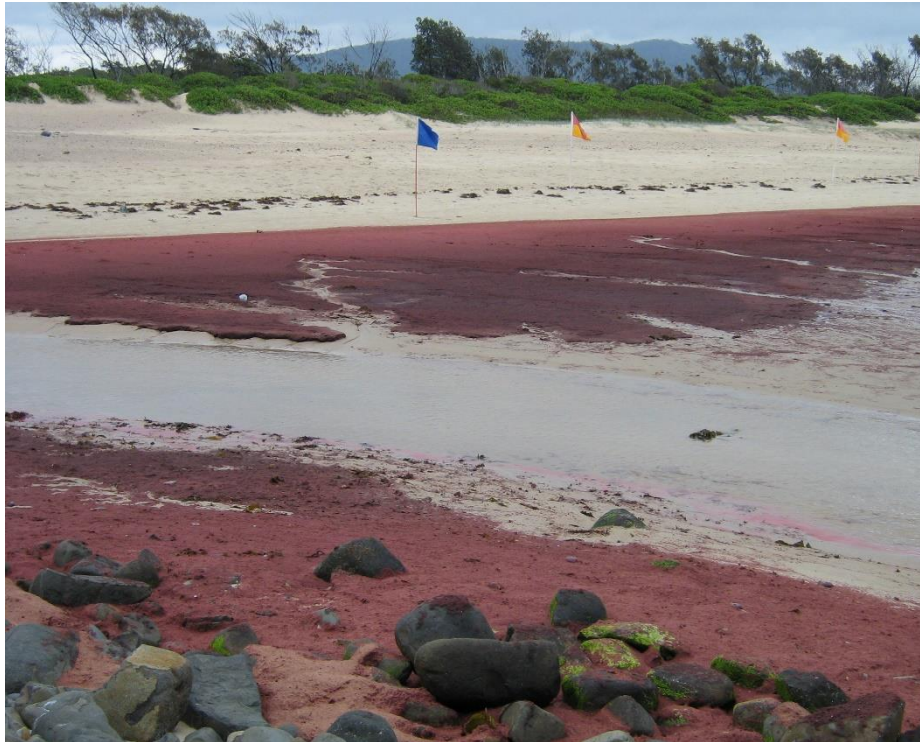
Figure 5-8 Red Algae bloom at Killick Creek in December 2006

The water at the lower reaches of the estuary has also been known to be affected by algal blooms – specifically from red algae (also known as Cornflake Weed). These events are typically precipitated by coastal upwelling events that bring nutrient rich waters from the ocean side during summers. These algae can be advected into the estuary, and when the algae eventually die, it can reduce the amount of oxygen in the water, sometimes causing fish kills and generating odours. Algal blooms and associated reduced oxygen levels can also cause adverse skin conditions in humans (BMT WBM, 2020). A series of notable algal bloom events occurred in December 2006, when a high volume of red algae was deposited onshore, see Figure 5-8.

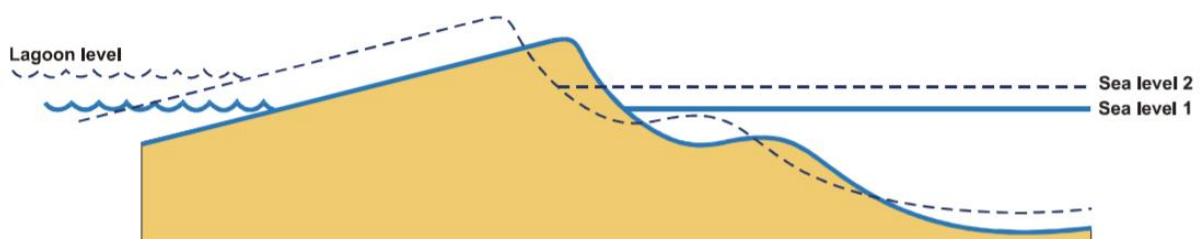
Figure 5-10 Upward and landward translation of an ICOLL berm under SLR (Hanslow, Davis, You, & Zastawny, 2000)

- **Entrance morphodynamics**: Disruptions from sea-level rise, littoral sand transport, and changes to rainfall and flooding behaviour are likely to result in an upward and landward shift in the beach profile, and potentially increased size, height and extent of the entrance berm (Hanslow, Davis, You, & Zastawny, 2000). This would then require higher water levels to precipitate a natural entrance breakout. As shown in Figure 5-10, an increase in mean sea level will result in an elevation of the base and maximum water levels, as well as the berm height within the ICOLL. This will cause inundation of additional properties in the low-lying areas adjacent to the lagoon and creek as the water level rises. It will likely require additional management of the ICOLL entrance to alleviate water level rise in the creek and lagoon due to prolonged entrance closure, as well as consideration of other measures to alleviate nuisance flooding including relocation or modification of built infrastructure.

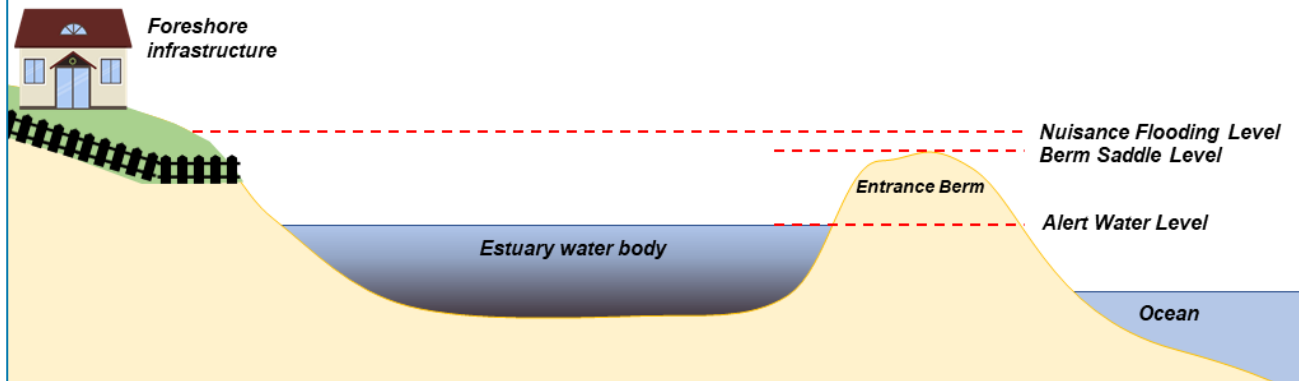
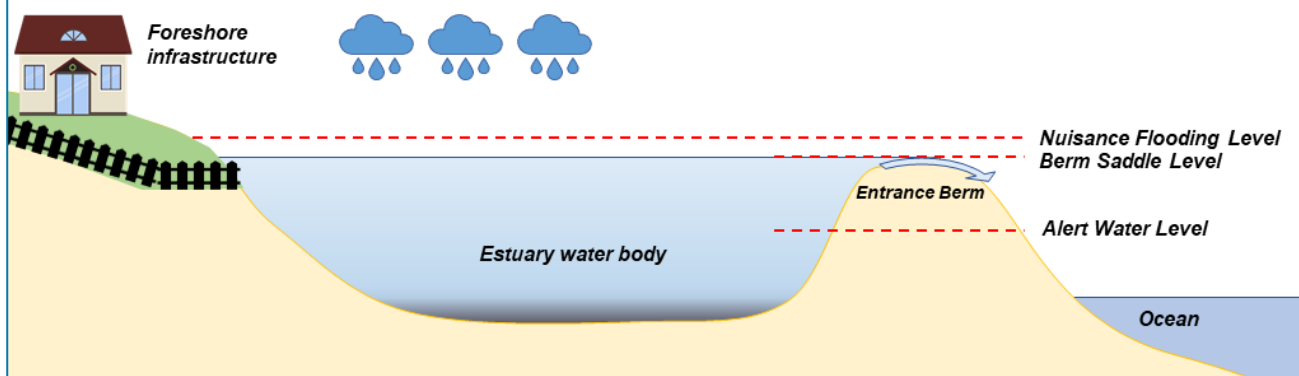
Prior to rainfall event: Once the Alert Water Level is reached, scrape the entrance berm to the Berm Saddle Level - to induce a natural opening later when rainfall occurs

During the rainfall event: Entrance berm naturally opens at the Berm Saddle Level with freshwater flows

Figure 7-1 Berm height management - breakout process

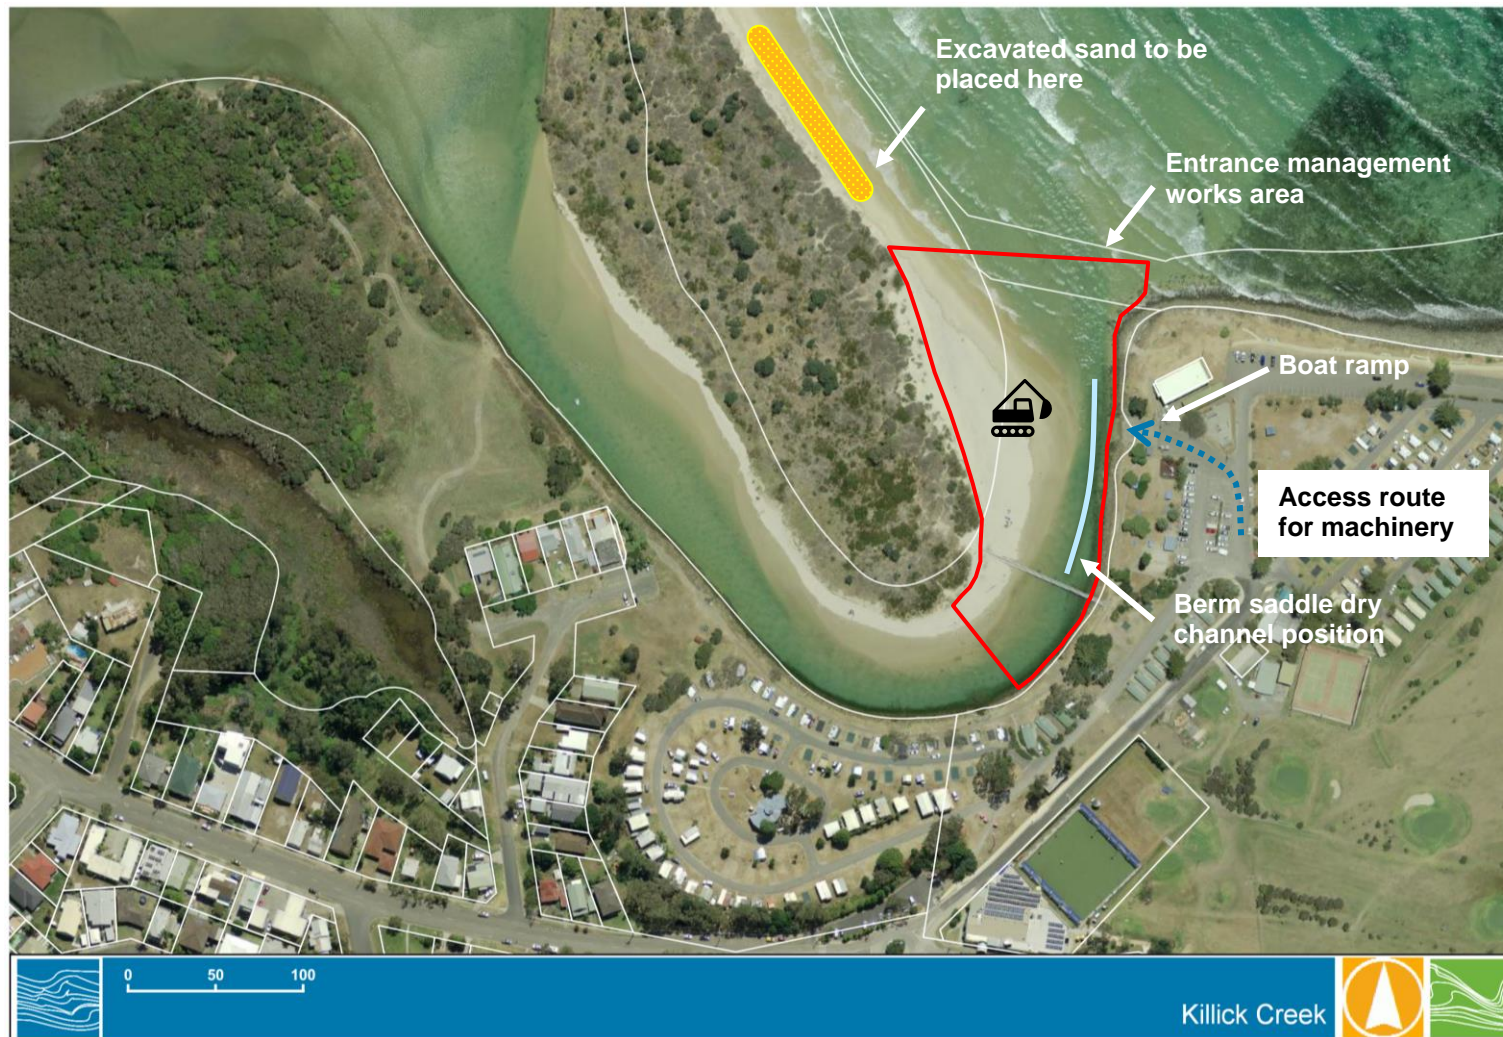
Figure 8-2 Entrance management schematic
