## 4 ESTUARY VALUES, USES AND ISSUES OF CONCERN

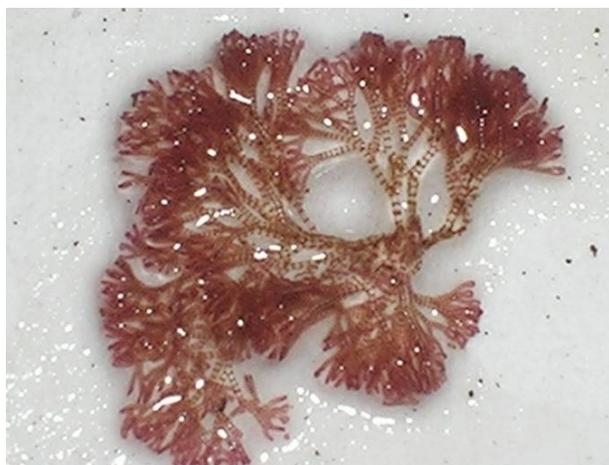
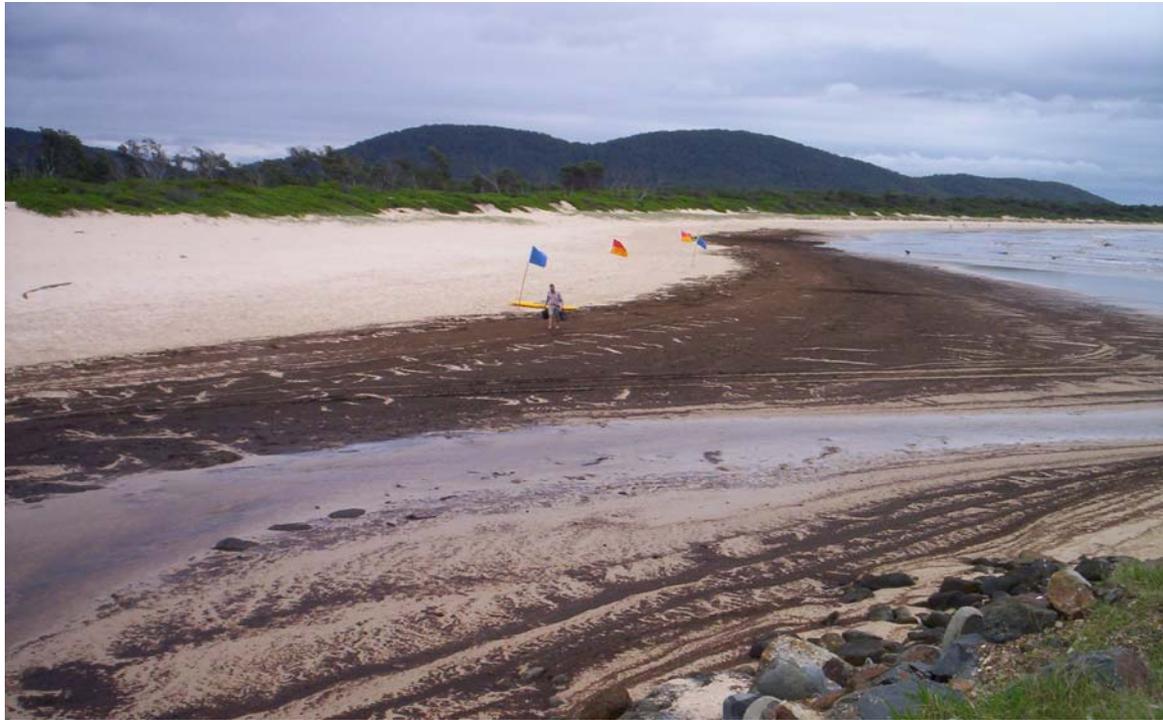
Red weed is a marine (ocean) macroalgae (see Figure 4-1) that is sometimes pushed into Killick Creek by the tides. Once the algae get into the estuary, it is trapped in the deeper holes upstream of the entrance shoal. When the algae eventually die, it can reduce the amount of oxygen in the water, sometimes causing fish kills and generating odours. Red weed has been recorded in Killick Creek at least twice since 2000.

Figure 4-1 Red weed at entrance to Killick Creek (source: KSC)

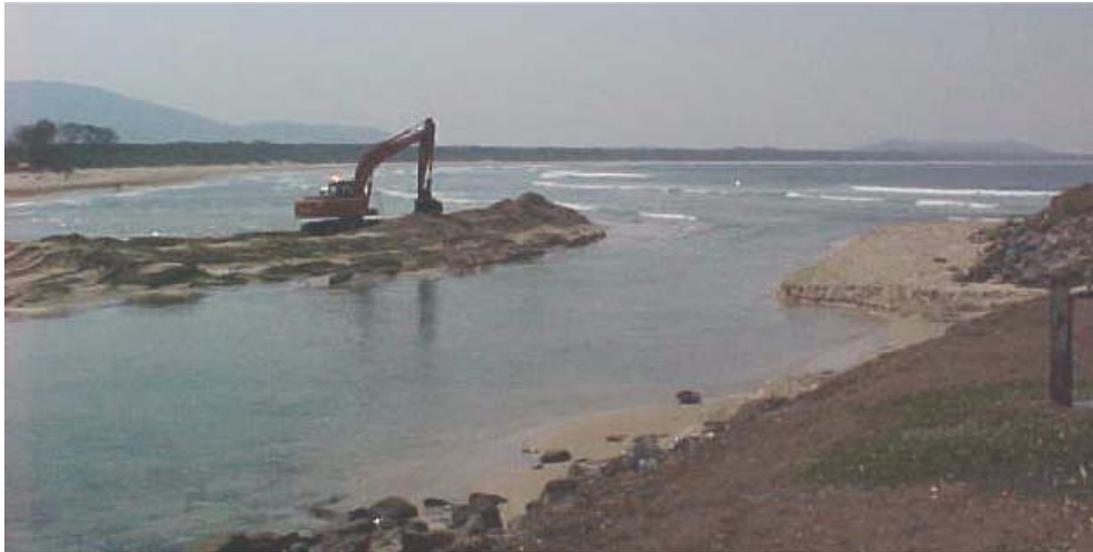
The Killick Creek entrance is usually kept open by natural processes, however, a recent exceptionally dry period has resulted in closure of the entrance. Council was required to artificially re-open the entrance to maintain water quality within the estuary given the recreational demands on the system (see Figure 4-2).

**Figure 4-2 Dredging of Killick Creek Entrance (October 2000, courtesy of Kempsey Shire Council)**

Kempsey Shire Council dredges the entrance channel of Killick Creek to “straighten the meander” that forms naturally adjacent to the Surf Club. Without correction, the meander pushes the main channel to the north, where it is feared that the channel will erode into existing coastal fore dunes. Dredging works within the estuary entrance channel have been carried out on a relatively regular basis, with benefits sometimes short-lived.

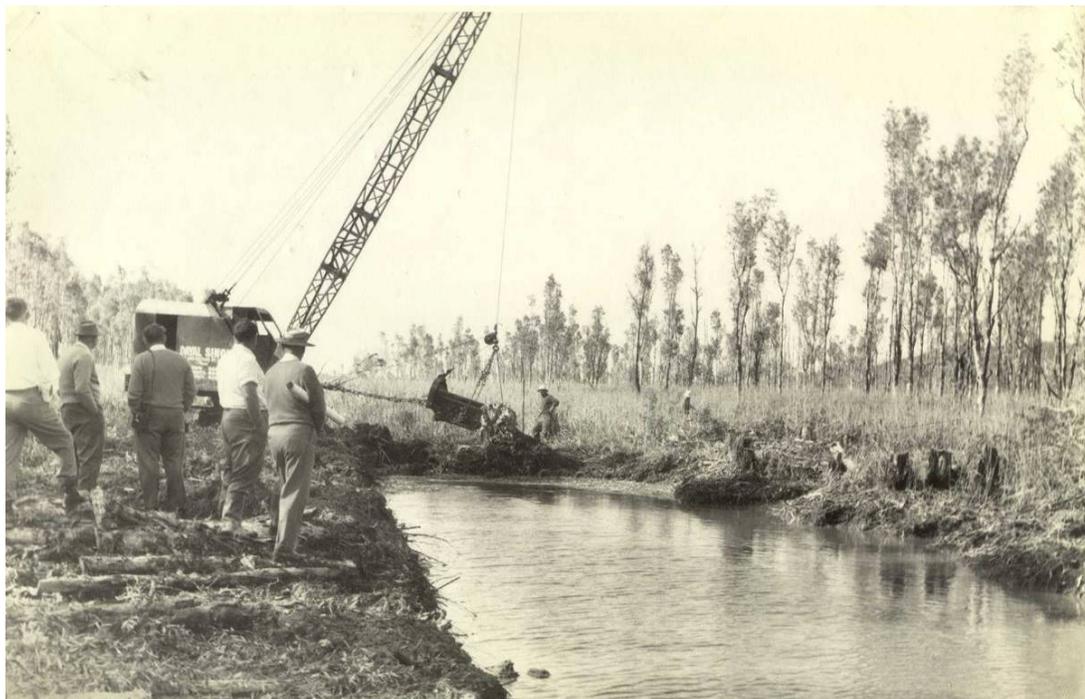
Figure 4-3 Excavation to create Killick Drain in the 1950s (photo courtesy KSC)

Killick Creek has been used to facilitate drainage from the Belmore Swamp area for more than 100 years. Drainage of low-lying land in the upper Belmore Swamp area is critical to the agricultural productivity and economic viability of this land. However, in recent years, the broad coverage of land serviced by the Killick Drain and its tributaries, along with the poor performance of the Killick Creek floodgates structure, can compromise the ability of agricultural land to be rehabilitated and better managed.

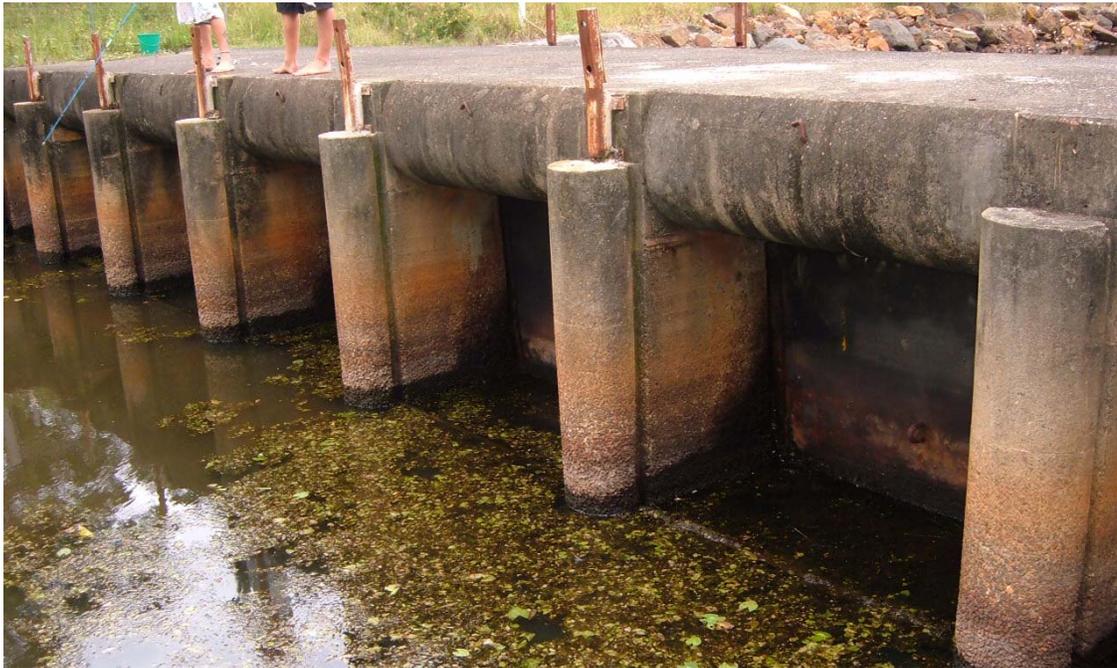
The floodgates on Killick Creek, which separate the estuary from the agricultural drains, are reportedly ineffective at times. Saltwater can migrate into the agricultural drains upstream of the gates, which significantly limits opportunities for land rehabilitation and other purposes. Their ineffectiveness may be related to poor design, poor maintenance or blockage/jamming of the gates by debris.

**Figure 4-4 Killick Creek Floodgates and dropboards (submerged)**

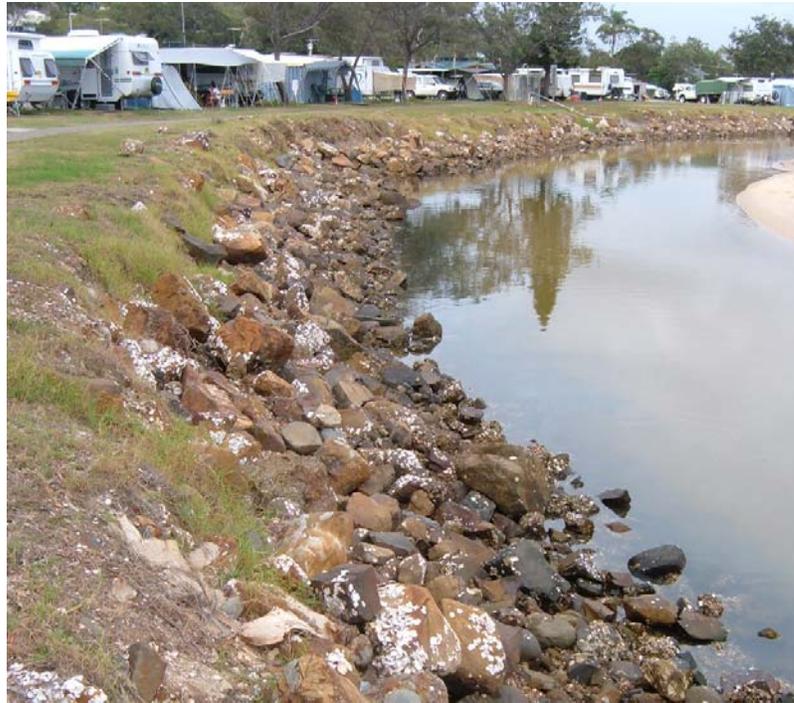
The rock training wall at the entrance of Killick Creek was constructed in the 1950s to facilitate the evacuation of flood waters from the estuary during flooding of the Lower Macleay River. The wall is comprised of loose rock rip-rap of varying size (up to approx. 0.5m diam.). The wall has lost material in several locations, resulting in localised erosion and bank retreat. The rocks are also subject to slumping, most likely due to an inadequate toe construction, and generally lack effective rock cover over the top 0.5 metres of wall (refer Figure 4-5). Rocks from in front of the wall toe are periodically replaced onto the top of the wall (as indicated by presence of oyster shells).

**Figure 4-5 Existing rock wall at Killick Creek entrance**

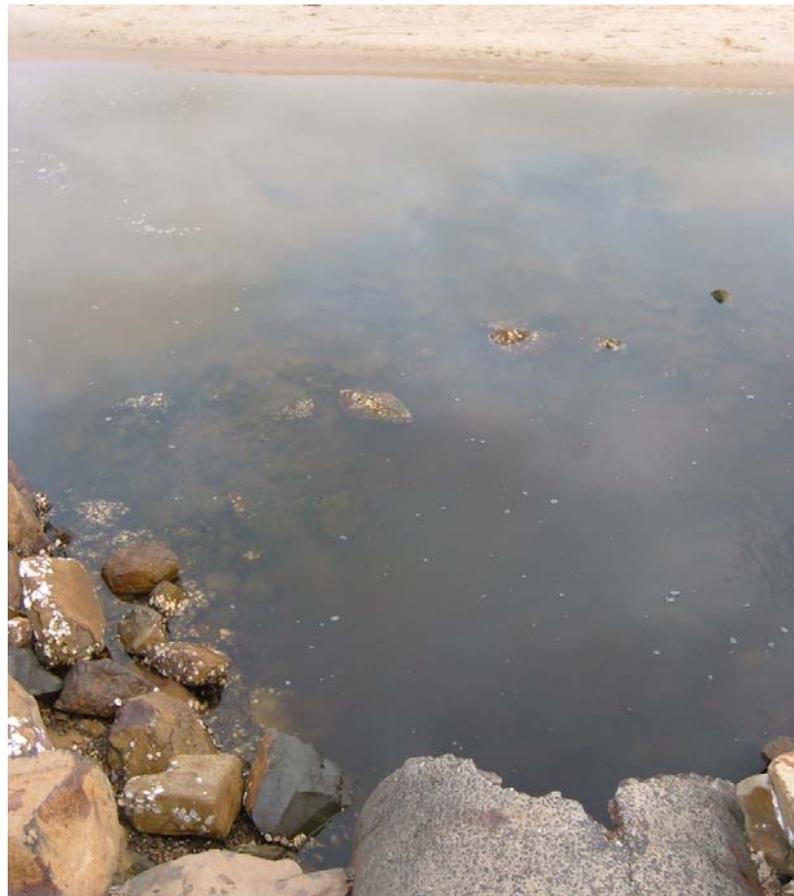
Furthermore, in the vicinity of some stormwater outlets, high flow stormwater discharges have dislodged rocks from the wall to form a rock-lined apron within the adjacent channel section (refer Section Figure 4-6). These swathes of rocks, which extent across the entire low flow channel, are particularly hazardous to recreational activities carried out in the vicinity.

**Figure 4-6 Rock apron formed from dislodged wall material**
